Inspection Report

Little Egg Harbor NJ 08087

JLC Home Inspections, llc

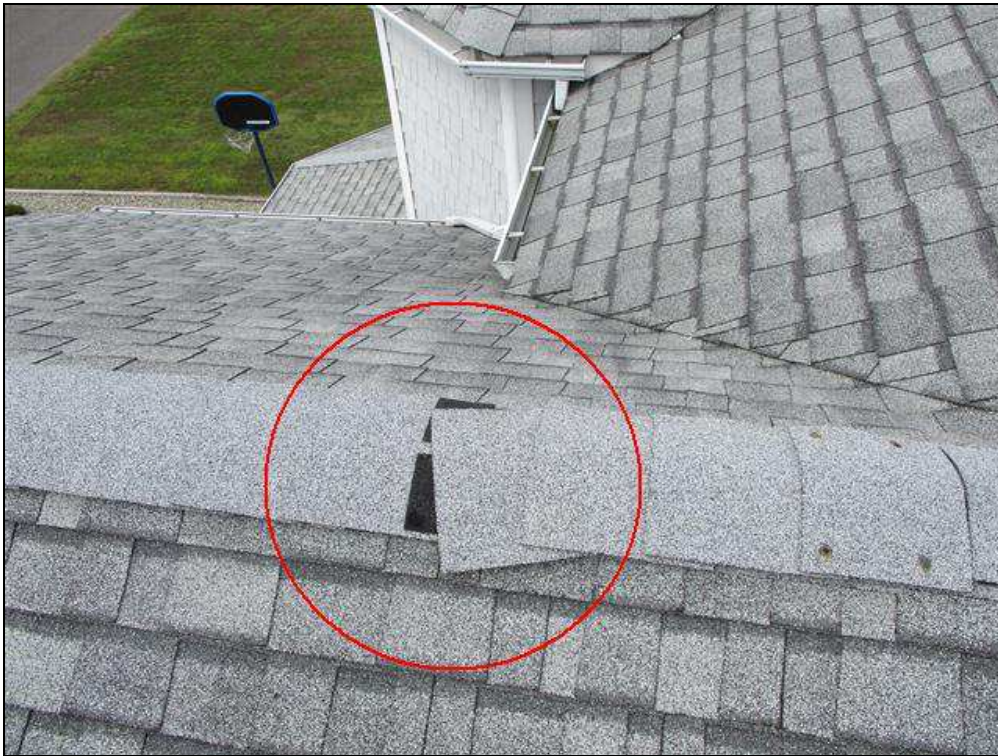
1.0 The damaged and loose roof shingles need to be repaired or replaced in order to avoid moisture intrusion. This work should be performed by a licensed professional roofer

1.0 Item 1(Picture) Loose roof shingle

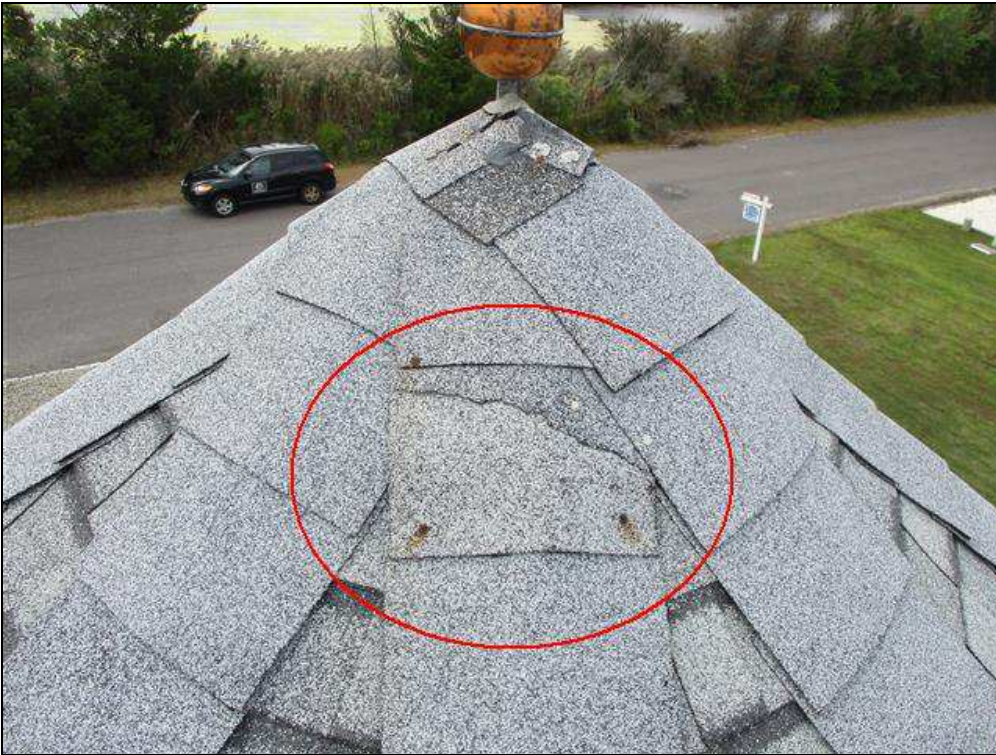
1.0 Item 2(Picture) Damaged roof shingle

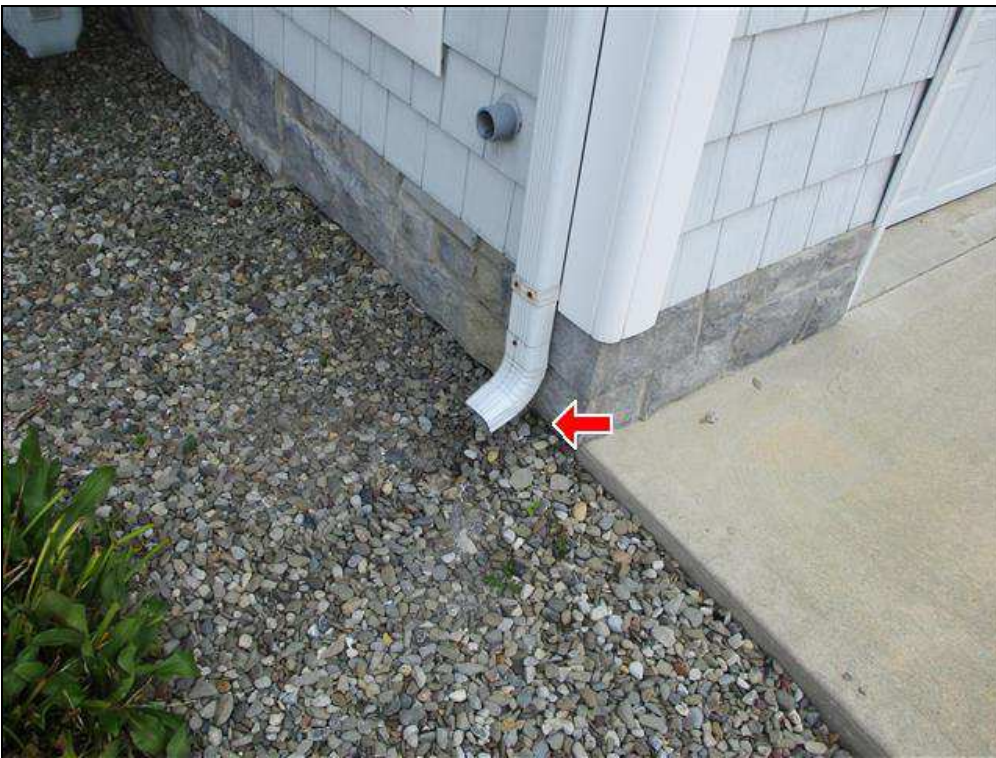
1.3 The entire house gutter downspout system should be equipped with 6 foot leaders in order to carry the water from the field of the roof away from the structure

1.3 Item 1(Picture) Gutter downspout termination

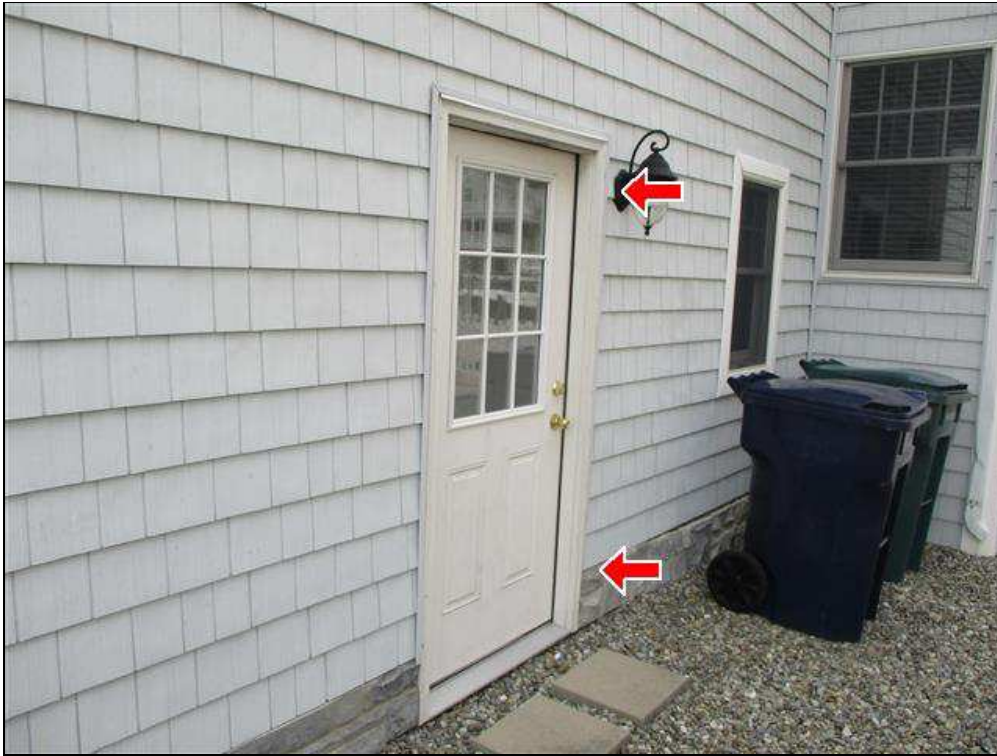
2.1 I recommend that a storm door be installed at the side garage entry door as it will protect the door framing from moisture intrusion.

2.1 Item 1(Picture) Garage entry door

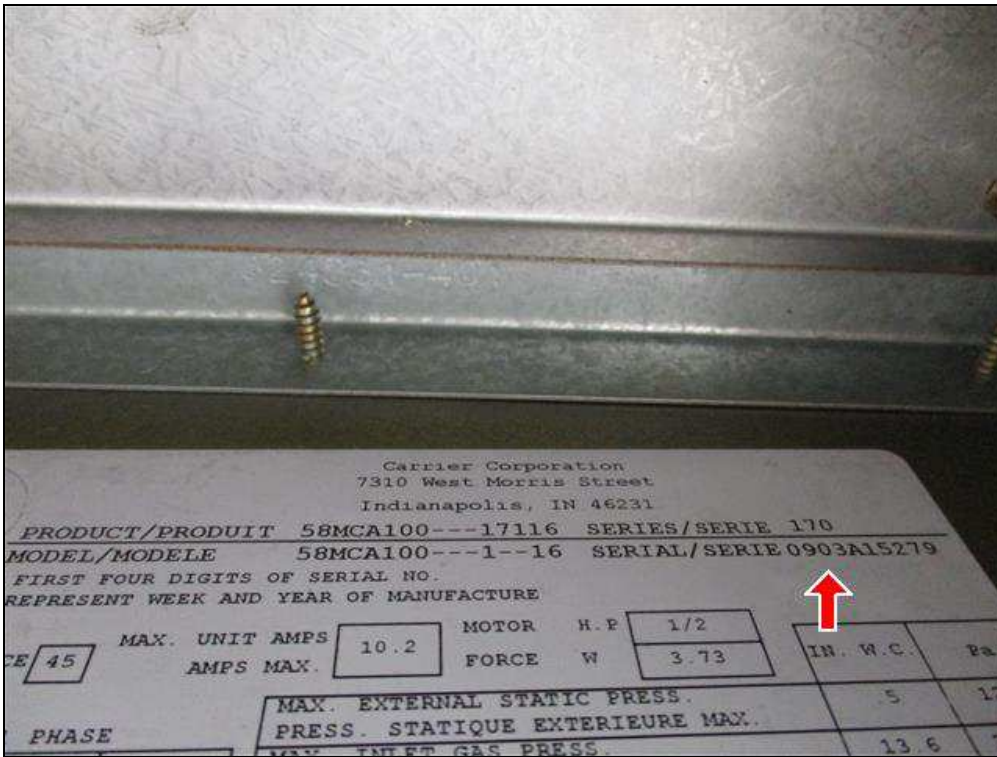
4.0 (1) The furnace data plate (garage unit) indicates a manufacture date during the 9th week of 2003

4.0 Item 1(Picture) Furnace data plate (garage unit)

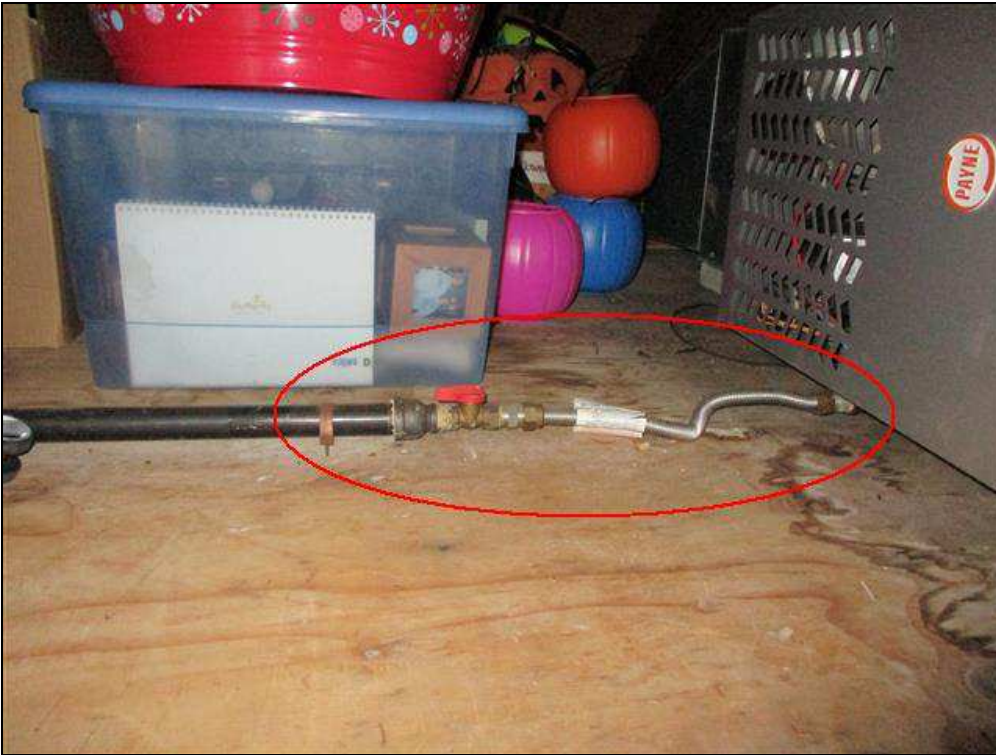
(4) The gas supply to the attic furnace is not equipped with a drip leg. A drip leg is used to catch any impurities in the gas before it enters the furnace. I recommend that a drip leg be installed by a licensed professional plumber

4.0 Item 6(Picture) No drip leg

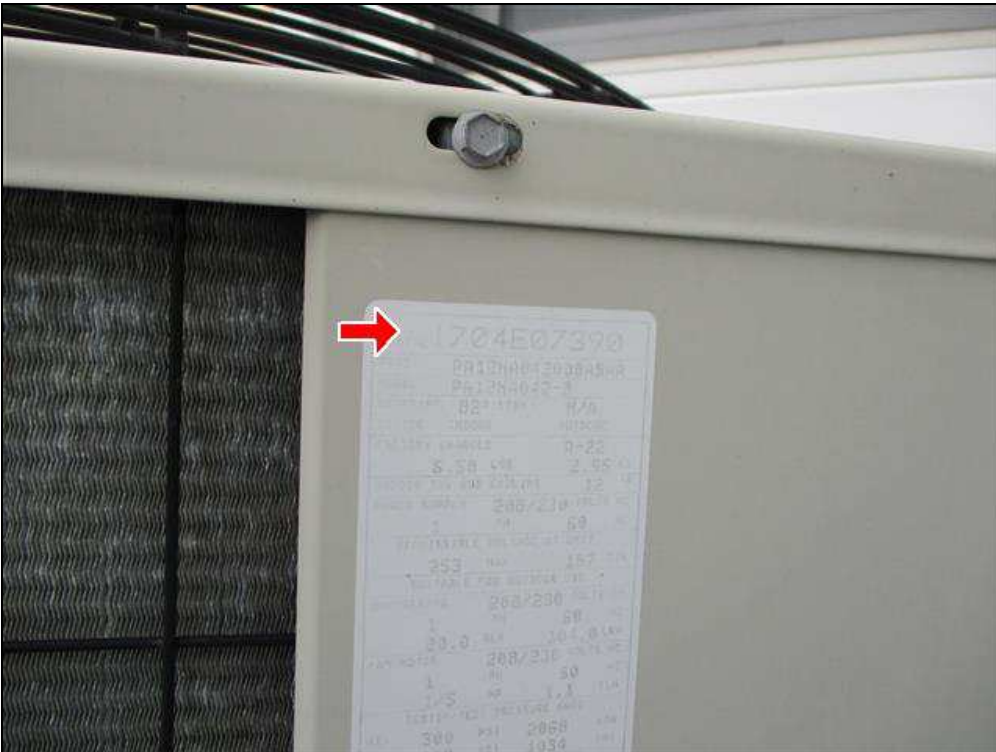
4.8 Item 1(Picture)

4.8 (1) The A/C condensing unit data plates indicate manufacture dates during the 17th week of 2004 (left side unit) and the 20th week of 2004 (right side unit)

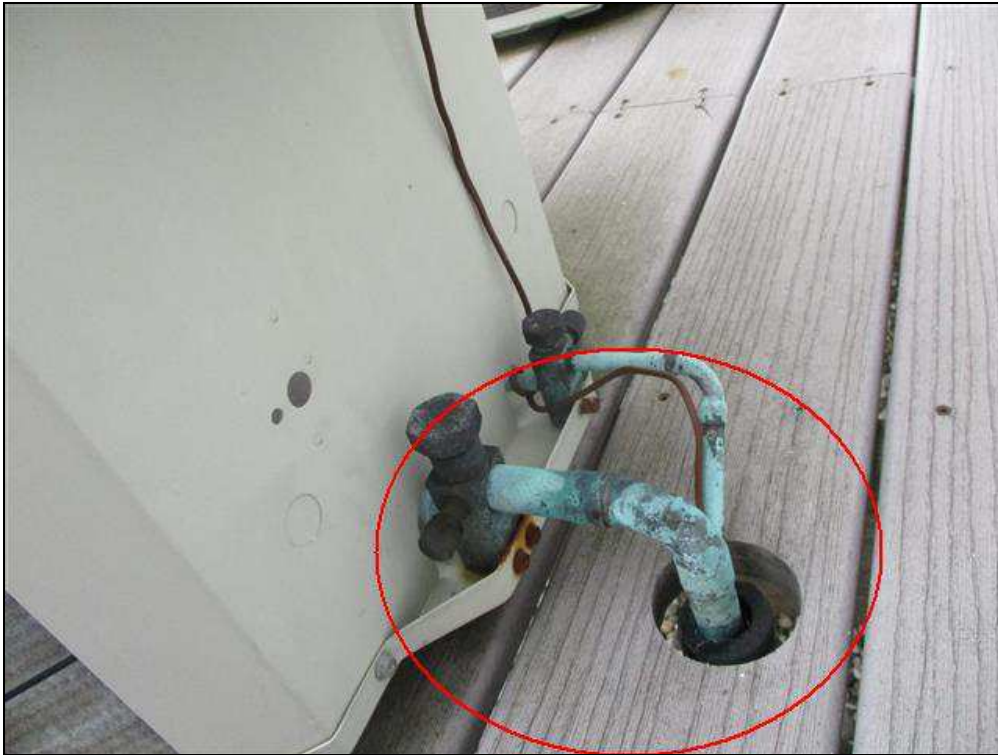
(2) The foam sleeve on the suction line is missing in area(s) at the outside unit. Missing foam on the suction line can cause energy loss and condensation. I recommend service or repair as needed.

4.8 Item 2(Picture) Missing insulation

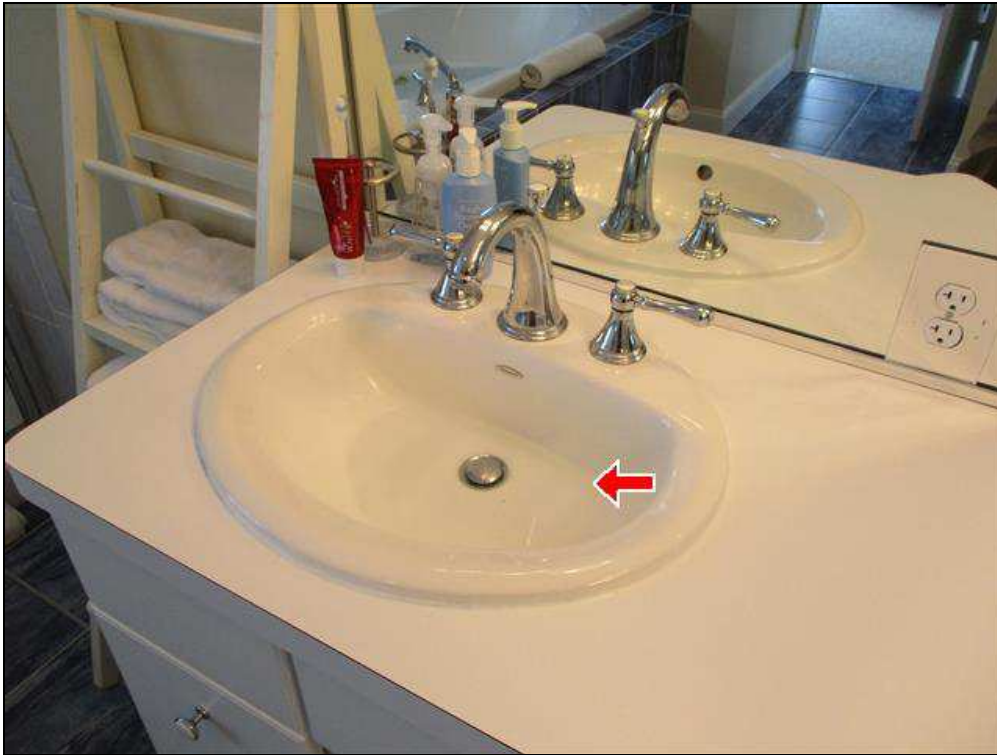
5.0 The sink in the master bathroom (left side) drained slowly at the time of the inspection. The P-trap could be clogged or there may be a venting issue. Further evaluation by a licensed professional plumber is recommended

5.0 Item 1(Picture) Master bathroom sink

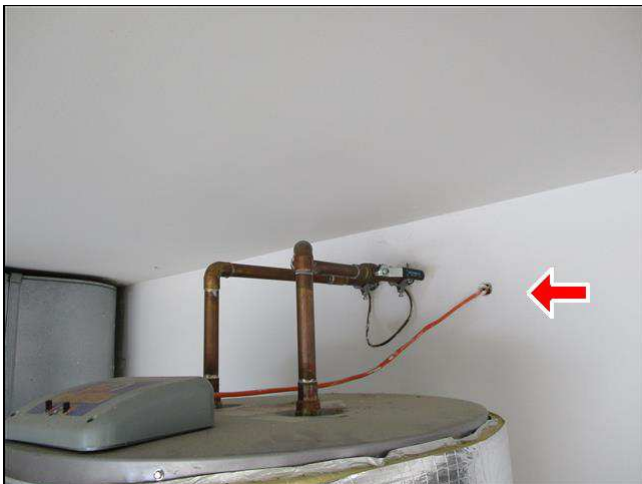
5.2 The water heater is wrapped in insulation, therefore I was unable to obtain data plate information without causing damage. The water heater is located within sight of the electrical panel, therefore the installation of a manual disconnect is not necessary. The electrical panel legend is mislabeled, which will make it difficult to isolate the water heater in the event of an emergency. I recommend that a qualified person ensure that the electrical service panel legend be filled out properly

5.2 Item 1(Picture) Water heater

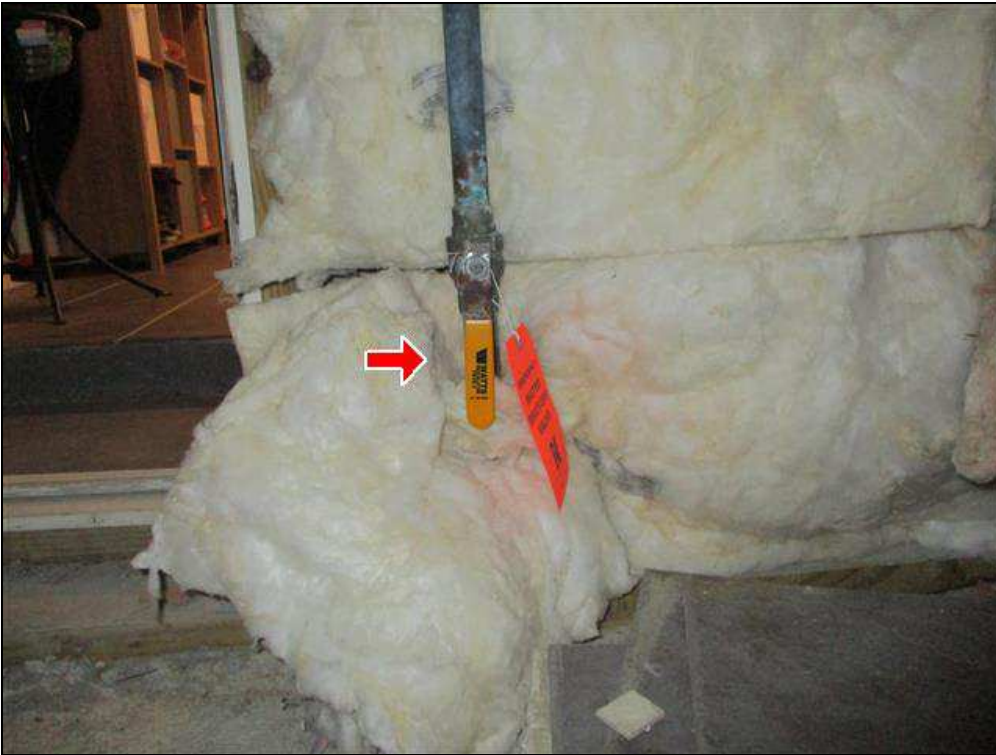
5.3 The main water shut off is the yellow lever located underneath in the crawlspace. This is for your information.

5.3 Item 1(Picture) Main water shut off

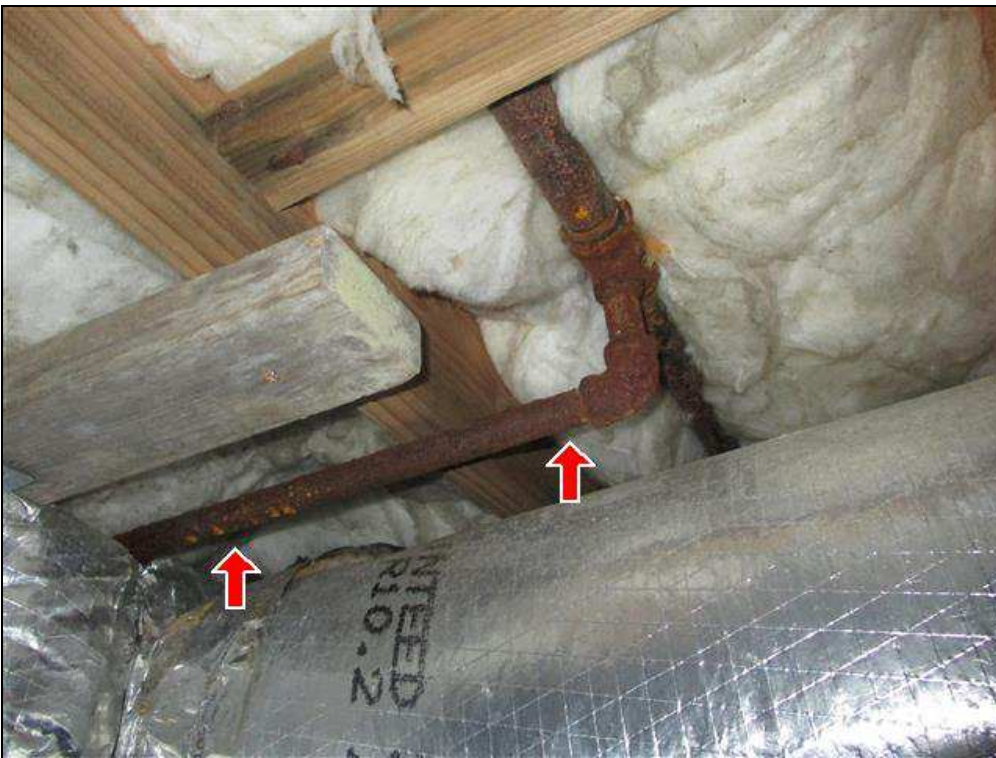
5.4 The gas lines in the crawlspace are suffering from surface rusting. Given the location of the pipes this is a natural occurrence. I recommend these pipes be sealed with an appropriate paint to ensure their longevity

5.4 Item 1(Picture) Gas lines

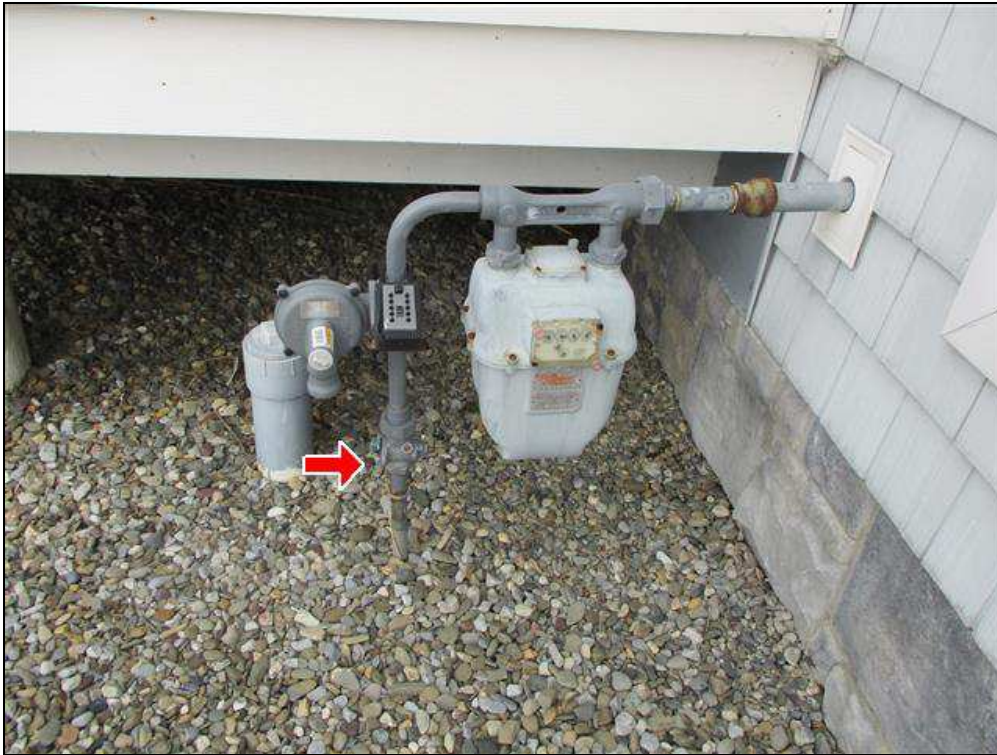
5.5 The main fuel shut off is at the gas meter outside

5.5 Item 1(Picture) Main fuel shut off

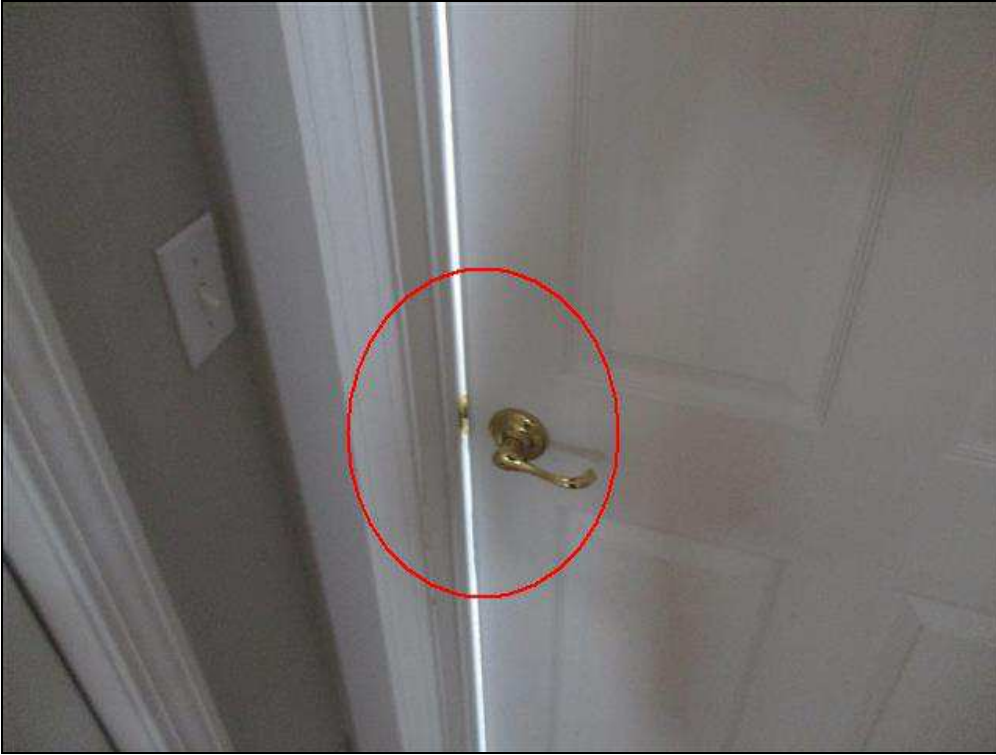
8.5 The entry door needs strike and latch adjustment to shut tight at the master bedroom. This is a maintenance issue and is for your information. A qualified person should repair or replace as needed.

8.5 Item 1(Picture) Master bedroom door

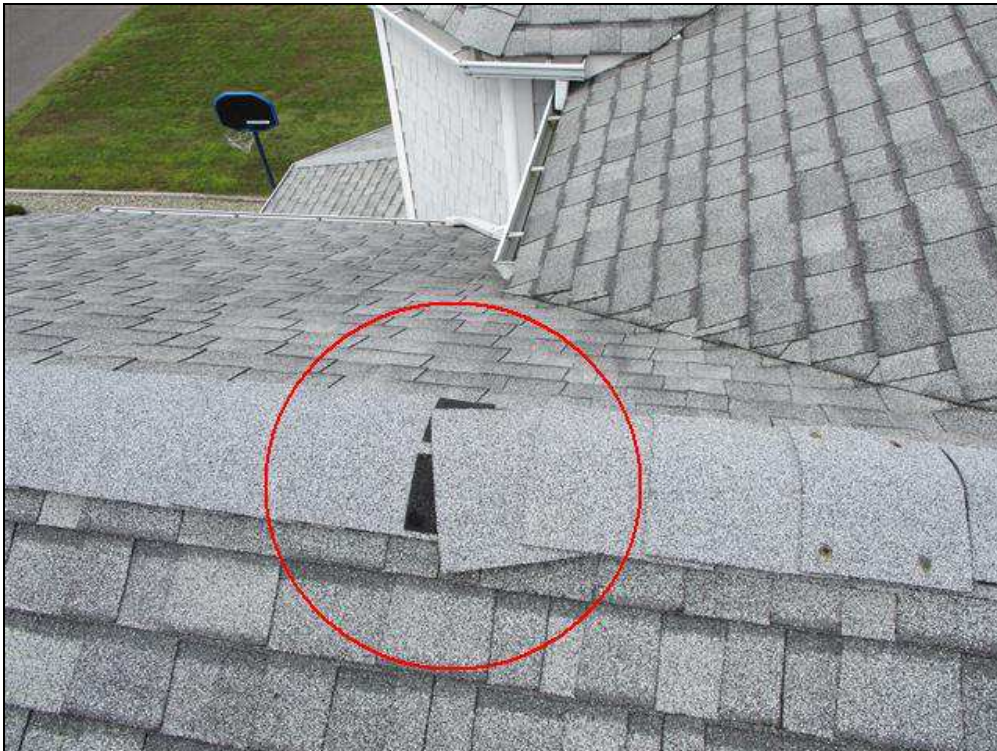
The damaged and loose roof shingles need to be repaired or replaced in order to avoid moisture intrusion. This work should be performed by a licensed professional roofer

1.0 Item 1(Picture) Loose roof shingle

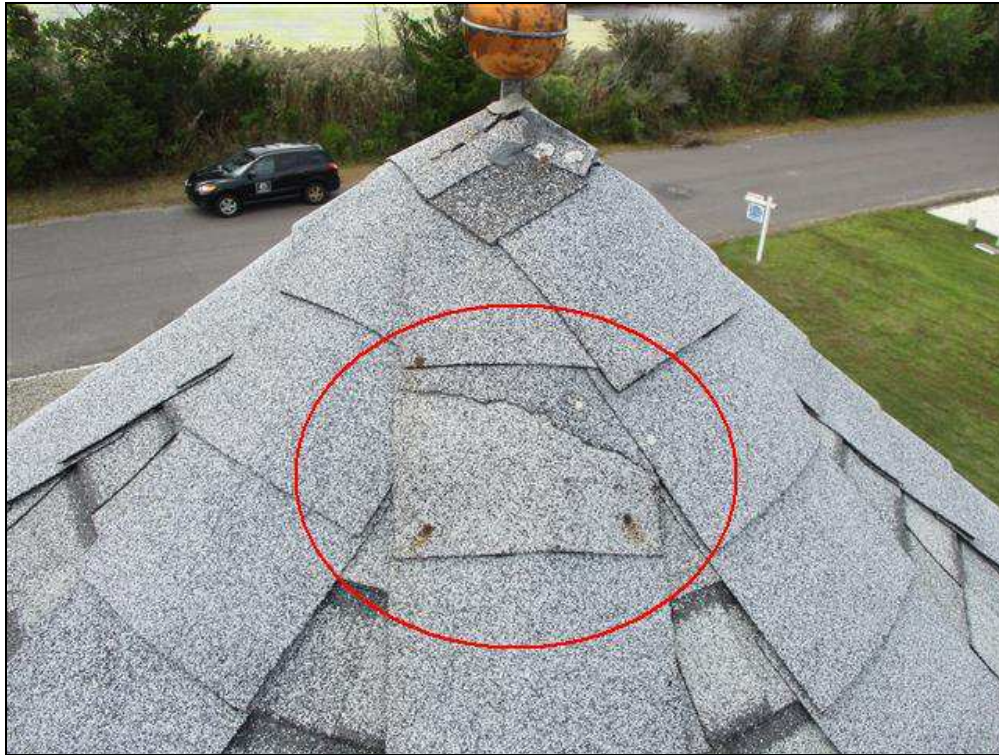
1.0 Item 2(Picture) Damaged roof shingle

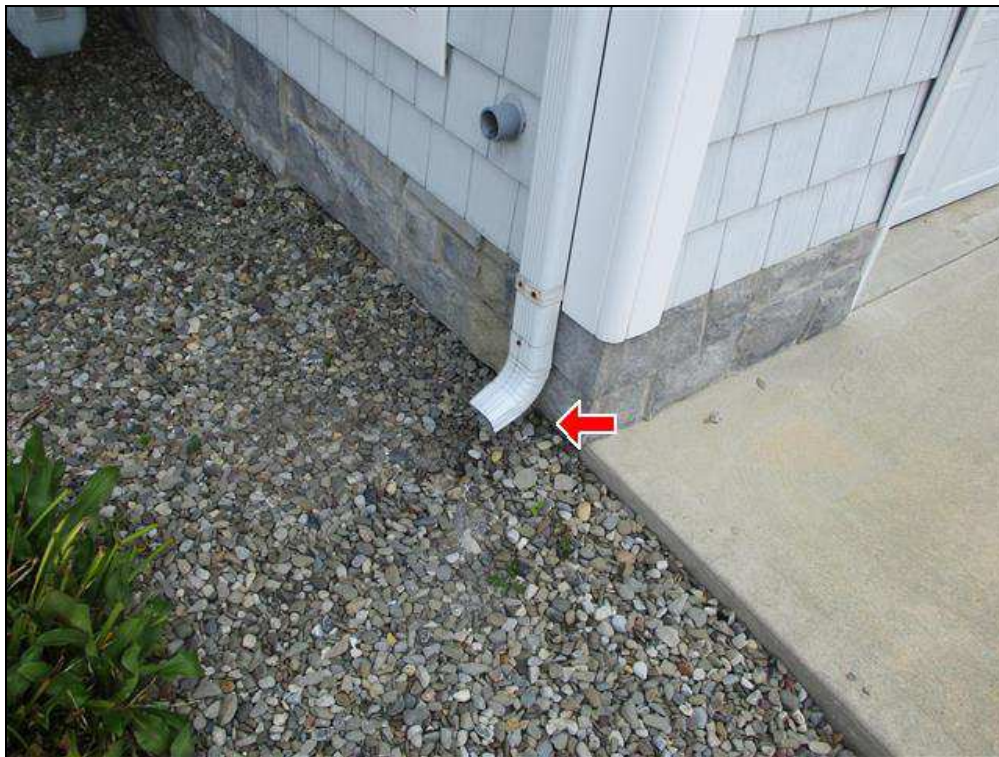
The entire house gutter downspout system should be equipped with 6 foot leaders in order to carry the water from the field of the roof away from the structure

1.3 Item 1(Picture) Gutter downspout termination

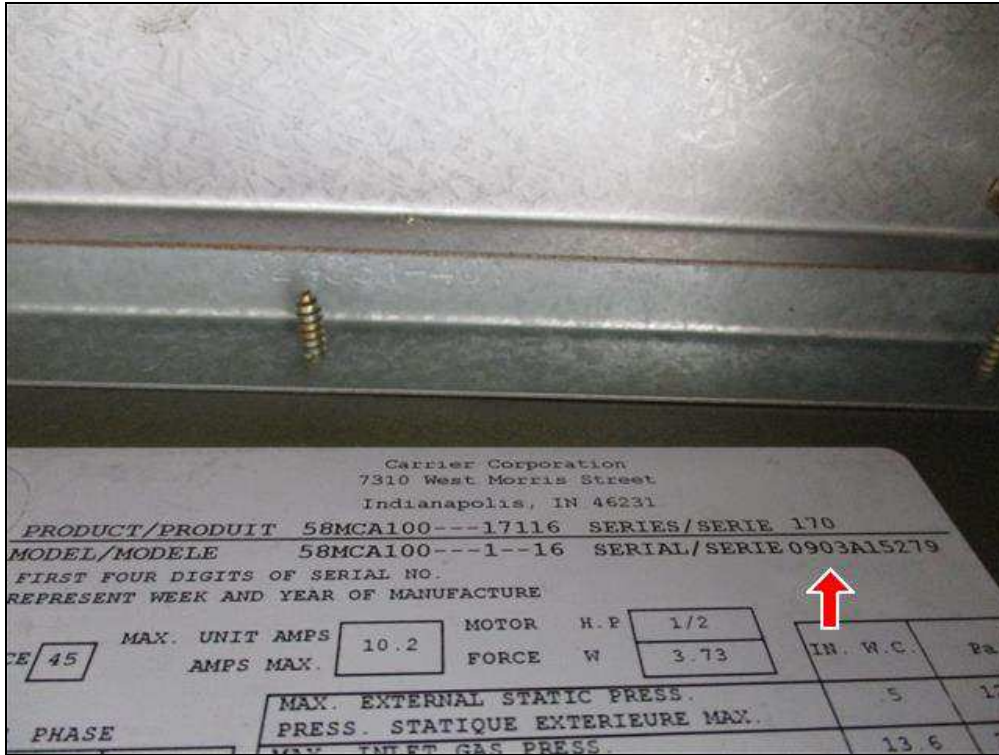
(1) The furnace data plate (garage unit) indicates a manufacture date during the 9th week of 2003

4.0 Item 1(Picture) Furnace data plate (garage unit)

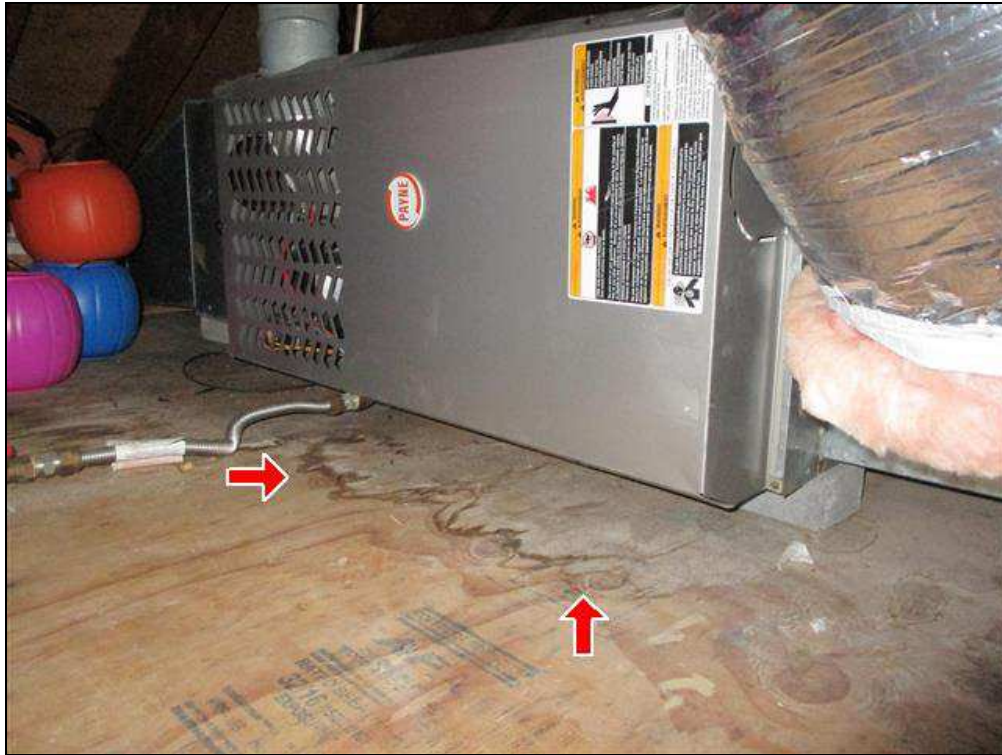
(3) Both attic and garage furnace and air handlers are not equipped with a secondary condensate drain pan. The attic unit shows sign of leakage at the wooden support sheathing. I recommend further evaluation by a licensed HVAC professional

4.0 Item 3(Picture) No secondary condensate drain pan (attic unit)

4.0 Item 4(Picture) No secondary condensate drain pan (attic unit)

4.0 Item 5(Picture) No secondary condensate drain pan (garage unit)

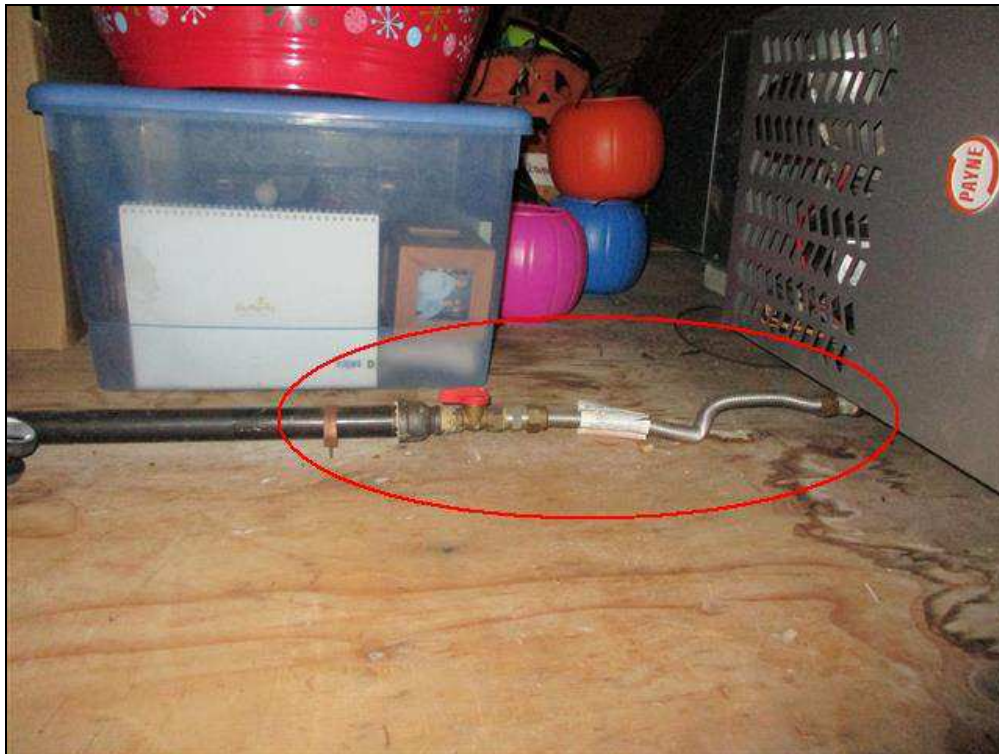
(4) The gas supply to the attic furnace is not equipped with a drip leg. A drip leg is used to catch any impurities in the gas before it enters the furnace. I recommend that a drip leg be installed by a licensed professional plumber

4.0 Item 6(Picture) No drip leg

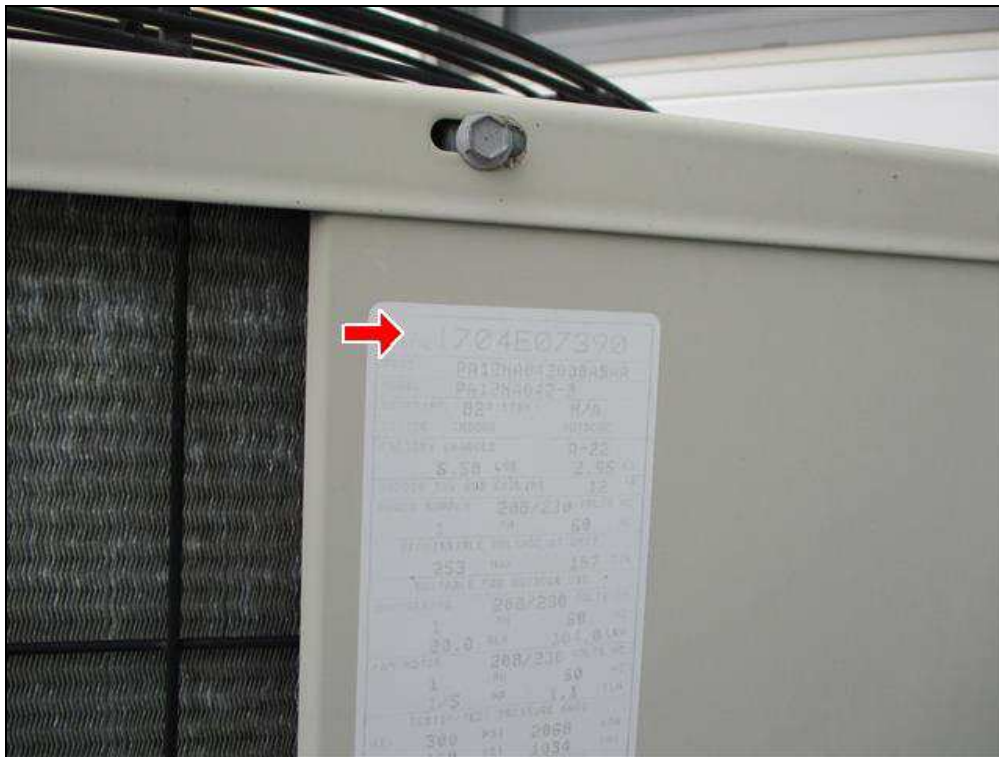
4.8 Item 1(Picture)

(1) The A/C condensing unit data plates indicate manufacture dates during the 17th week of 2004 (left side unit) and the 20th week of 2004 (right side unit)

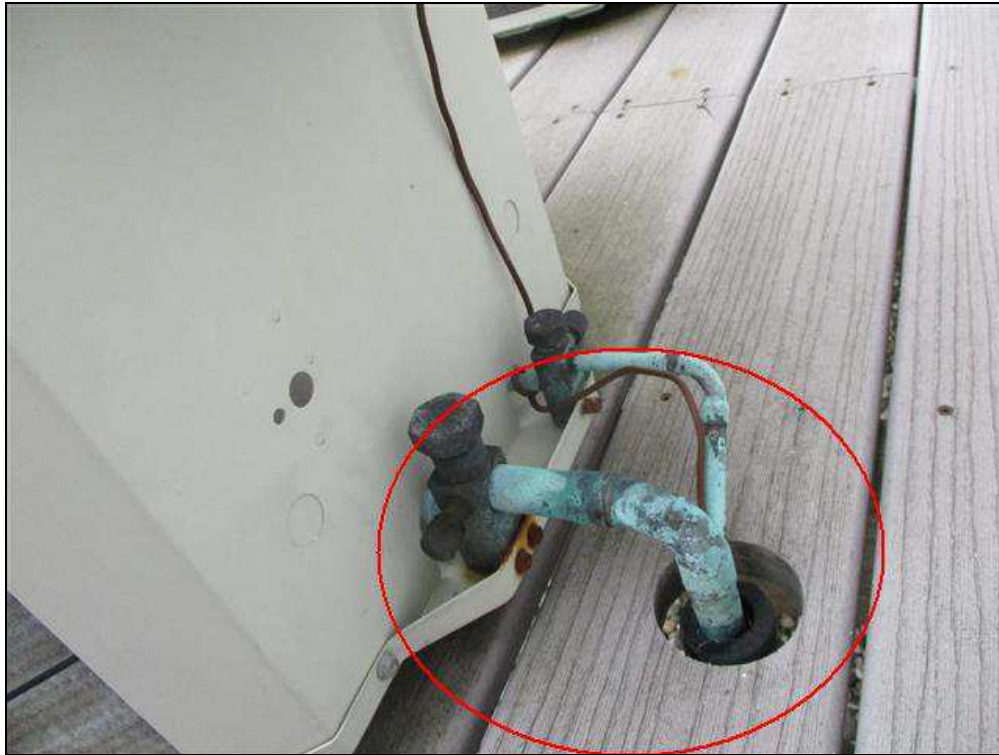
(2) The foam sleeve on the suction line is missing in area(s) at the outside unit. Missing foam on the suction line can cause energy loss and condensation. I recommend service or repair as needed.

4.8 Item 2(Picture) Missing insulation

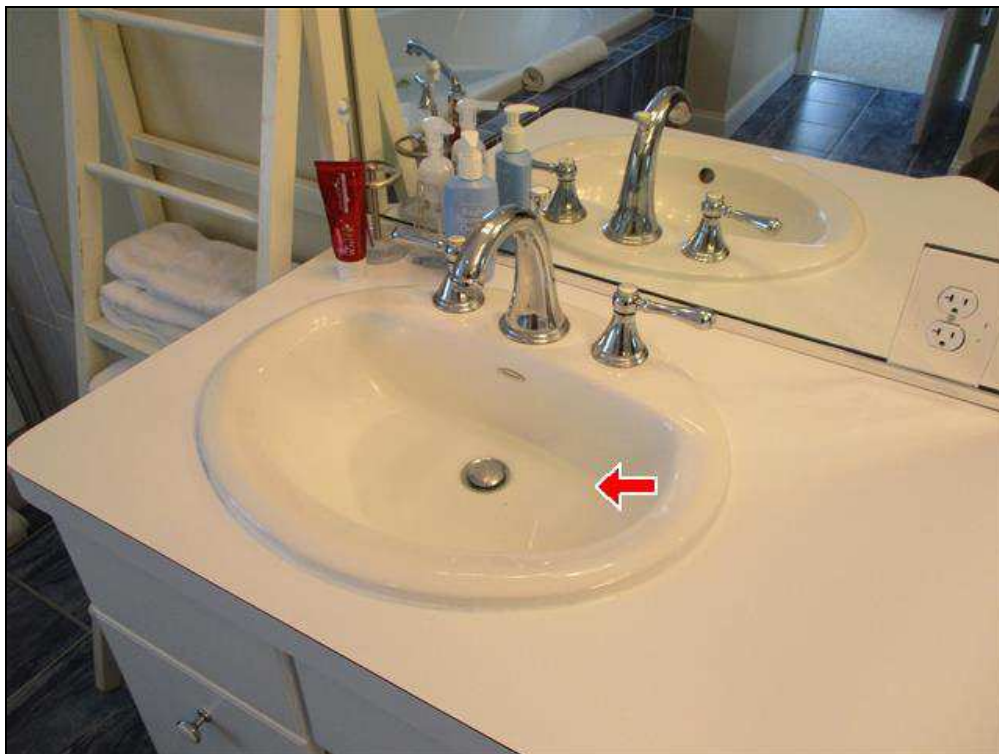
The sink in the master bathroom (left side) drained slowly at the time of the inspection. The P-trap could be clogged or there may be a venting issue. Further evaluation by a licensed professional plumber is recommended

5.0 Item 1(Picture) Master bathroom sink

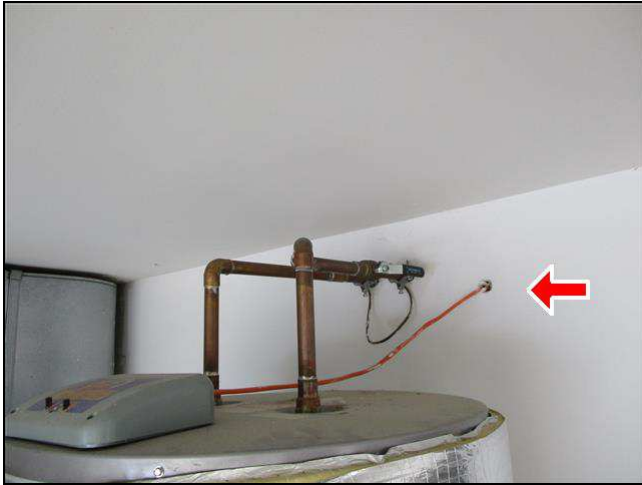
The water heater is wrapped in insulation, therefore I was unable to obtain data plate information without causing damage. The water heater is located within sight of the electrical panel, therefore the installation of a manual disconnect is not necessary. The electrical panel legend is mislabeled, which will make it difficult to isolate the water heater in the event of an emergency. I recommend that a qualified person ensure that the electrical service panel legend be filled out properly

5.2 Item 1(Picture) Water heater

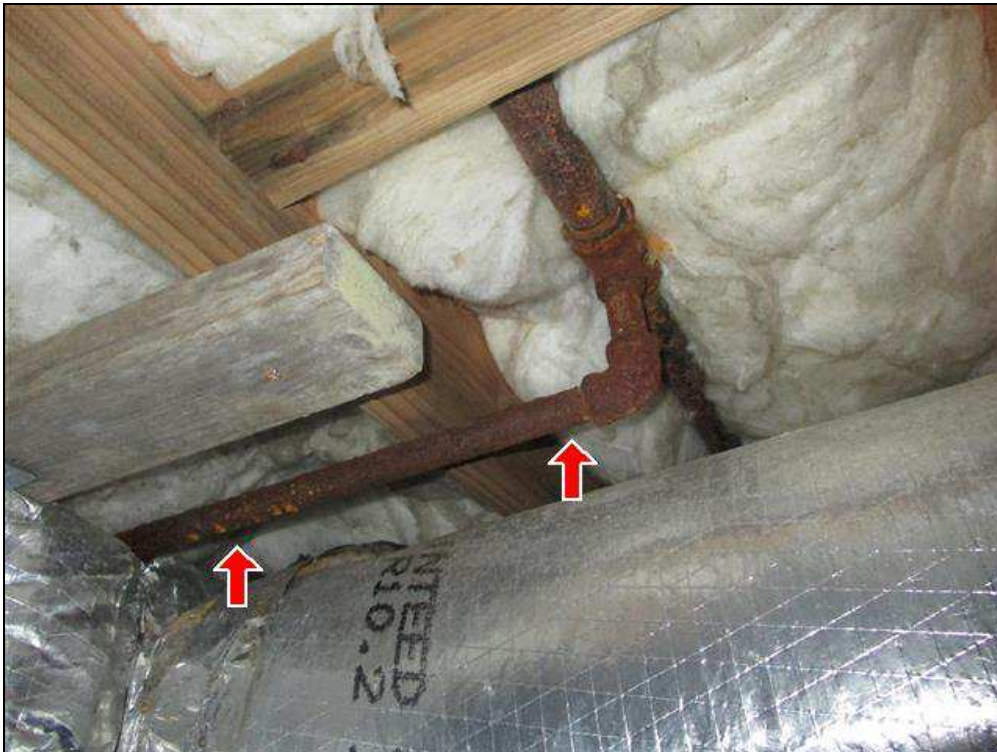
The gas lines in the crawlspace are suffering from surface rusting. Given the location of the pipes this is a natural occurrence. I recommend these pipes be sealed with an appropriate paint to ensure their longevity

5.4 Item 1(Picture) Gas lines

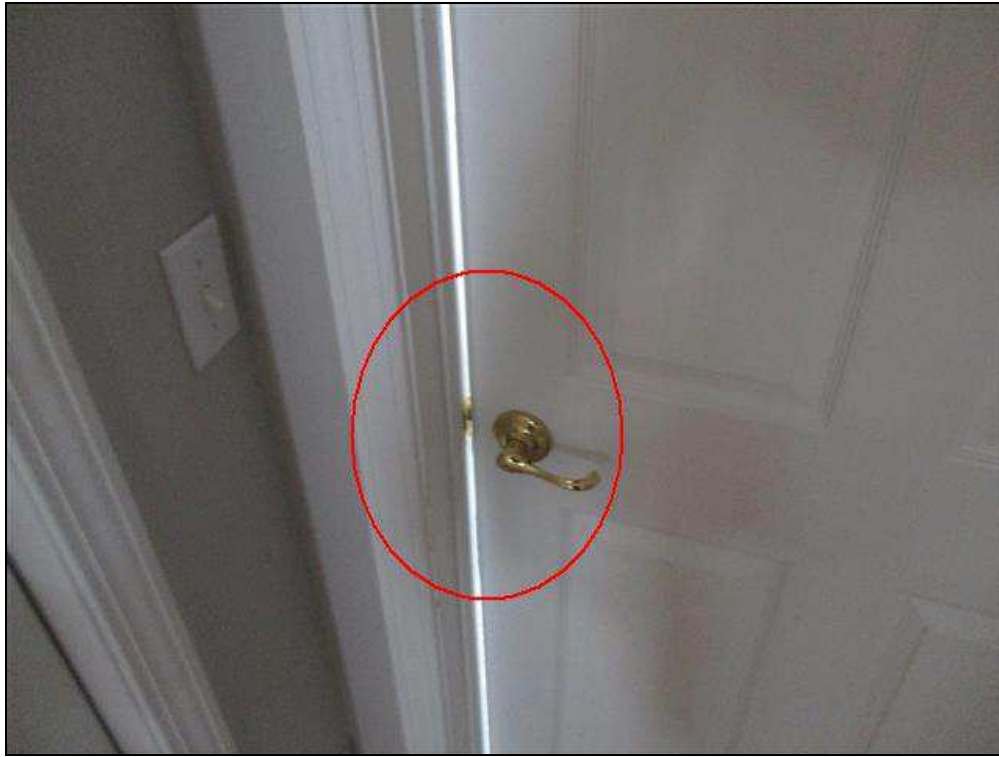
The entry door needs strike and latch adjustment to shut tight at the master bedroom. This is a maintenance issue and is for your information. A qualified person should repair or replace as needed.

8.5 Item 1(Picture) Master bedroom door
