Inspection Report

Brick NJ 08723

JLC Home Inspections, llc

Date: 9/12/2017	Time: 09:00 AM	Report ID:
Property:	Customer:	Real Estate Professional:
Brick NJ 08723

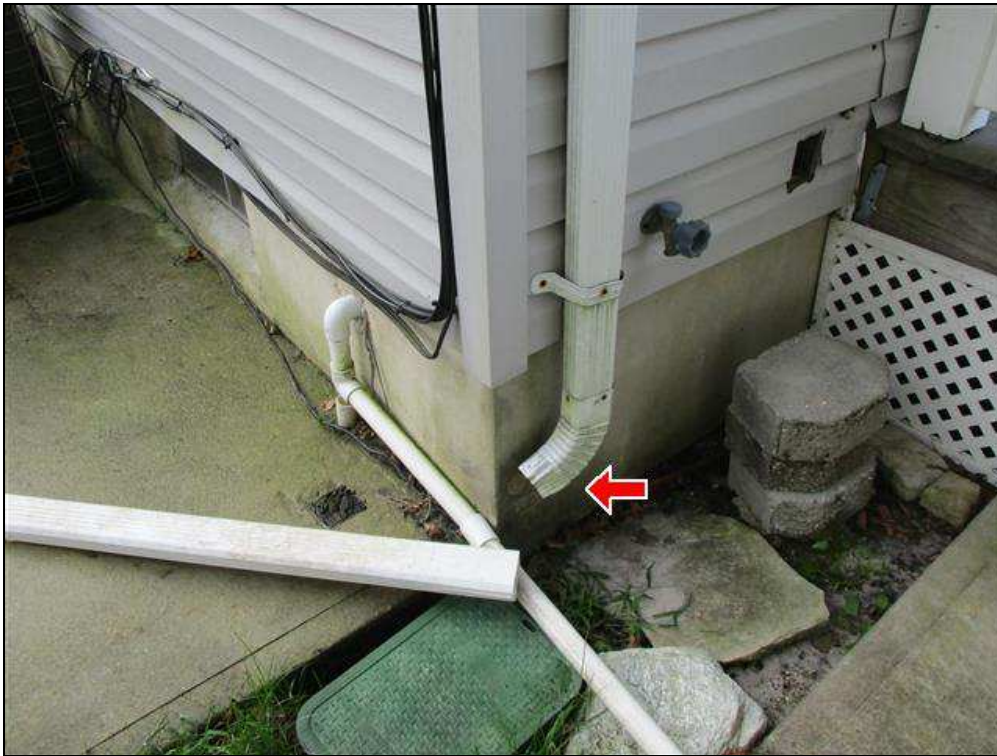
1.3 Item 1(Picture) Gutter downspout termination

1.3 The entire house gutter downspout system should be equipped with 6 foot leaders in order to carry the water from the field of the roof away from the structure

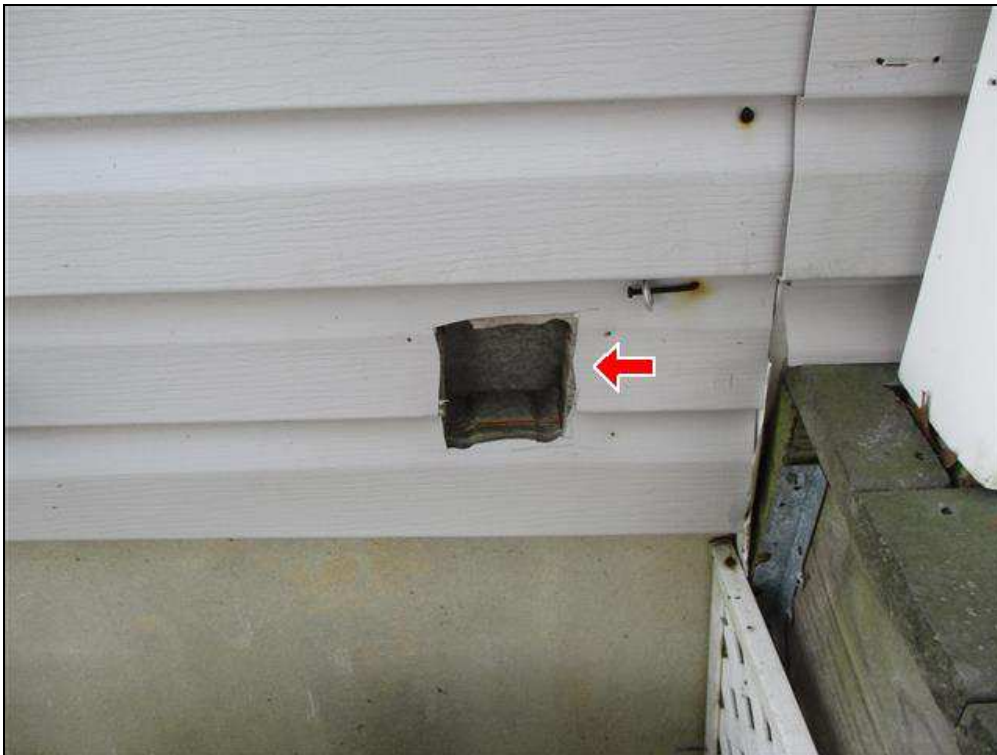
2.0 Item 1(Picture) Hole in siding

2.0 The pictured hole in the siding should be sealed in order to avoid moisture and/or insect intrusion

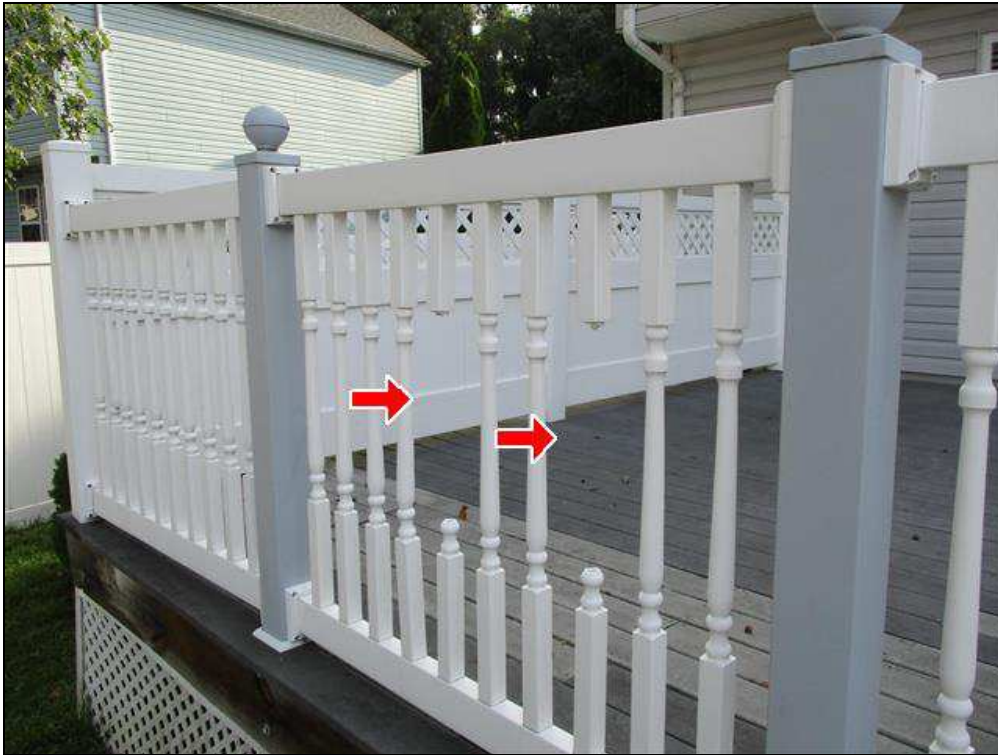
2.3 Item 1(Picture) Missing spindles

2.3 (1) The hand/guard rail for the rear deck is missing numerous spindles. A fall or injury could occur if not corrected. A qualified contractor should repair or replace as needed.

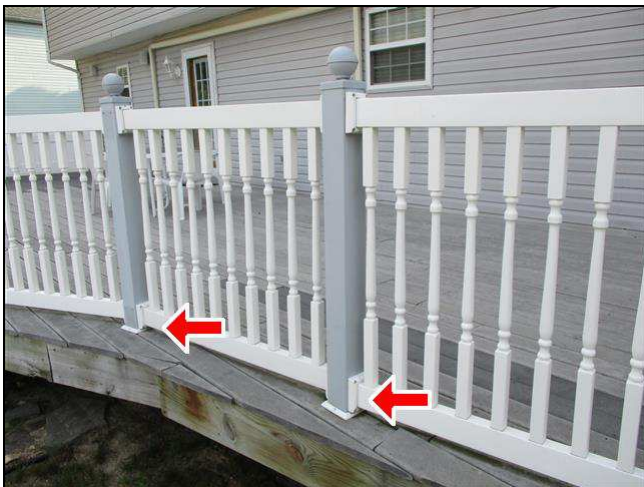
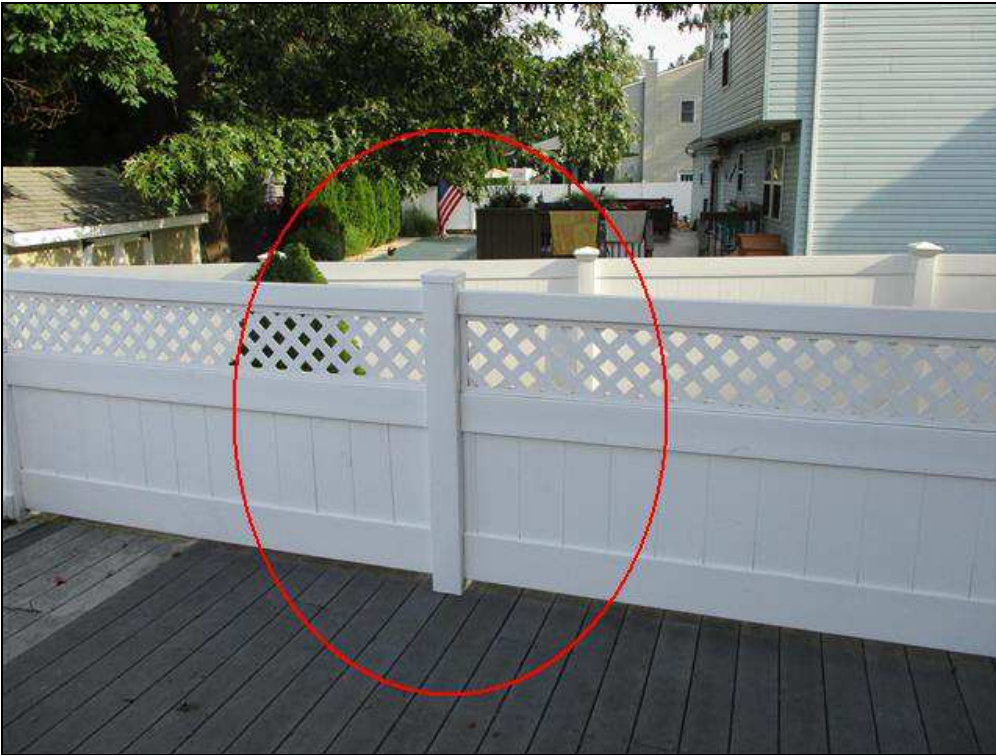
2.3 Item 2(Picture) Loose handrail

(2) The hand/guard rail for the rear deck is loose in areas. A fall or injury could occur if not corrected. A qualified contractor should repair or replace as needed.

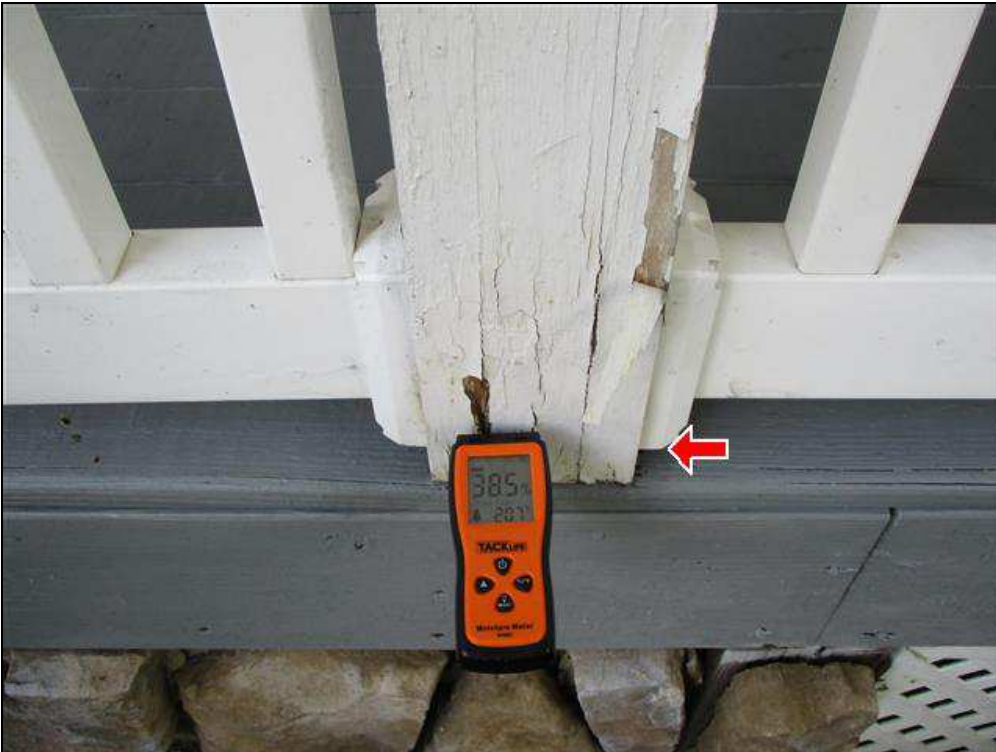
2.3 Item 4(Picture) Deck railing post

(3) The deck railing post at the left side facing front of the home was saturated as moisture meter readings indicate 38.5 percent moisture. It appears as though the sprinklers may be the cause of the moisture intrusion and i recommend re directing them as so they do not spray the wooden structure.

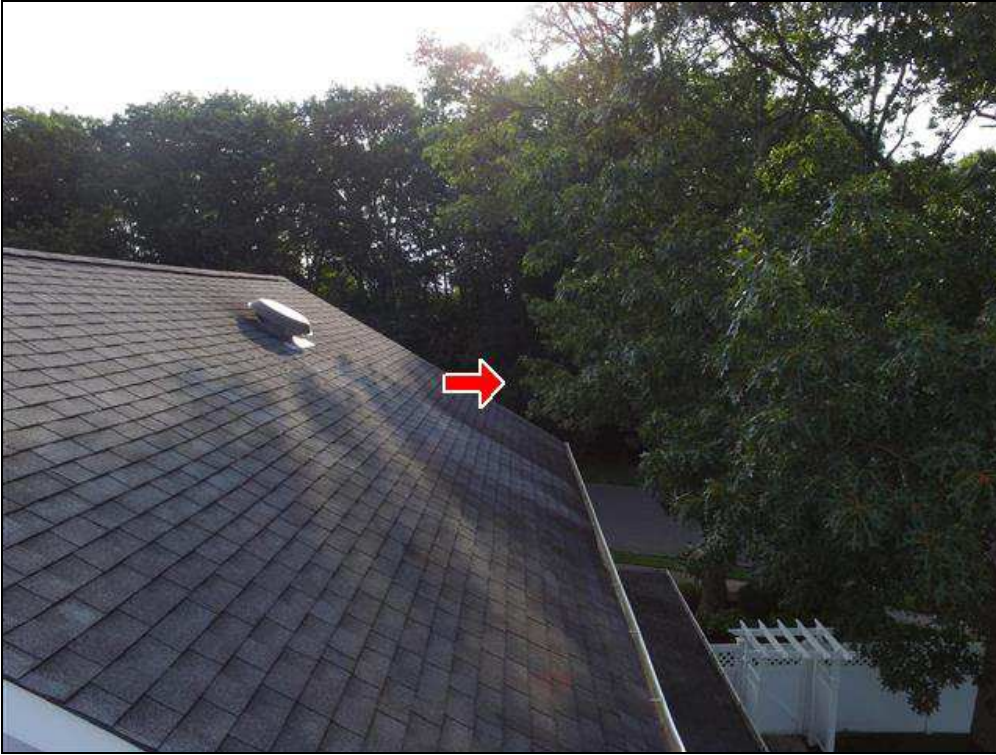
2.4 Item 1(Picture) Tree near roof

2.4 The tree limbs that are in contact with the roof or hanging near the roof should be trimmed.

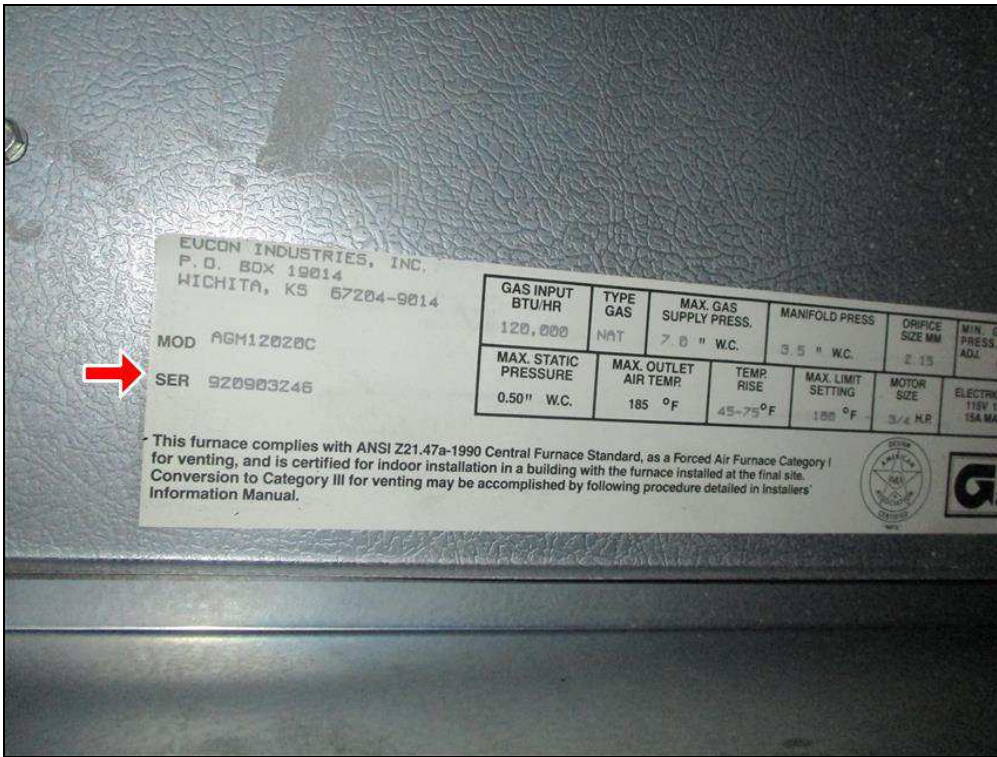
4.0 Item 1(Picture) Furnace data plate (basement)

4.0 (1) The furnace data plate (basement) indicates a manufacture date during September of 1992

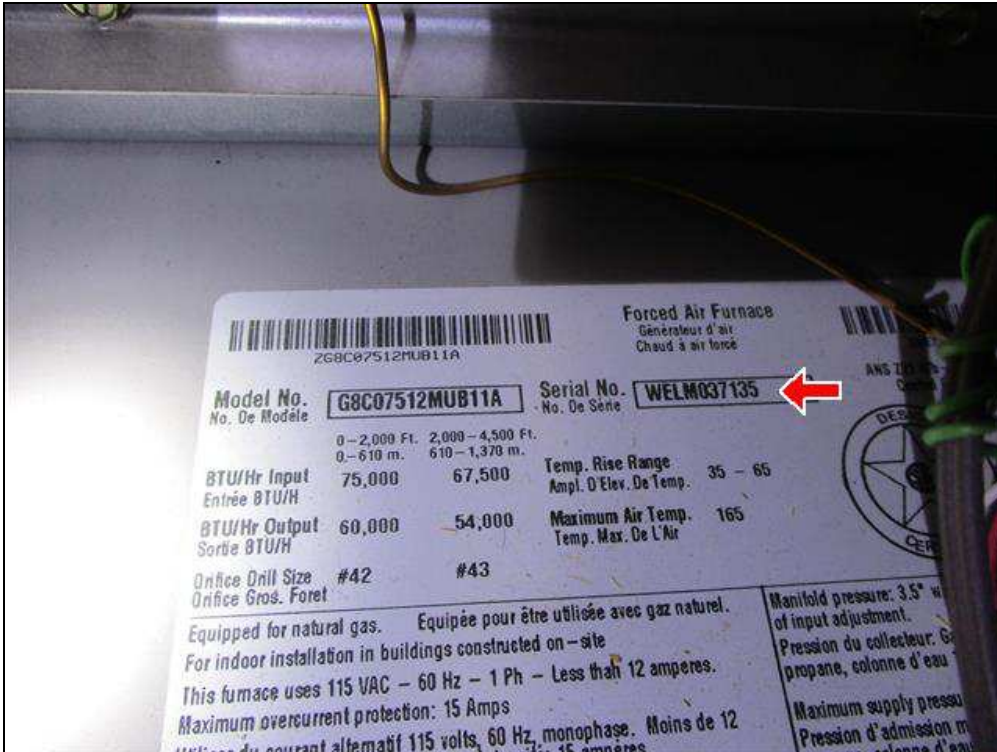
4.0 Item 2(Picture) Furnace data plate (attic)

(2) The attic furnace data plate indicates a manufacture date during May of 2002. The burners failed to operate as intended during the inspection, therefore no hot air was provided to the entire upstairs living space. I recommend further evaluation by a licensed HVAC professional

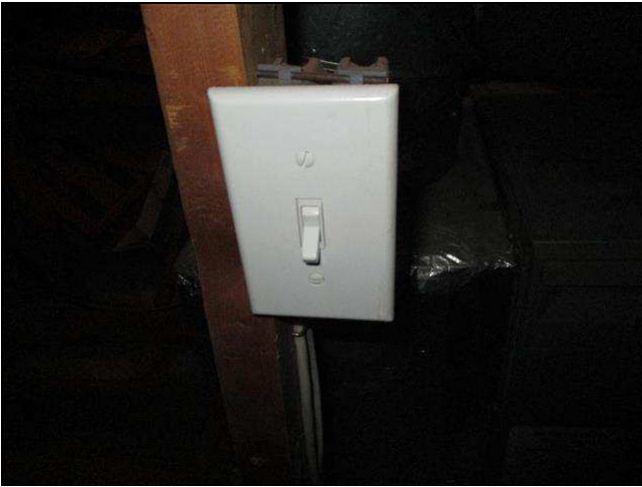
4.2 Item 1(Picture) Emergency shut off switch (attic furnace)

4.2 The attic furnace emergency shut off switch should be identified with a red cover plate indicating such.

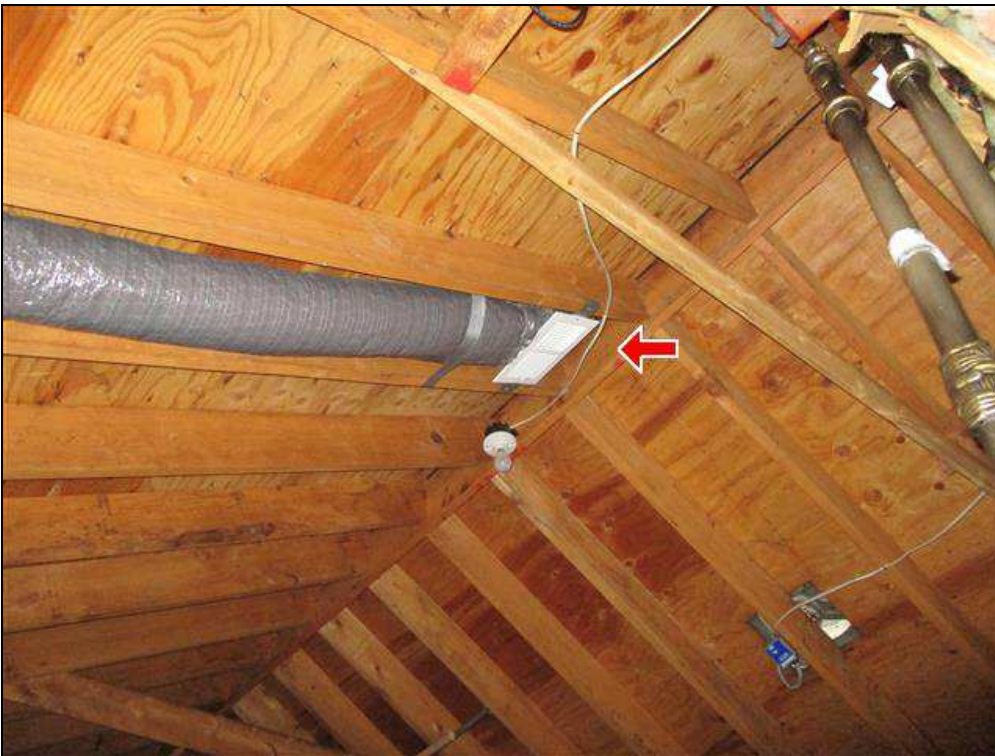
4.3 Item 1(Picture) Supply duct in attic

4.3 The pictured supply ductwork in the attic is of poor design. Attic space is intended to be the same temperature as the outdoors. In case of snow build up on the roof, heated air will rise to the ridge causing snow to melt allowing it to run down to the eaves where it will refreeze and cause ice damming. I recommend that an HVAC professional disconnect and cap off this supply ductwork

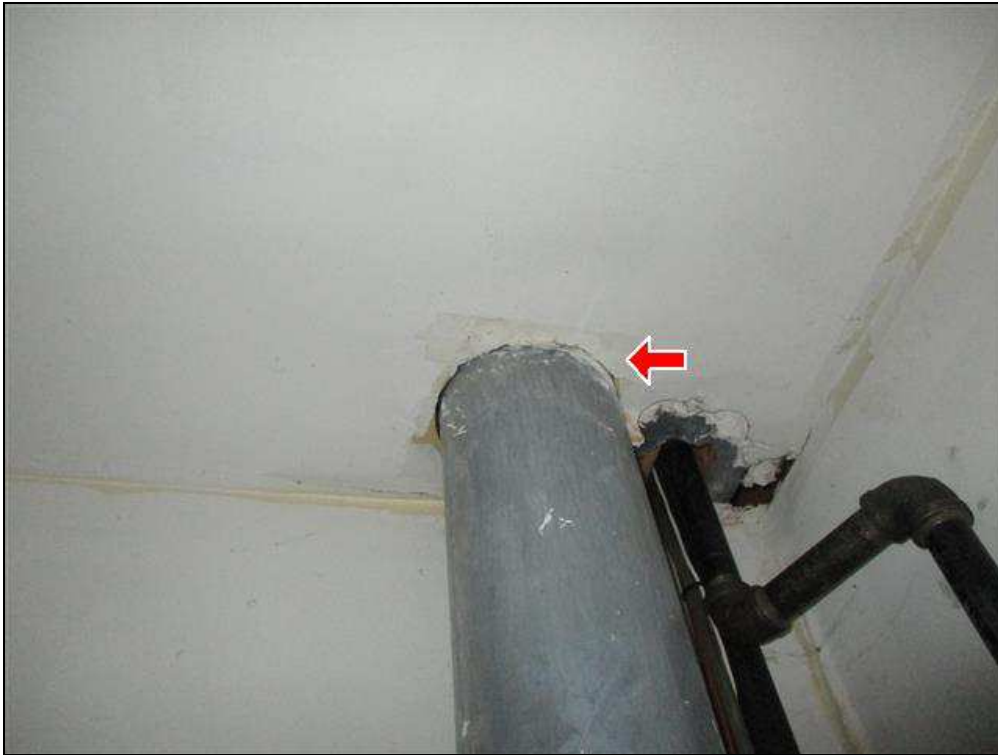
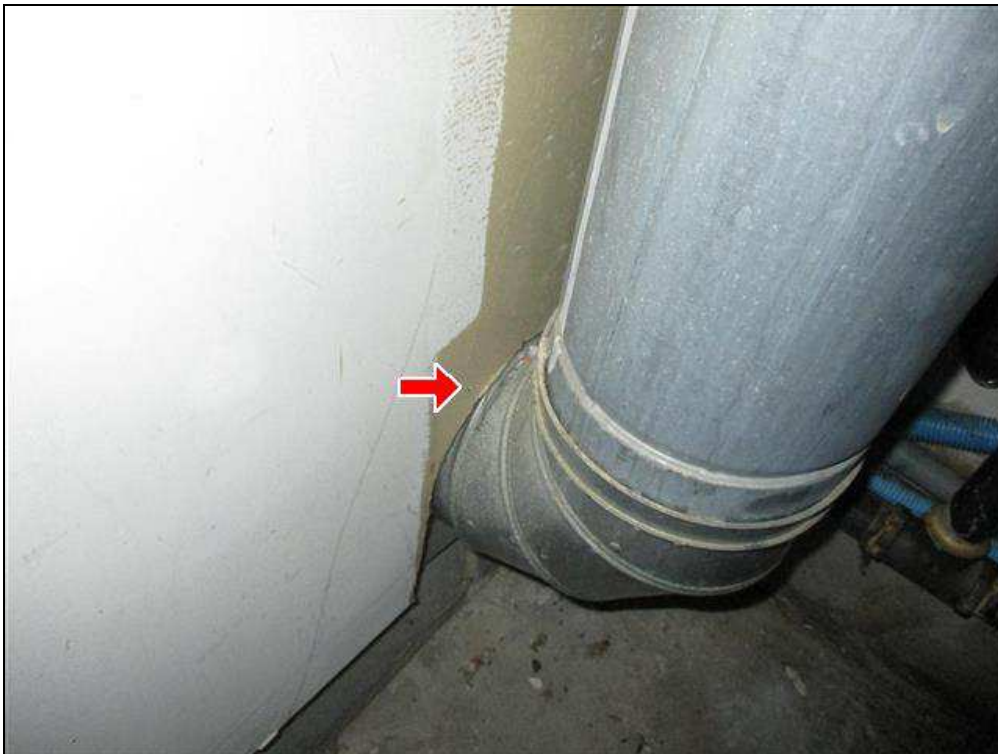
4.5 Item 1(Picture) Water heater and furnace chimney

4.5 The B-vent chimney for the water heater and furnace requires a minimum 1 inch combustible clearance. Currently drywall is in direct contact with the chimney in multiple areas. I recommend that a qualified person ensures the clearance is met for safety purposes.

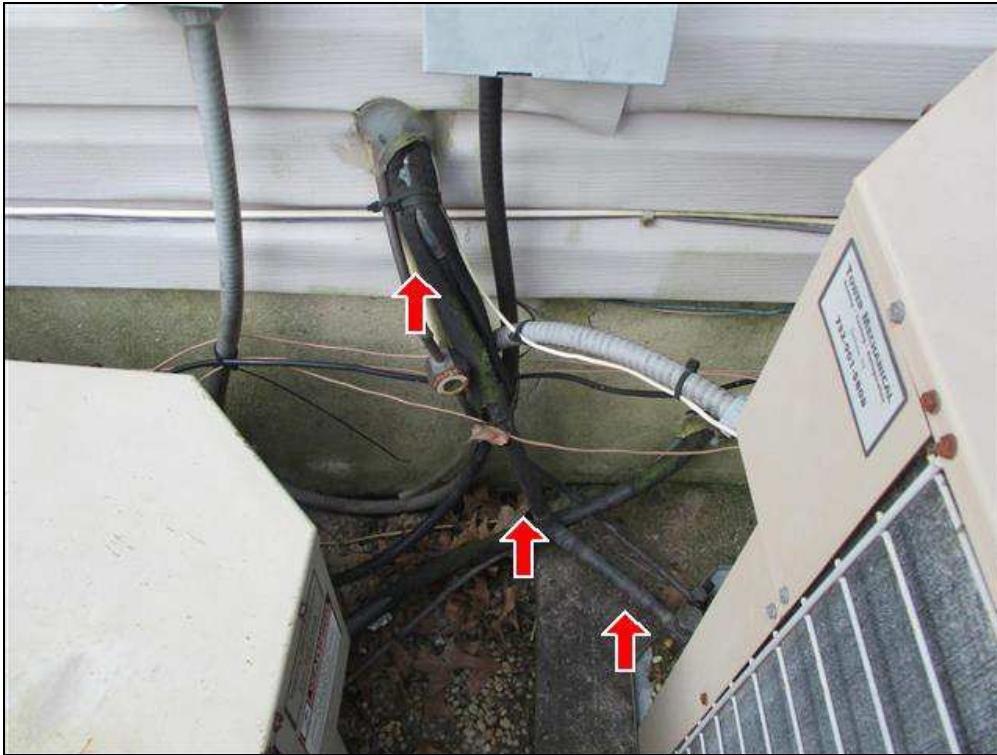
4.8 Item 1(Picture) Missing insulation

4.8 The foam sleeve on the suction line is missing in area(s) at the outside unit. Missing foam on the suction line can cause energy loss and condensation. I recommend service or repair as needed.

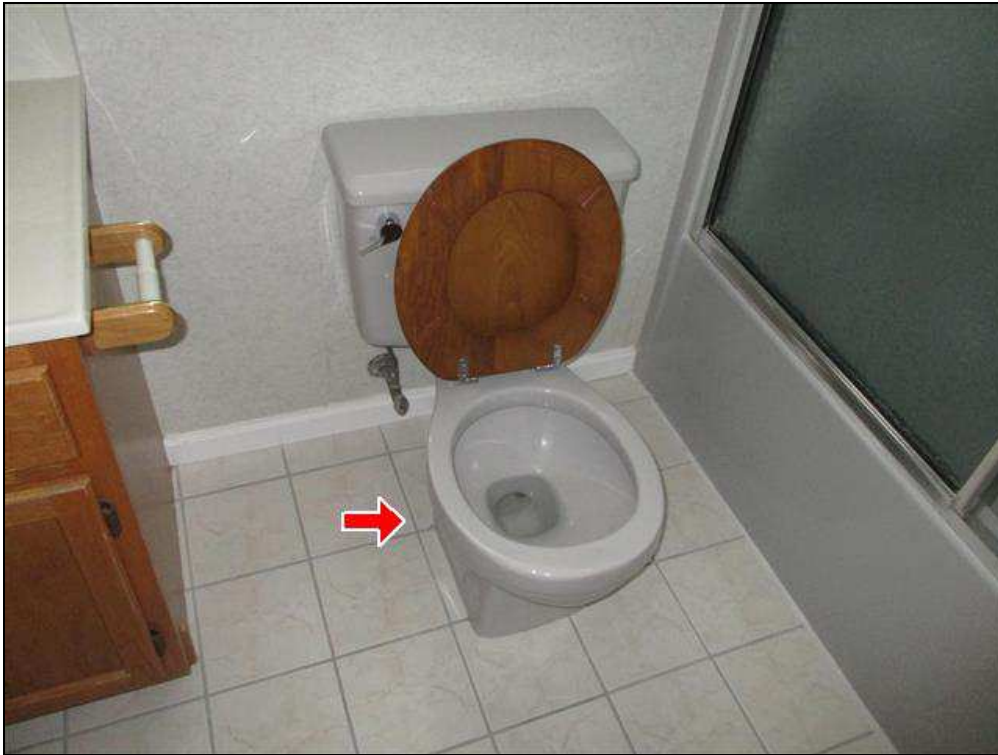
5.0 Item 1(Picture) Loose toilet

5.0 (1) The toilet is loose at the floor at the upstairs hallway bathroom. Repairs may involve re-setting the toilet on a new wax seal. I recommend a qualified licensed plumber repair or correct as needed.

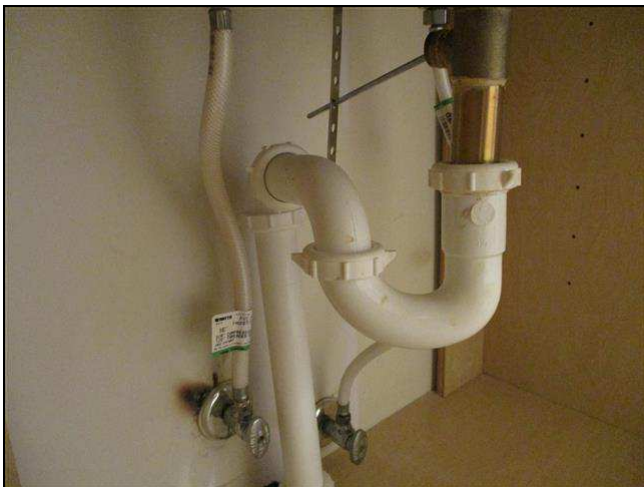
5.0 Item 2(Picture) Master bathroom sink

(2) The P-trap at the master bathroom sink struggles when draining. I recommend the installation of an auto vent to aid in ventilation and increase drain flow. This work can be performed by a qualified person.

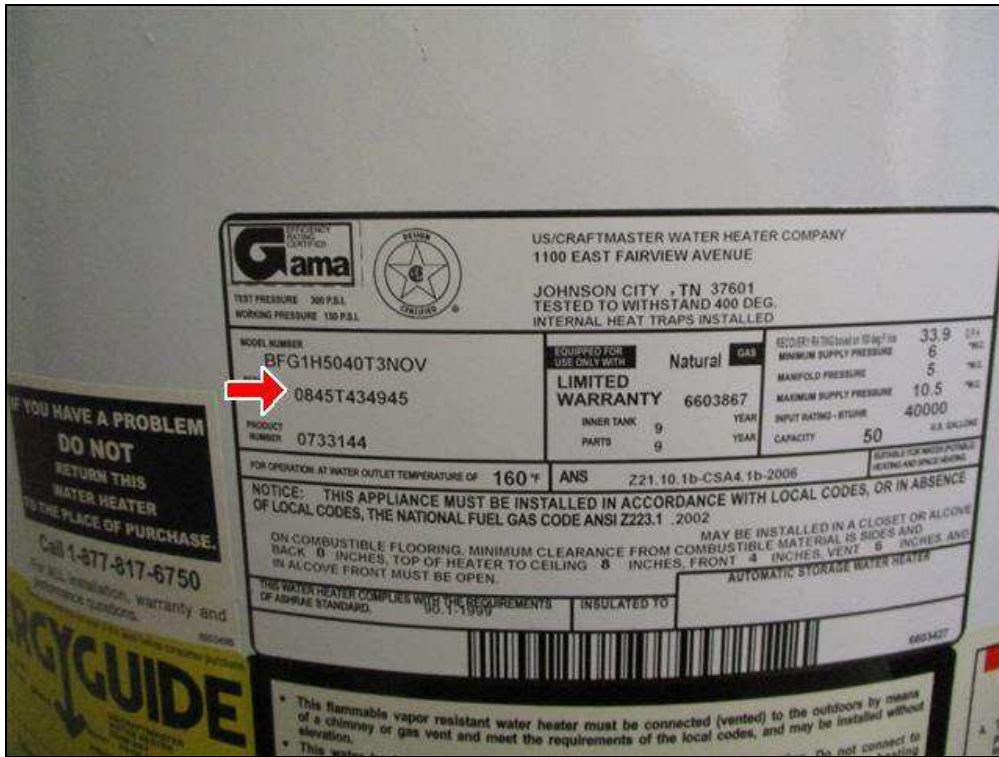
5.2 Item 1(Picture) Water heater data plate

5.2 (1) The water heater data plate indicates a manufacture date during the 45th week of 2008. Be advised the average life expectancy of a water heater in NJ is 10 years

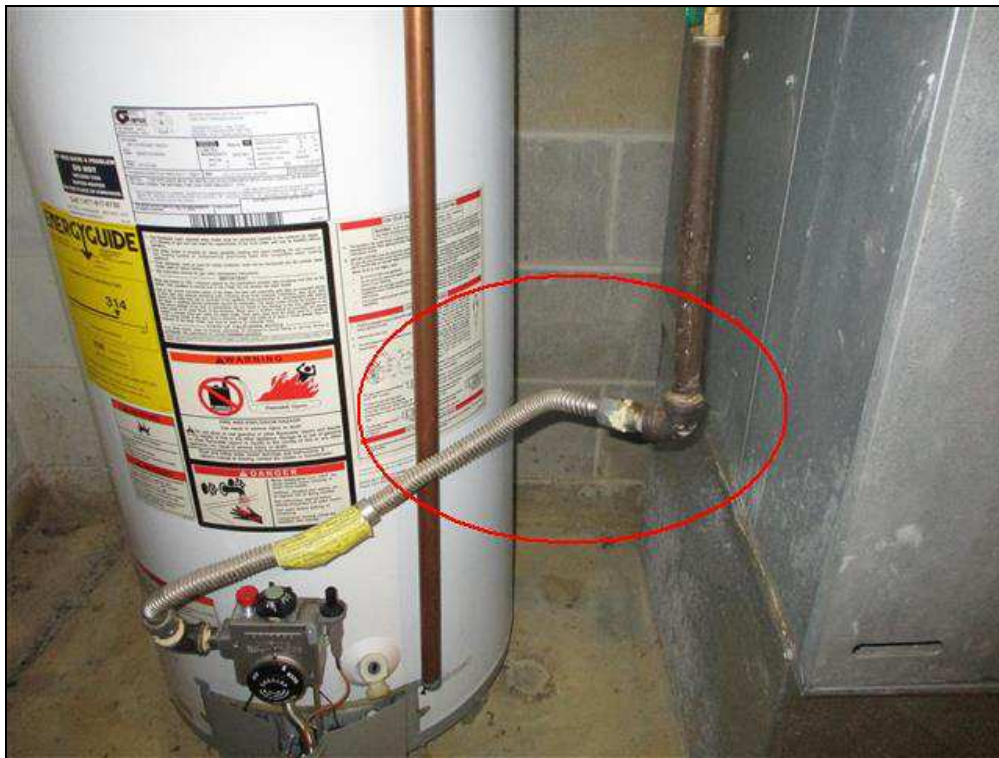
5.2 Item 2(Picture) No drip leg

(2) The gas supply line to the water heater is not equipped with a drip leg. A drip leg is designed to catch any impurities in the gas before it enters the appliance. I recommend that a drip leg be installed by a licensed professional plumber.

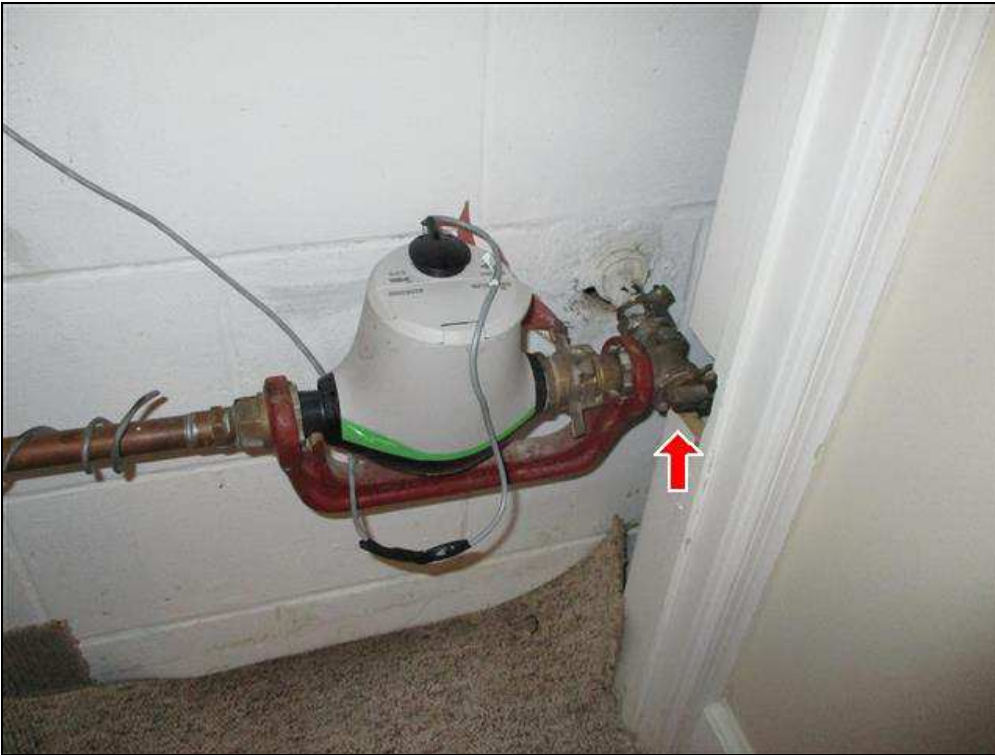
5.3 Item 1(Picture) Main water shut off

5.3 The main water shut off is the brass lever located in the basement. This is for your information.

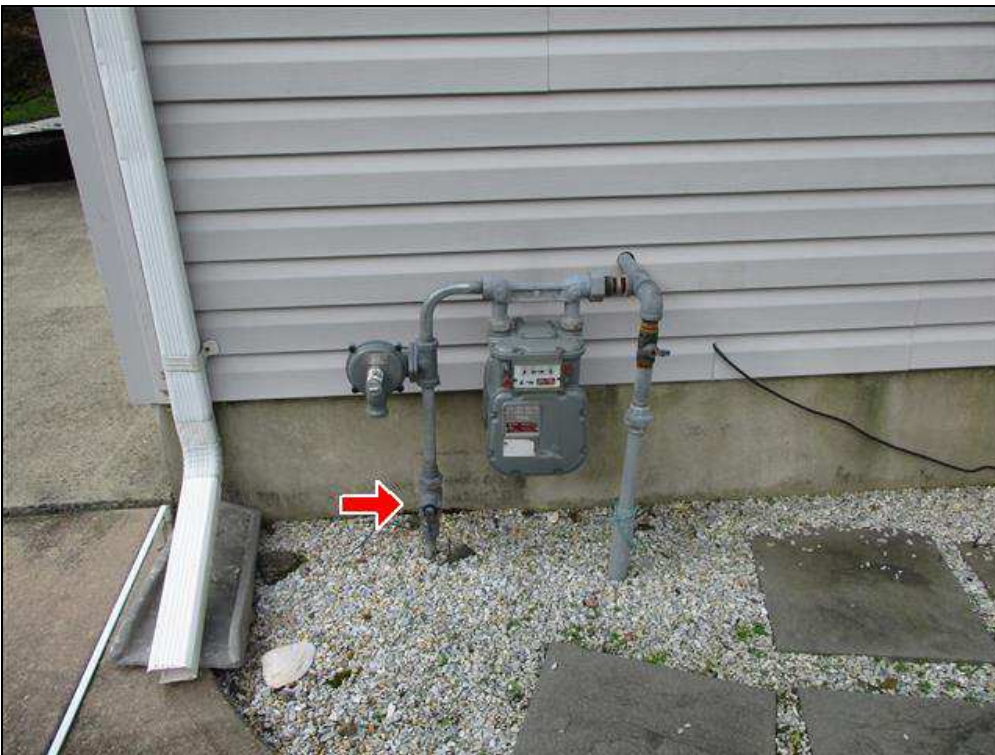
5.5 Item 1(Picture) Main gas shut off

5.5 The main fuel shut off is at the gas meter outside

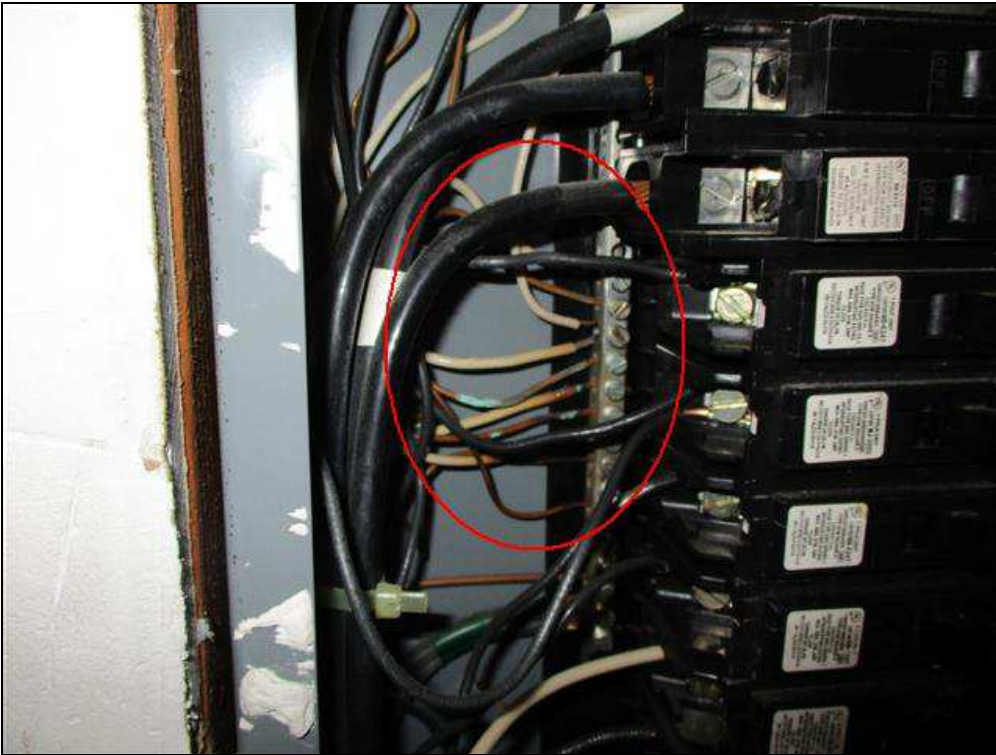
6.1 Item 1(Picture) Neutral bus bar

6.1 (1) Multiple neutral and ground wires have scorch marks at the neutral bus bar. This is evidence that over heating has occurred or is occurring and could potentially result in a fire. Further evaluation by a licensed electrician is recommended

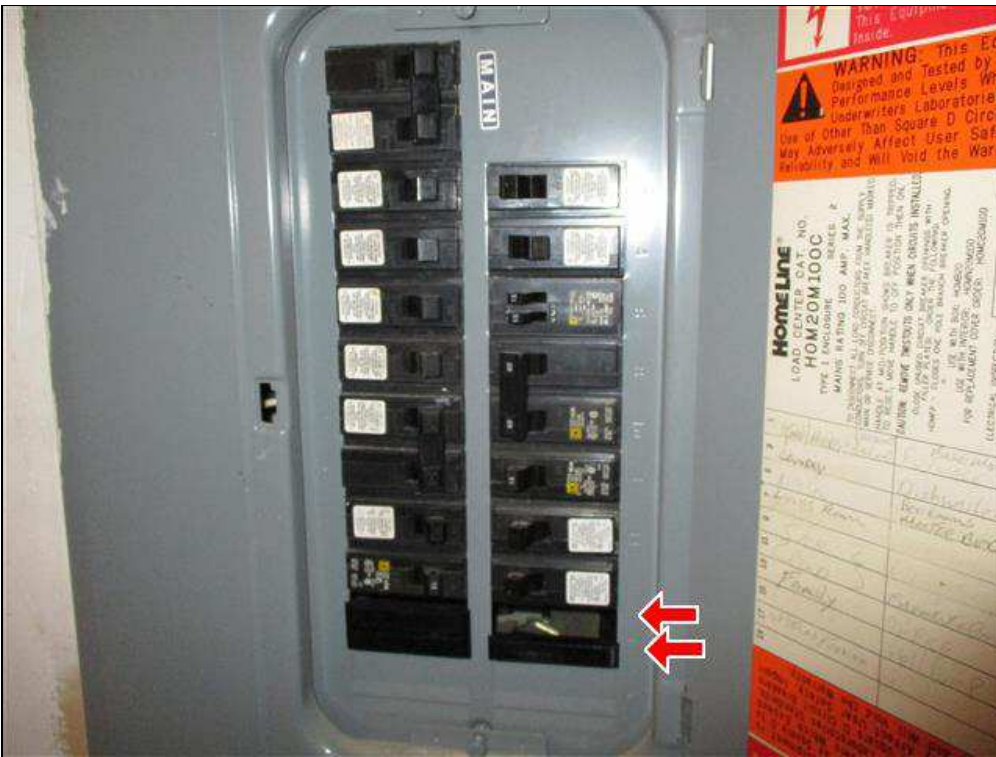
6.1 Item 2(Picture) Missing knockout covers

(2) There were multiple missing knockout cover plates in the electrical panel noted during the inspection. This situation allows direct access to the hot bus bars while the distribution panel cover is open. Serious bodily injury or death may occur if contact is made with the hot bus. I recommend additional knockout cover plates be installed. All repairs at the electrical panel should be performed by a licensed electrician

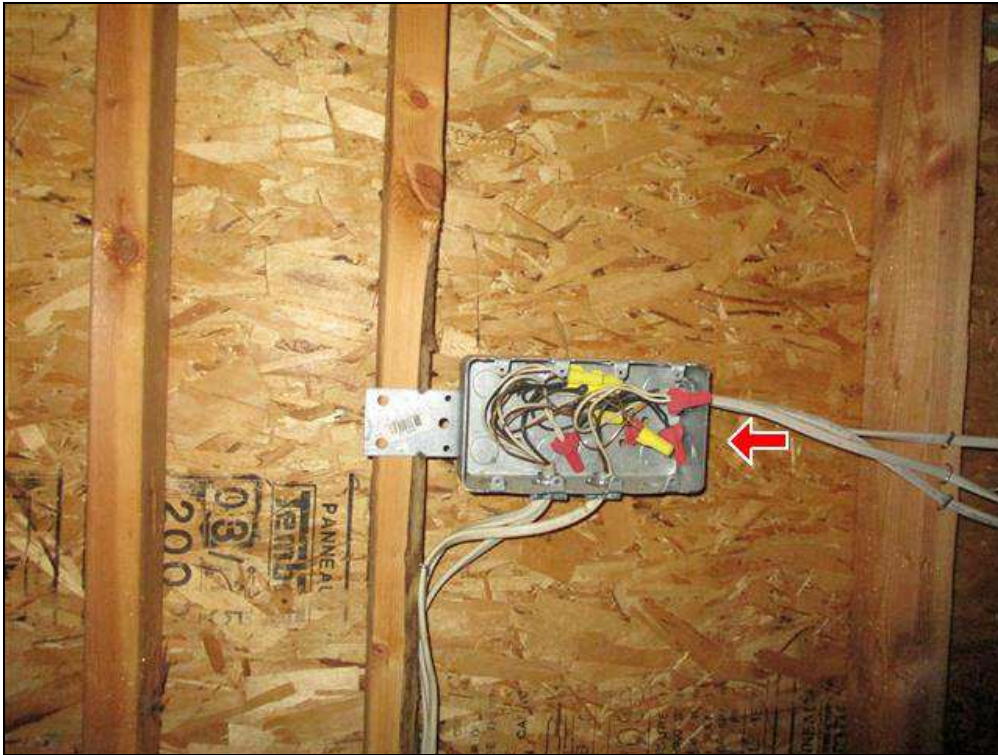
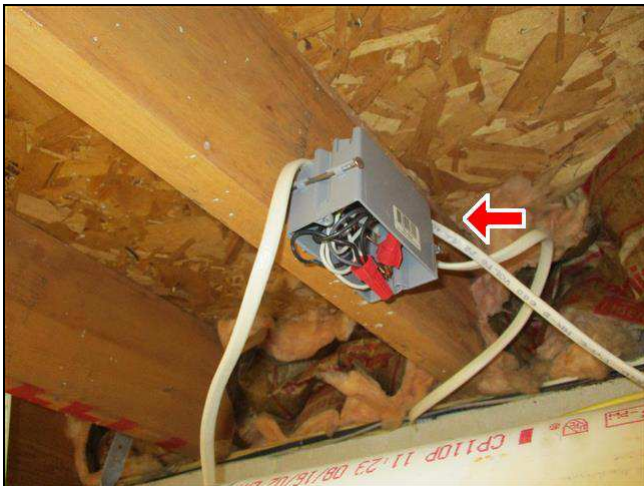
6.3 Item 1(Picture) Attic junction box

6.3 The pictured attic and basement junction boxes should be equipped with an appropriate sized cover plate for safety purposes.

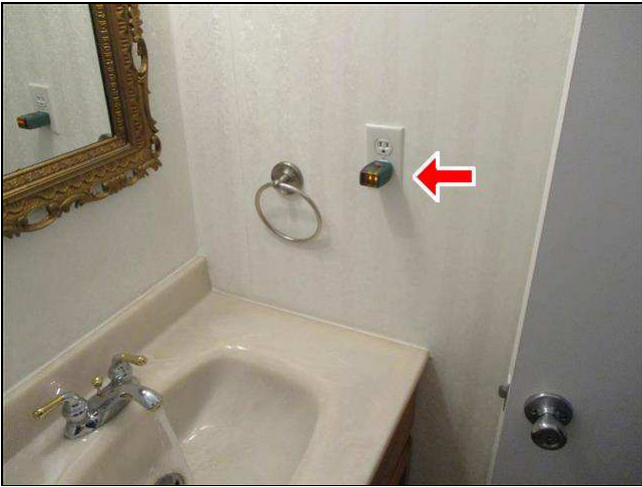
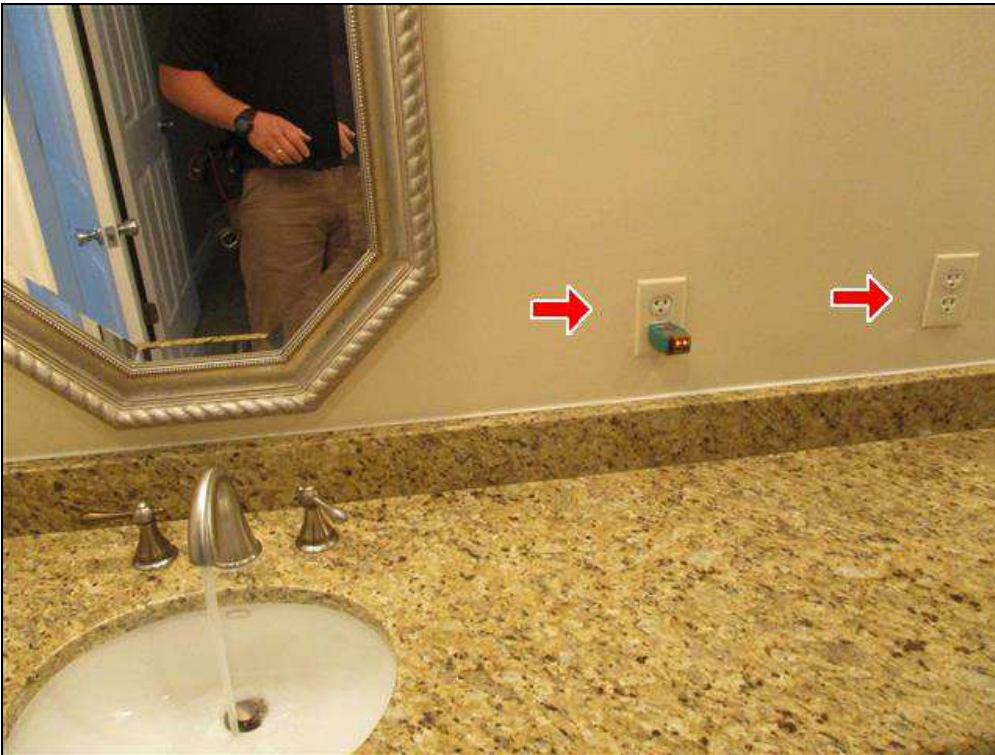
6.4 Item 1(Picture) First floor bathroom

6.4 (1) The pictured outlets at the first floor and master bathrooms are not GFCI protected. All outlets located within 3 feet of a water source are to be GFCI protected otherwise they are to be considered a shock hazard. All repairs involving wiring should be performed by a licensed professional electrician

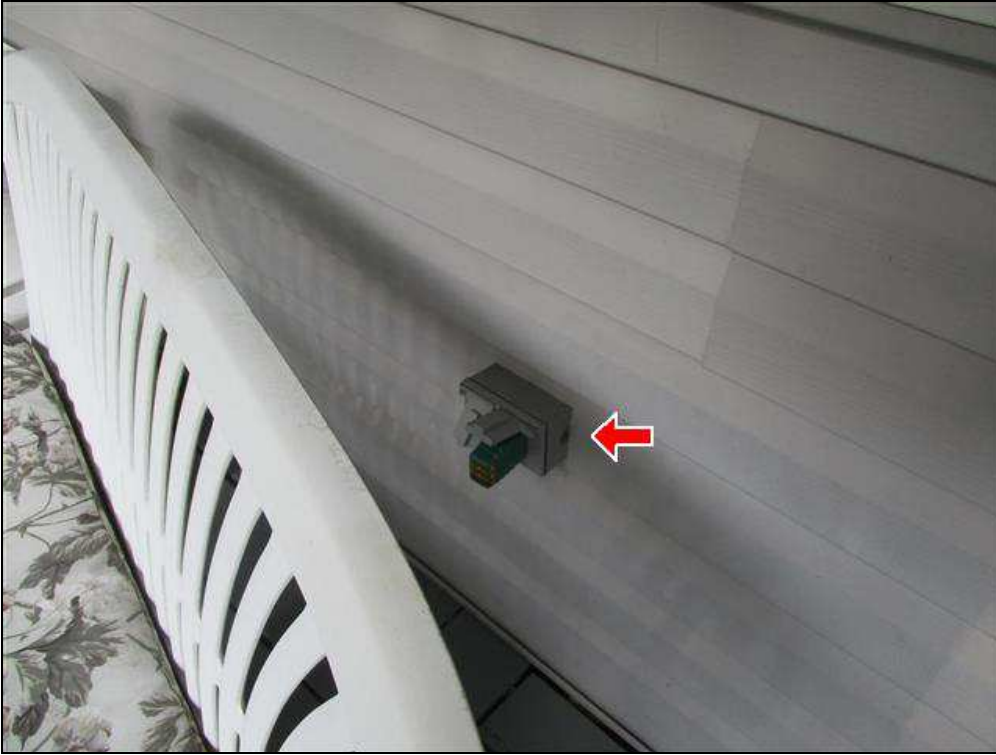
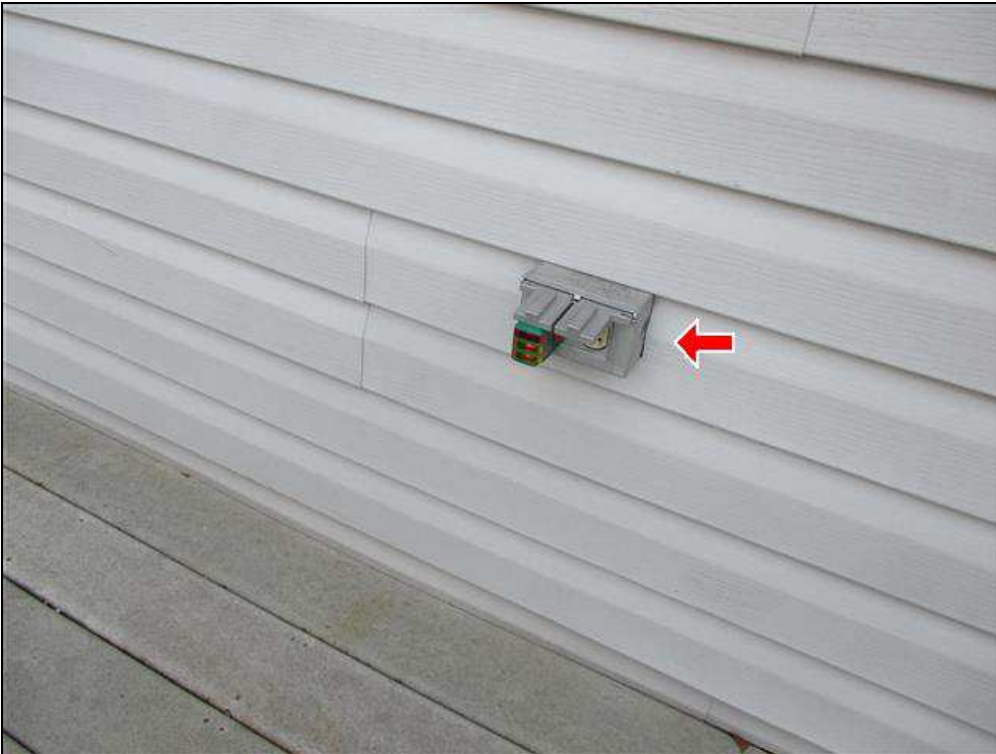
6.4 Item 3(Picture) front porch

(2) The pictured exterior outlets are not GFCI protected. All exterior outlets are naturally exposed to water and need to be GFCI protected. All repairs involving wiring should be performed by a licensed professional electrician

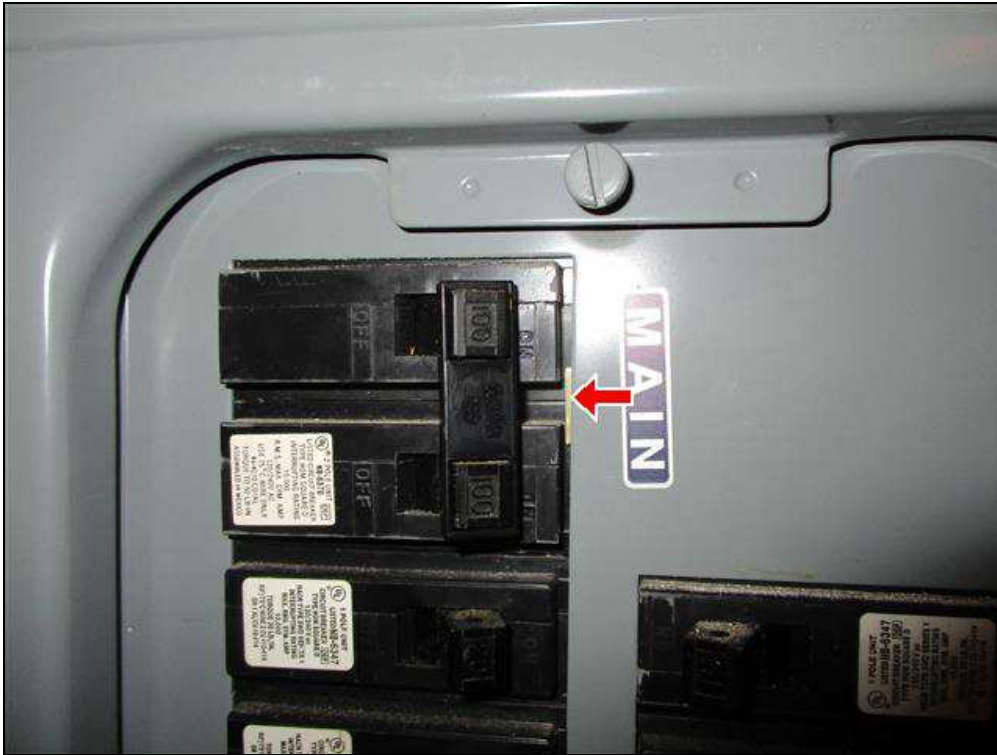
6.7 Item 1(Picture) 100 amp main breaker

6.7 The electrical distribution panel is located in the garage

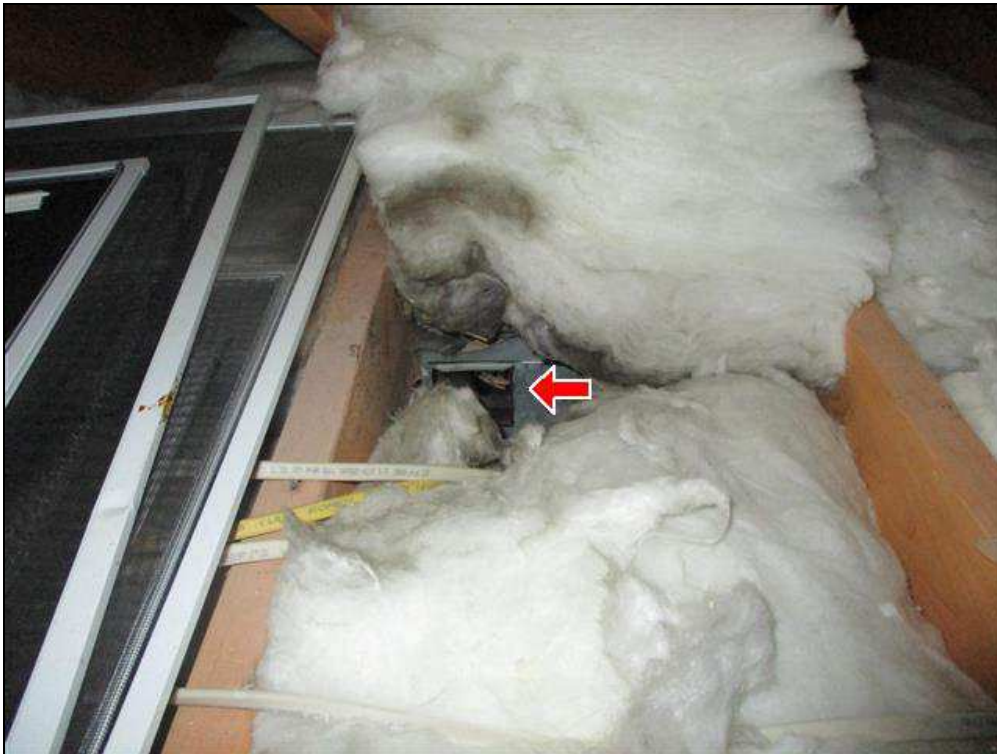
7.4 Item 1(Picture) Master bathroom exhaust fan

7.4 The exhaust fan does not vent to the outside at the master bathroom. Vent pipes that terminate in attic space can sometimes cause moisture that can lead to mold or cause condensation. A qualified contractor should inspect and repair as needed.

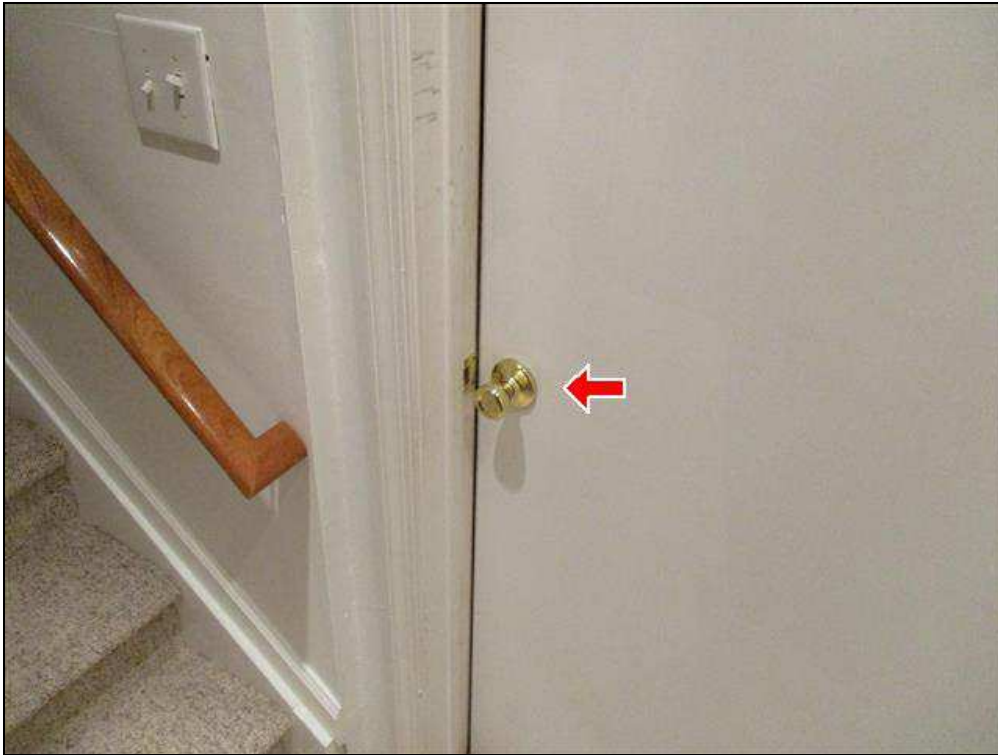
8.5 Item 1(Picture) Basement office

8.5 The entry door needs strike and latch adjustment to shut tight at the basement office. This is a maintenance issue and is for your information. A qualified person should repair or replace as needed.
