Inspection Report

Brick NJ 08723

JLC Home Inspections, llc

Date: 9/12/2017	Time: 09:00 AM	Report ID:
Property:	Customer:	Real Estate Professional:
Brick NJ 08723

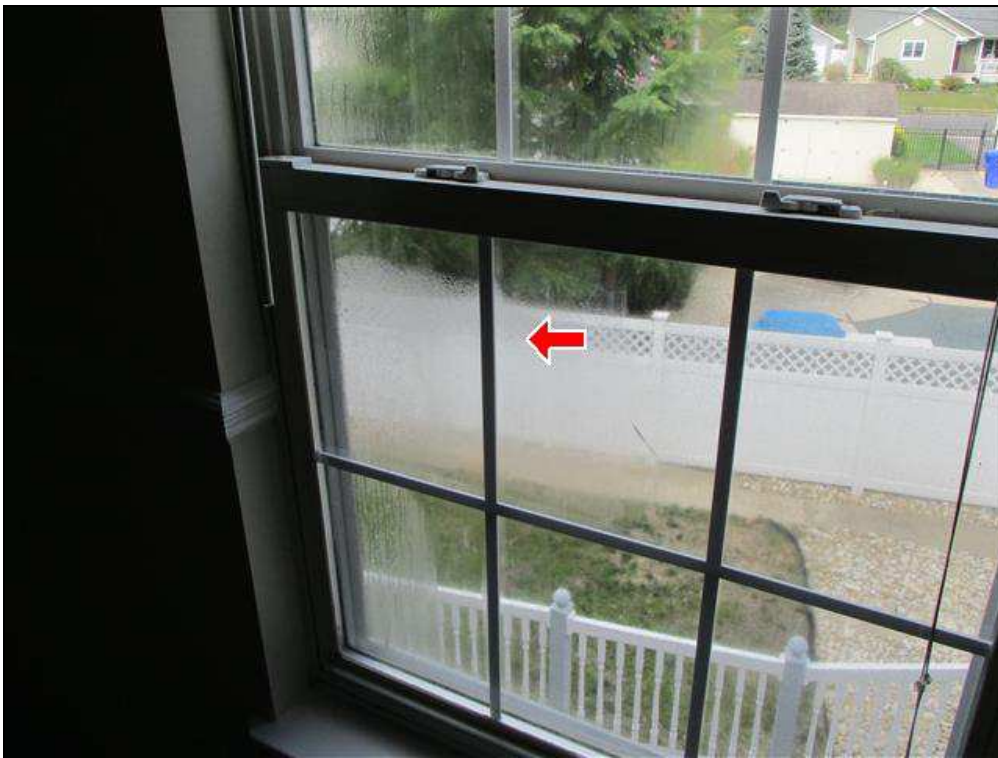
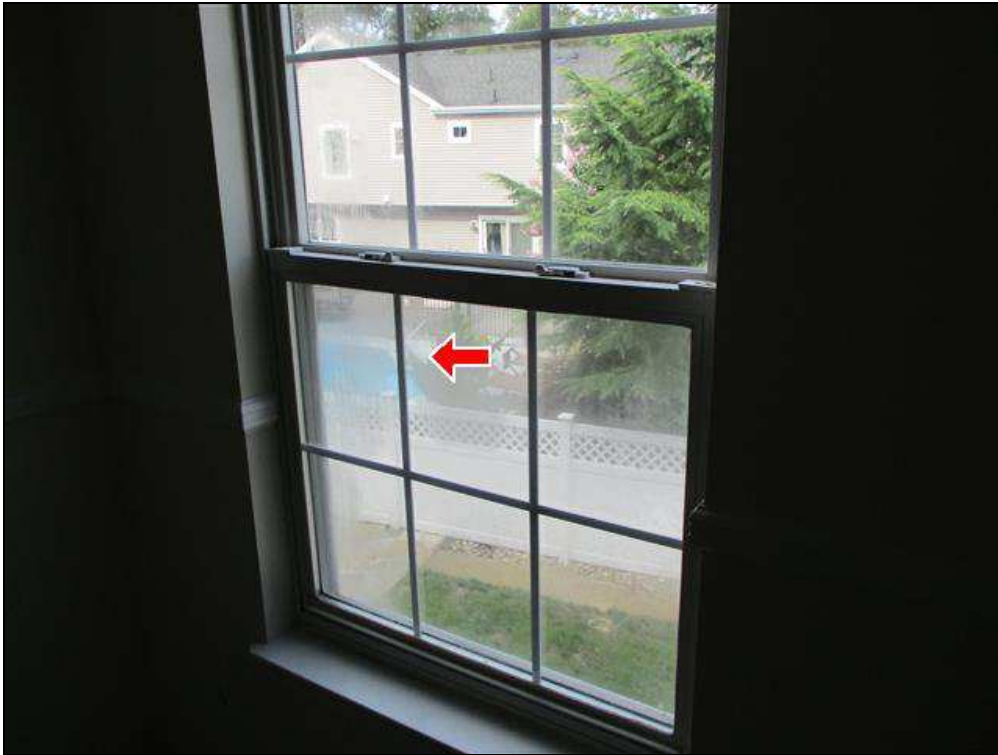
8.6 Item 1(Picture) Guest bedroom

8.6 Two windows are cloudy (lost seal) at the guest bedroom. This can cause some heat loss in winter and loss of cool air in summer if not corrected. A qualified contractor should inspect and repair as needed.

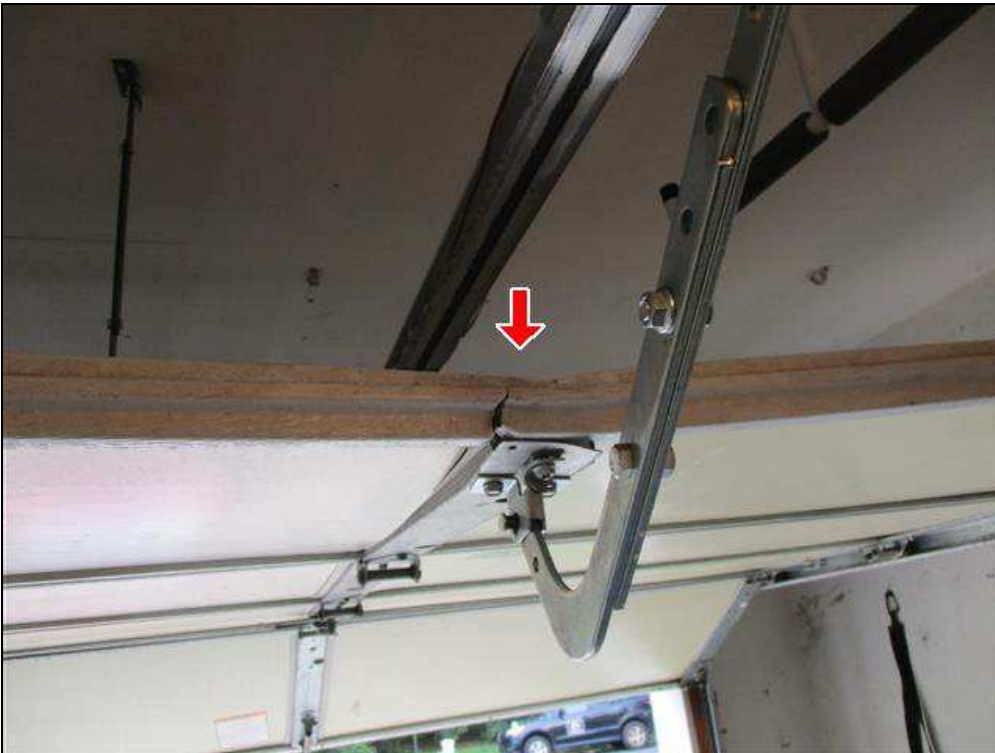
9.3 Item 1(Picture) Garage door

9.3 The garage door is broken in the top middle portion where it connects to the door opener. This is for your information.

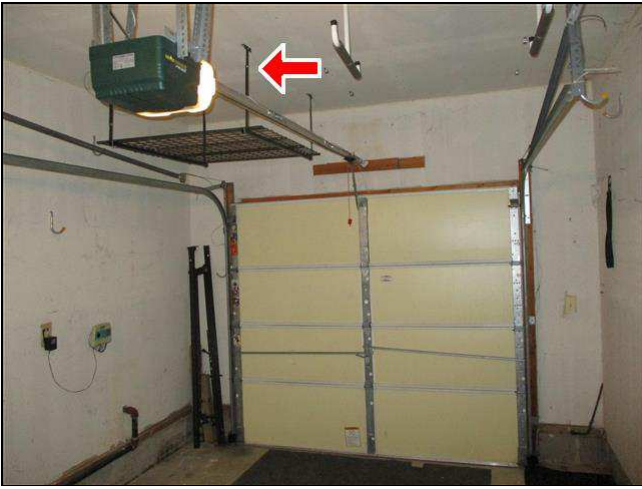
9.5 Item 1(Picture) Garage door operator

9.5 The garage door operator does not reverse when met with resistance. This is a safety concern and serious bodily injury or death may occur if not corrected. I recommend further evaluation by a licensed garage door specialist

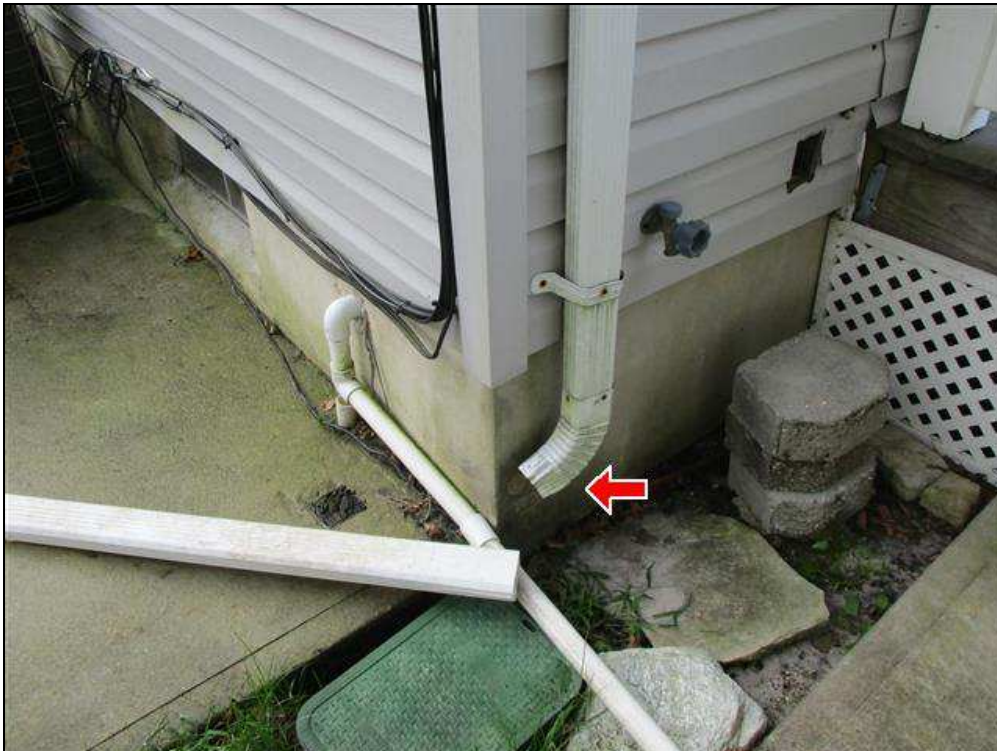
1.3 Item 1(Picture) Gutter downspout termination

The entire house gutter downspout system should be equipped with 6 foot leaders in order to carry the water from the field of the roof away from the structure

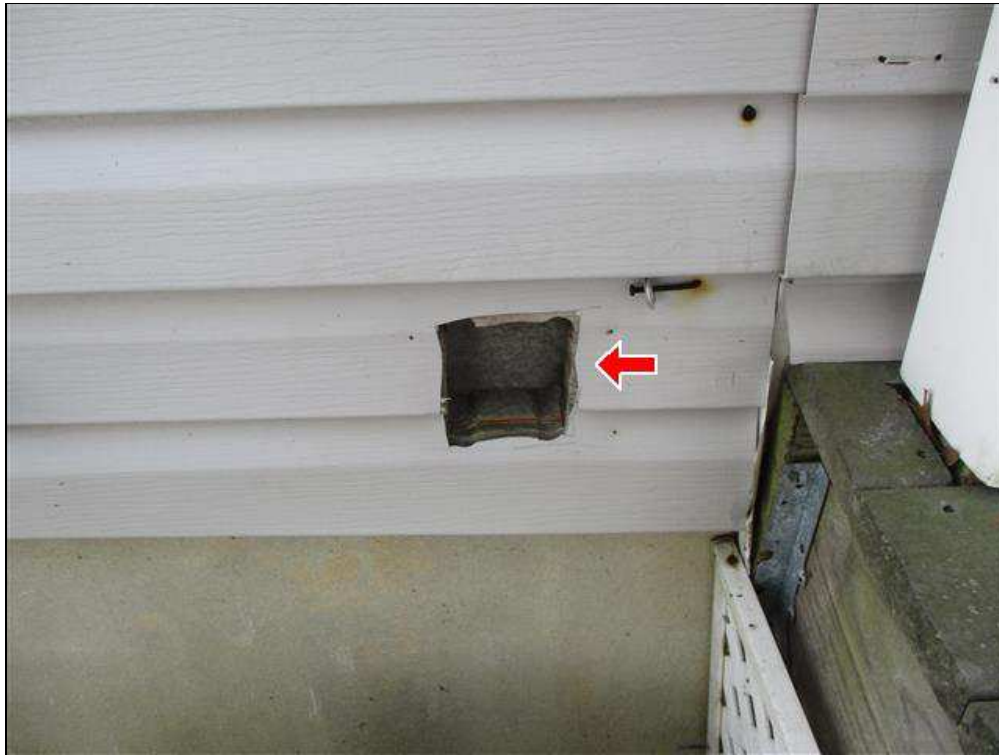
2.0 Item 1(Picture) Hole in siding

The pictured hole in the siding should be sealed in order to avoid moisture and/or insect intrusion

2.0 The pictured hole in the siding should be sealed in order to avoid moisture and/or insect intrusion

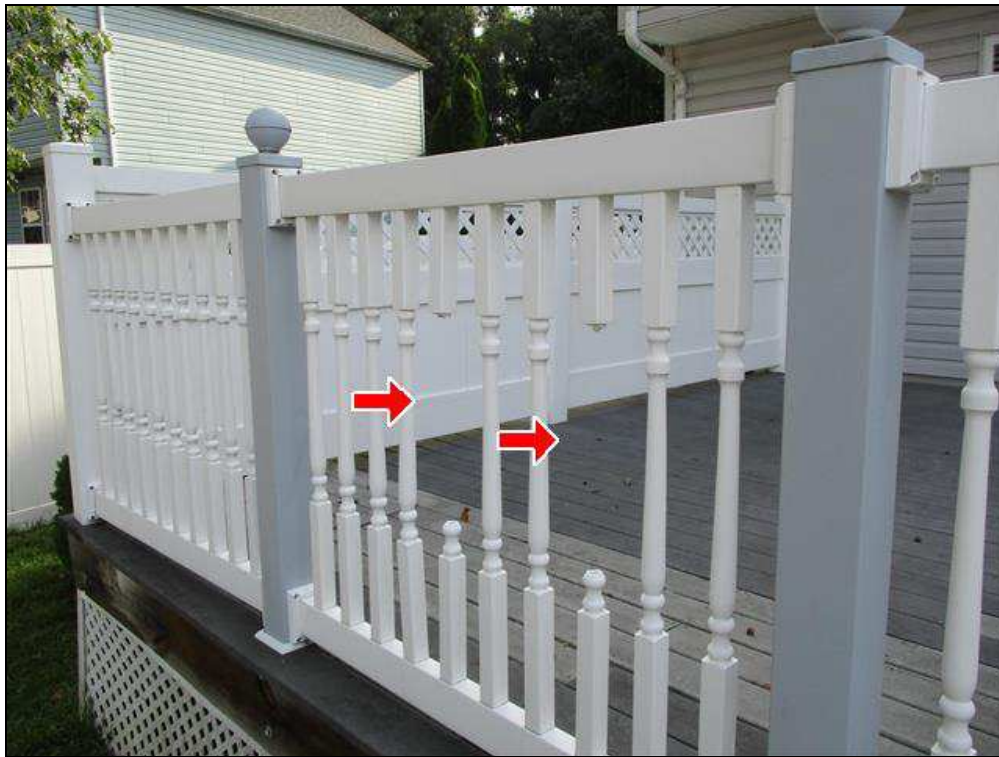
(1) The hand/guard rail for the rear deck is missing numerous spindles. A fall or injury could occur if not corrected. A qualified contractor should repair or replace as needed.

2.3 (1) The hand/guard rail for the rear deck is missing numerous spindles. A fall or injury could occur if not corrected. A qualified contractor should repair or replace as needed.

2.3 Item 1(Picture) Missing spindles

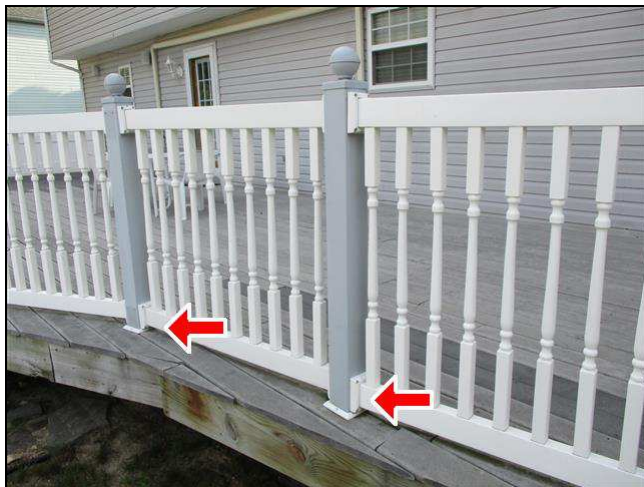
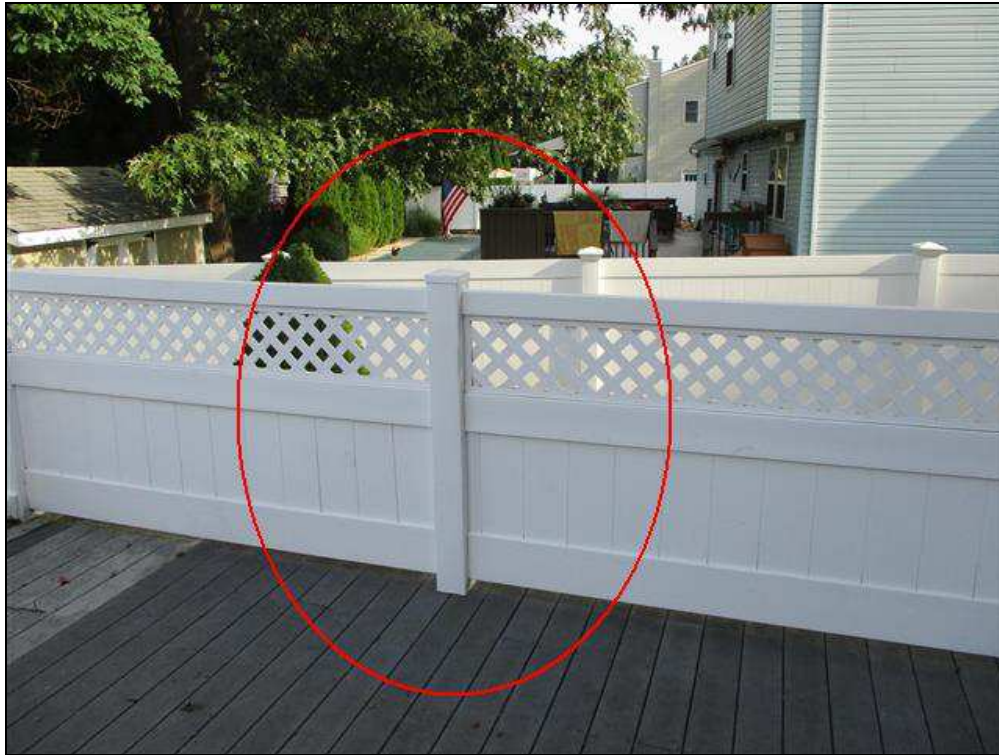
(2) The hand/guard rail for the rear deck is loose in areas. A fall or injury could occur if not corrected. A qualified contractor should repair or replace as needed.

2.3 Item 3(Picture) Loose handrail

(2) The hand/guard rail for the rear deck is loose in areas. A fall or injury could occur if not corrected. A qualified contractor should repair or replace as needed.

2.3 Item 2(Picture) Loose handrail

2.3 Item 3(Picture) Loose handrail

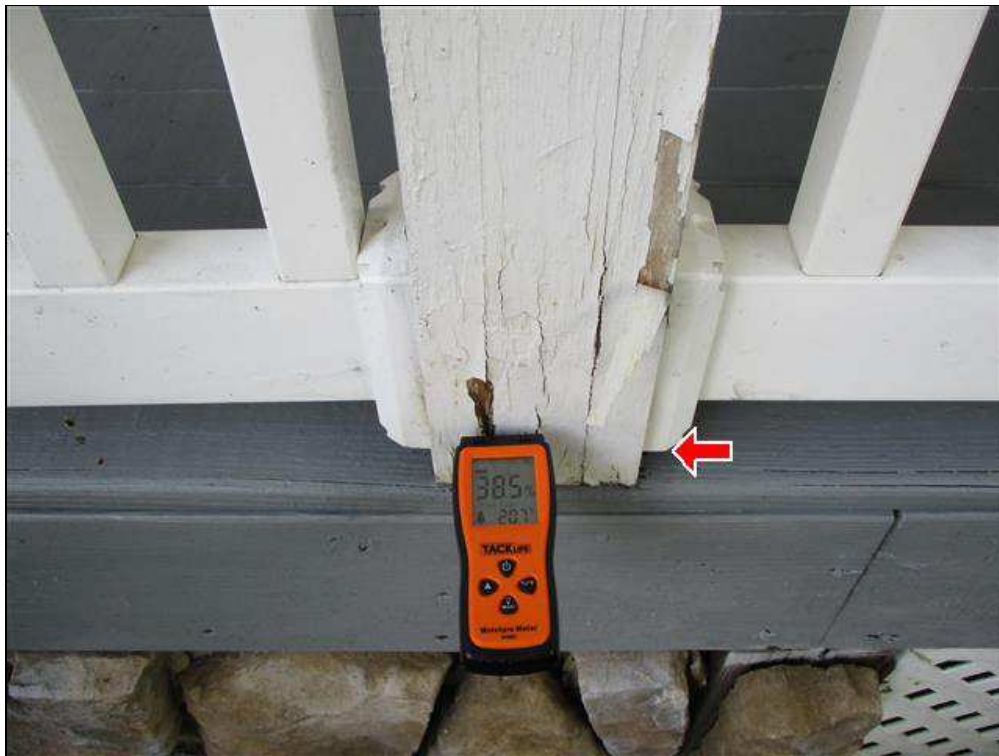
2.3 Item 4(Picture) Deck railing post

(3) The deck railing post at the left side facing front of the home was saturated as moisture meter readings indicate 38.5 percent moisture. It appears as though the sprinklers may be the cause of the moisture intrusion and i recommend re directing them as so they do not spray the wooden structure.

(3) The deck railing post at the left side facing front of the home was saturated as moisture meter readings indicate 38.5 percent moisture. It appears as though the sprinklers may be the cause of the moisture intrusion and i recommend re directing them as so they do not spray the wooden structure.

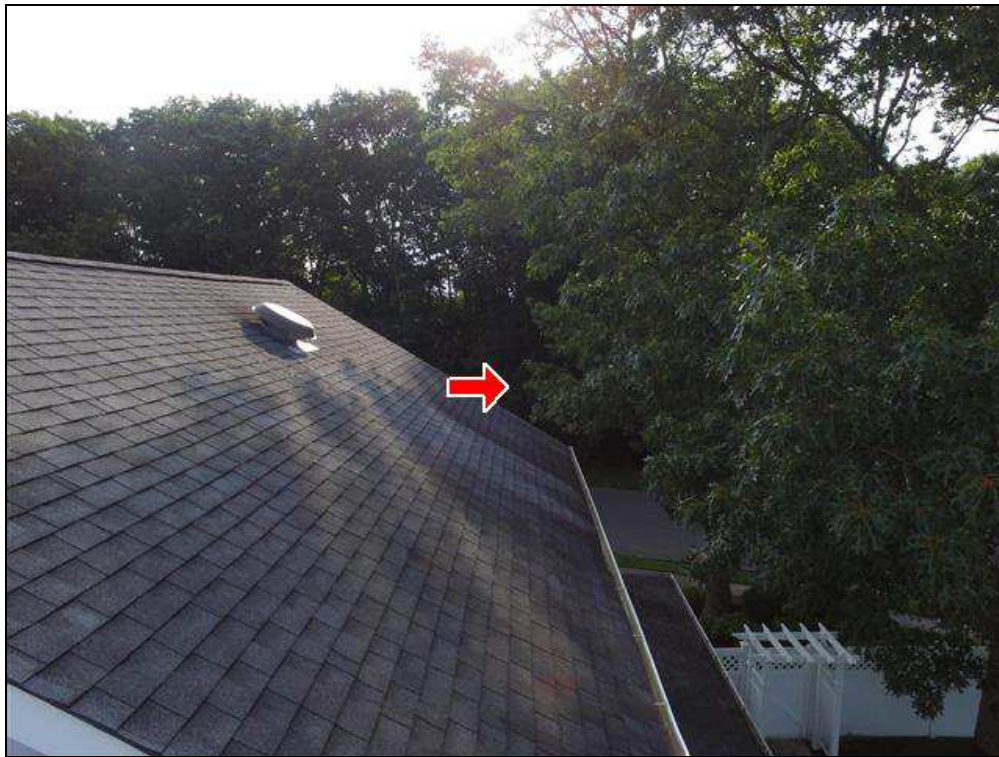
2.4 Item 1(Picture) Tree near roof

The tree limbs that are in contact with the roof or hanging near the roof should be trimmed.

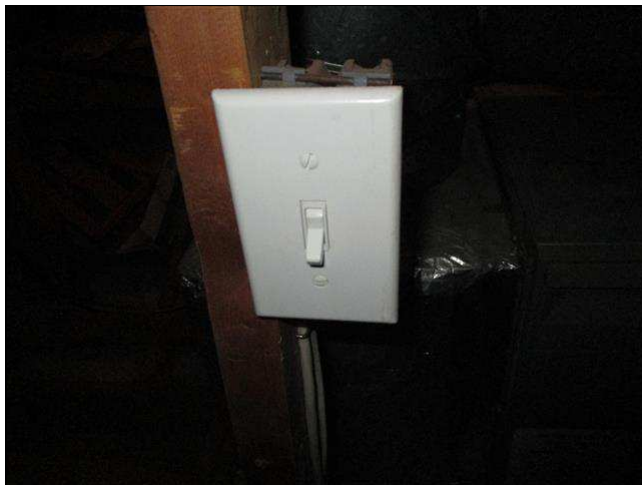
4.2 Item 1(Picture) Emergency shut off switch (attic furnace)

The attic furnace emergency shut off switch should be identified with a red cover plate indicating such.

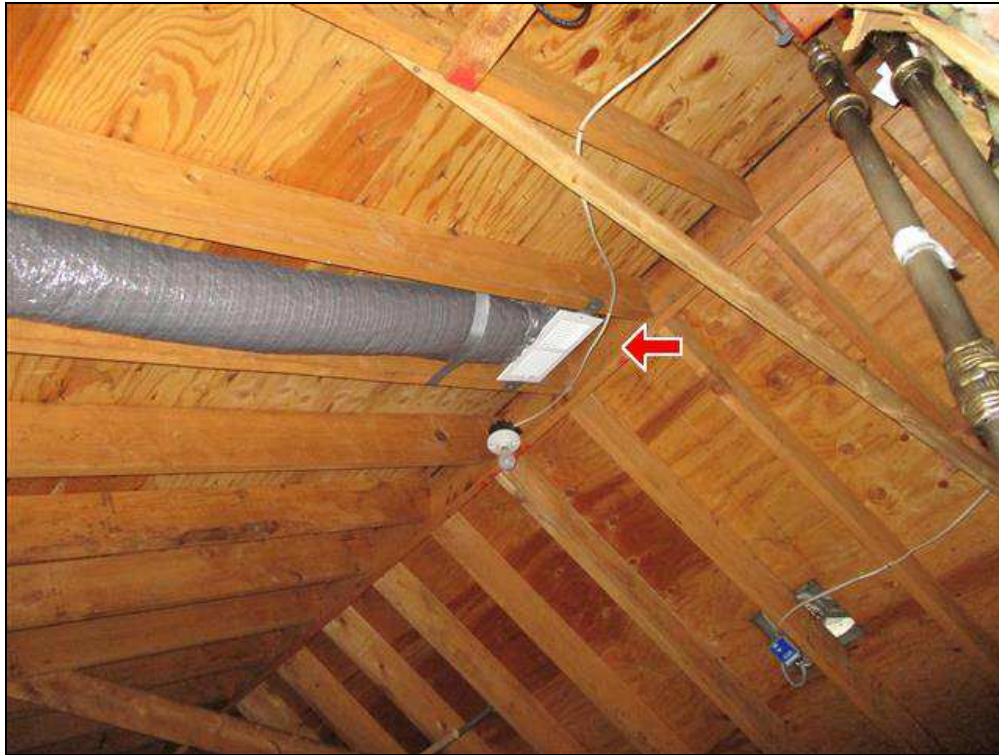
4.3 Item 1(Picture) Supply duct in attic

The pictured supply ductwork in the attic is of poor design. Attic space is intended to be the same temperature as the outdoors. In case of snow build up on the roof, heated air will rise to the ridge causing snow to melt allowing it to run down to the eaves where it will refreeze and cause ice damming. I recommend that an HVAC professional disconnect and cap off this supply ductwork

4.3 The pictured supply ductwork in the attic is of poor design. Attic space is intended to be the same temperature as the outdoors. In case of snow build up on the roof, heated air will rise to the ridge causing snow to melt allowing it to run down to the eaves where it will refreeze and cause ice damming. I recommend that an HVAC professional disconnect and cap off this supply ductwork

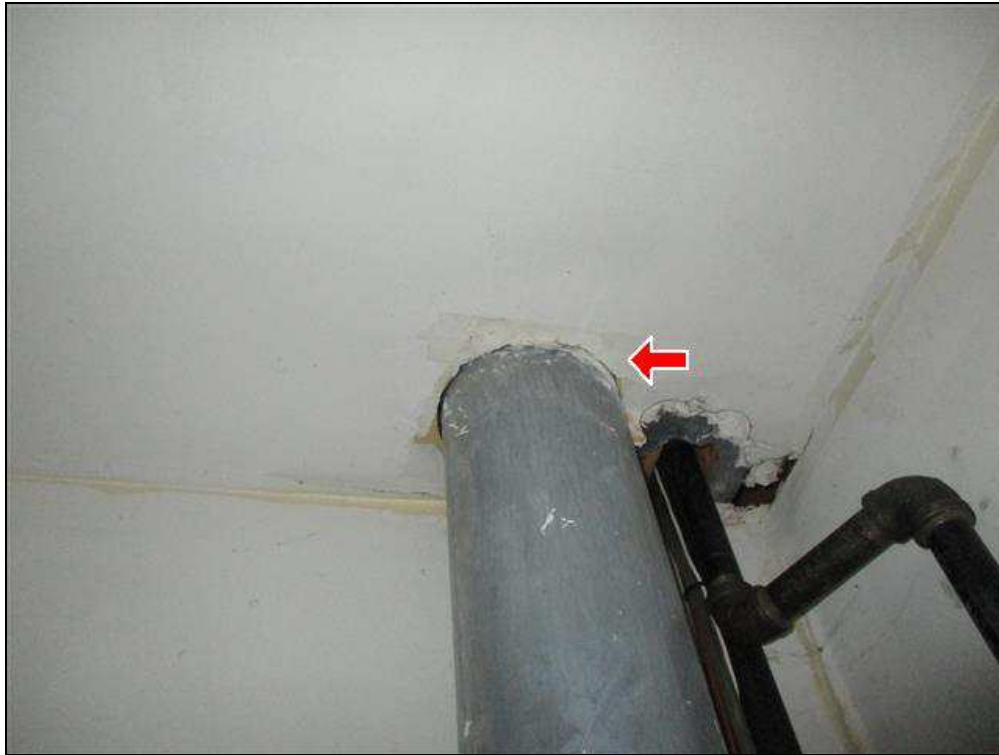
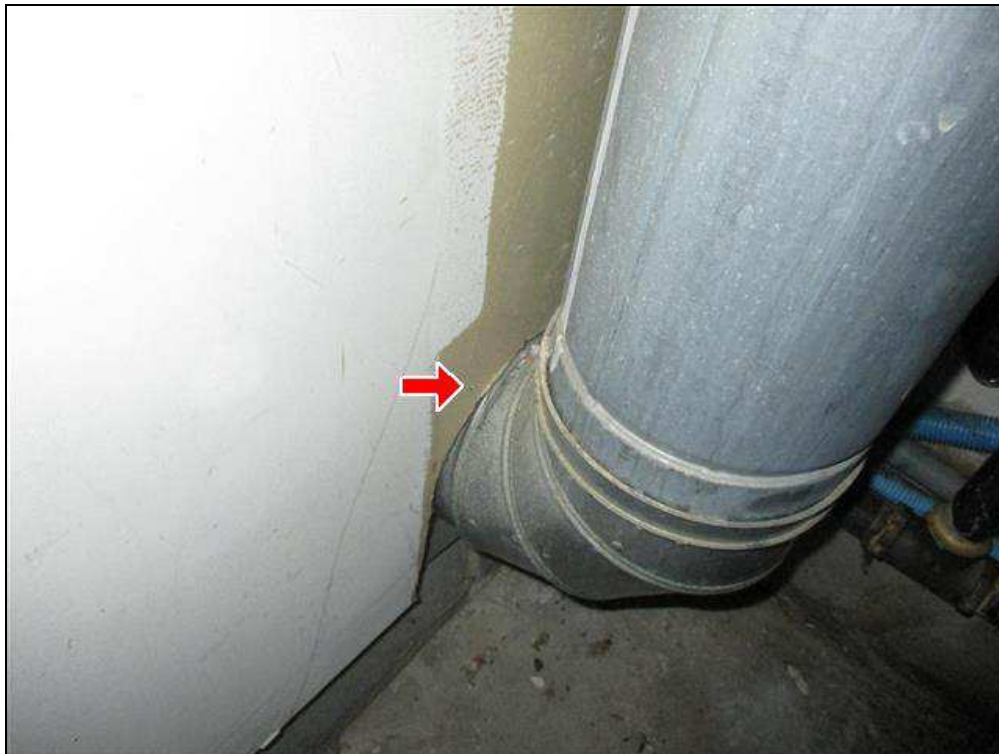
4.5 Item 1(Picture) Water heater and furnace chimney

The B-vent chimney for the water heater and furnace requires a minimum 1 inch combustible clearance. Currently drywall is in direct contact with the chimney in multiple areas. I recommend that a qualified person ensures the clearance is met for safety purposes.

4.5 Item 2(Picture) Water heater and furnace chimney

4.5 The B-vent chimney for the water heater and furnace requires a minimum 1 inch combustible clearance. Currently drywall is in direct contact with the chimney in multiple areas. I recommend that a qualified person ensures the clearance is met for safety purposes.

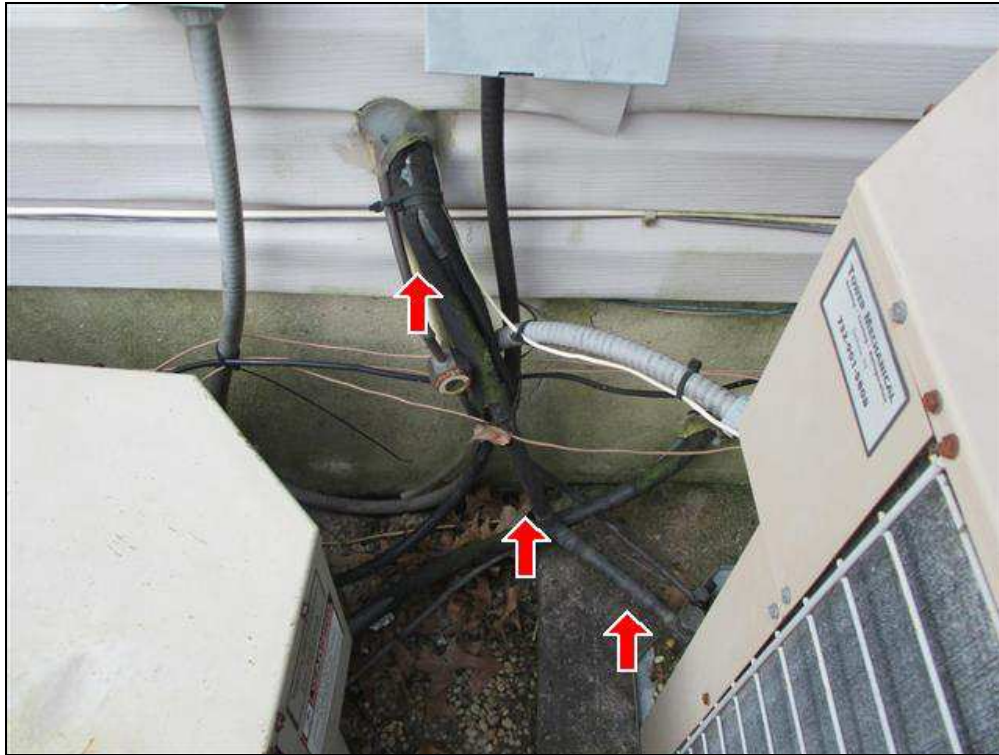
The foam sleeve on the suction line is missing in area(s) at the outside unit. Missing foam on the suction line can cause energy loss and condensation. I recommend service or repair as needed.

4.8 The foam sleeve on the suction line is missing in area(s) at the outside unit. Missing foam on the suction line can cause energy loss and condensation. I recommend service or repair as needed.

4.8 Item 1(Picture) Missing insulation

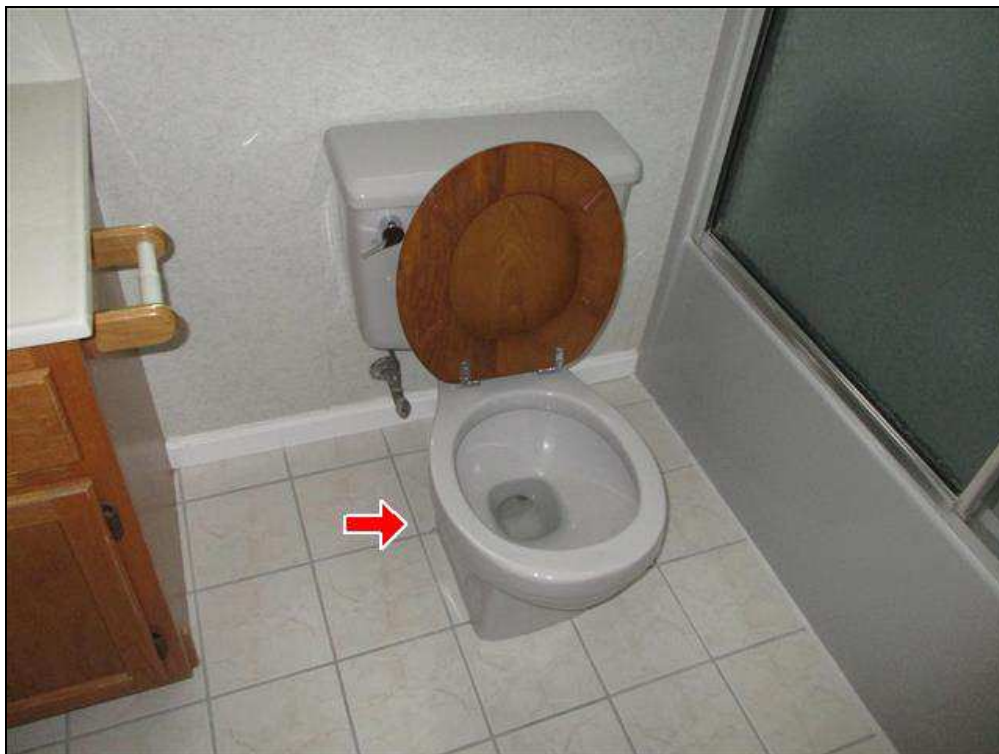
(1) The toilet is loose at the floor at the upstairs hallway bathroom. Repairs may involve re-setting the toilet on a new wax seal. I recommend a qualified licensed plumber repair or correct as needed.

5.0 (1) The toilet is loose at the floor at the upstairs hallway bathroom. Repairs may involve re-setting the toilet on a new wax seal. I recommend a qualified licensed plumber repair or correct as needed.

5.0 Item 1(Picture) Loose toilet

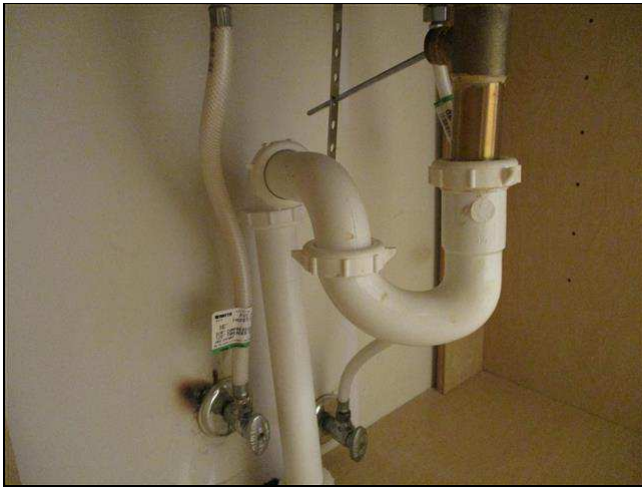
5.0 Item 2(Picture) Master bathroom sink

(2) The P-trap at the master bathroom sink struggles when draining. I recommend the installation of an auto vent to aid in ventilation and increase drain flow. This work can be performed by a qualified person.

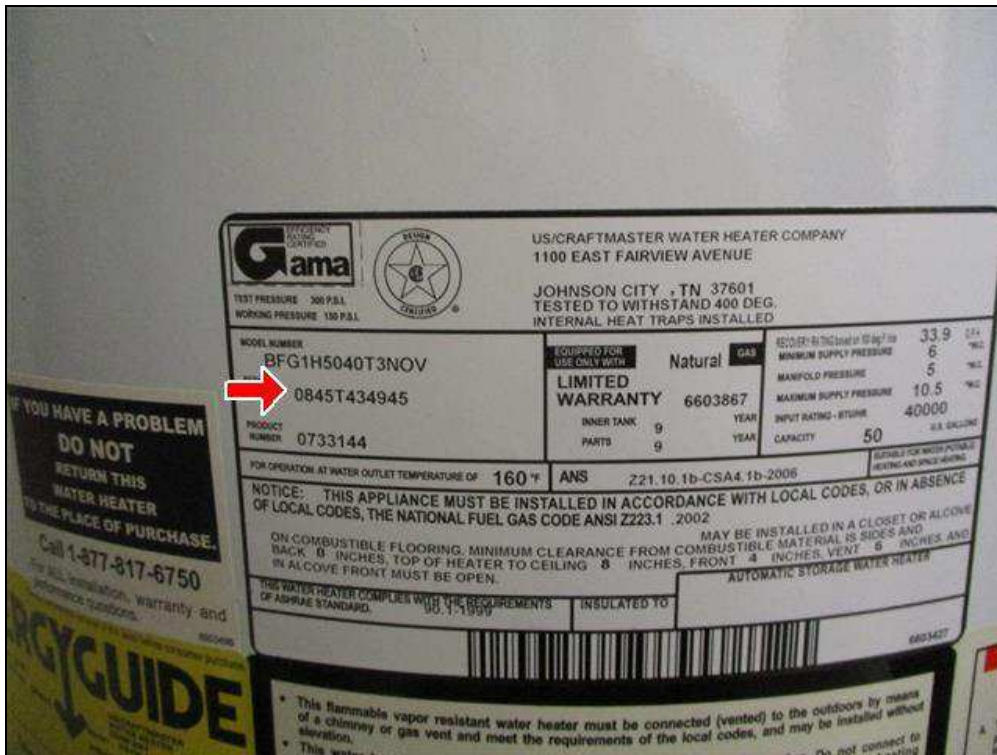
5.2 Item 1(Picture) Water heater data plate

(1) The water heater data plate indicates a manufacture date during the 45th week of 2008. Be advised the average life expectancy of a water heater in NJ is 10 years

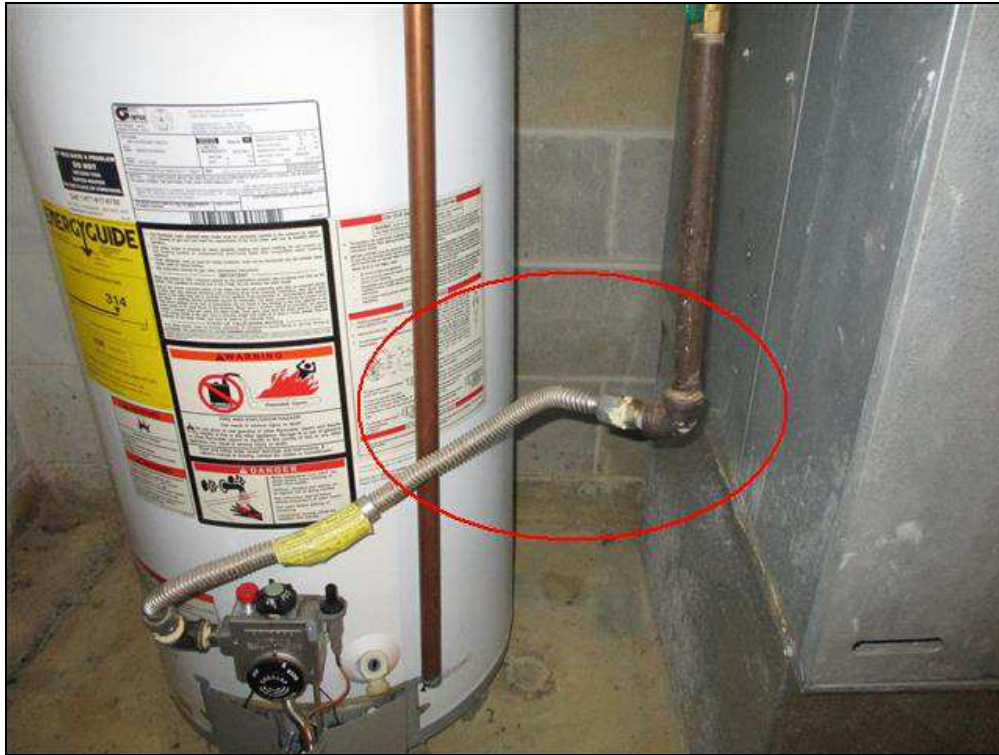
5.2 Item 2(Picture) No drip leg

(2) The gas supply line to the water heater in not equipped with a drip leg. A drip leg is designed to catch any impurities in the gas before it enters the appliance. I recommend that a drip leg be installed by a licensed professional plumber.

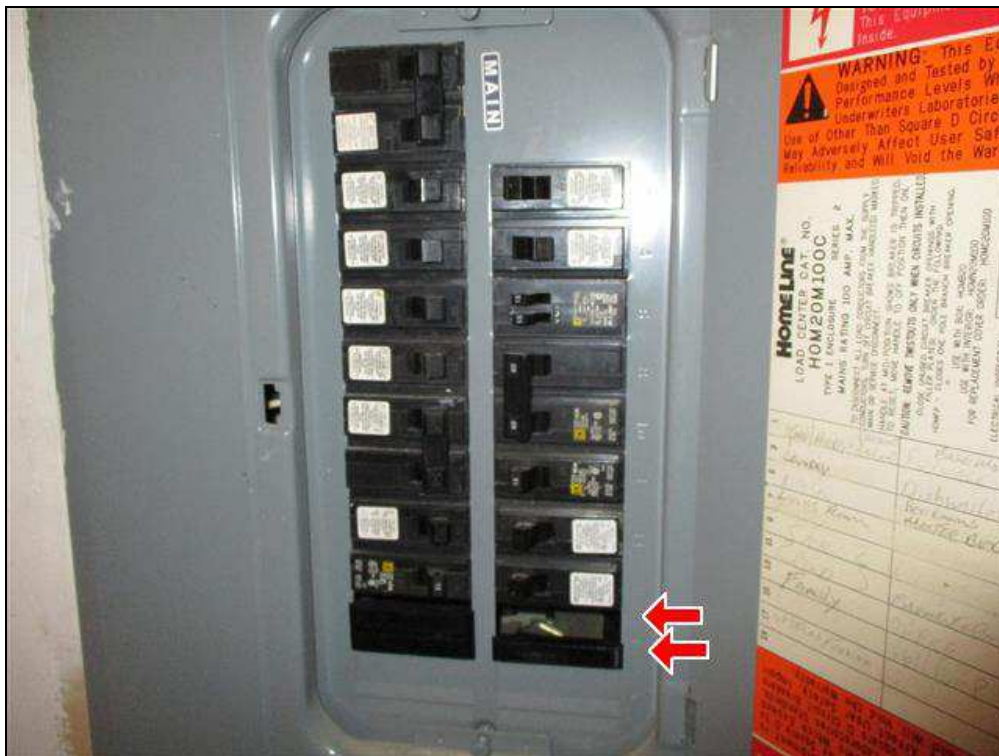
6.1 Item 2(Picture) Missing knockout covers

(2) There were multiple missing knockout cover plates in the electrical panel noted during the inspection. This situation allows direct access to the hot bus bars while the distribution panel cover is open. Serious bodily injury or death may occur if contact is made with the hot bus. I recommend additional knockout cover plates be installed. All repairs at the electrical panel should be performed by a licensed electrician

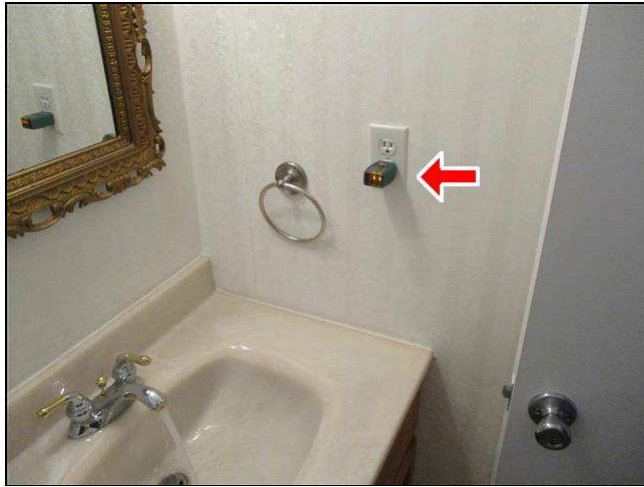
6.4 Item 1(Picture) First floor bathroom

(1) The pictured outlets at the first floor and master bathrooms are not GFCI protected. All outlets located within 3 feet of a water source are to be GFCI protected otherwise they are to be considered a shock hazard. All repairs involving wiring should be performed by a licensed professional electrician

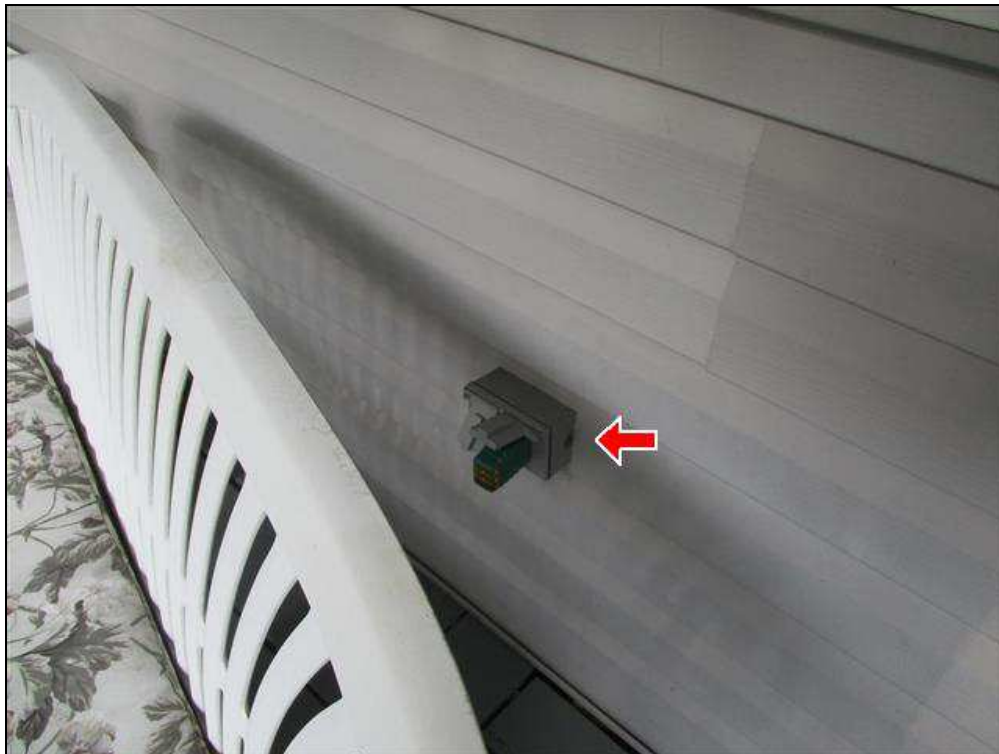
6.4 Item 3(Picture) front porch

(2) The pictured exterior outlets are not GFCI protected. All exterior outlets are naturally exposed to water and need to be GFCI protected. All repairs involving wiring should be performed by a licensed professional electrician

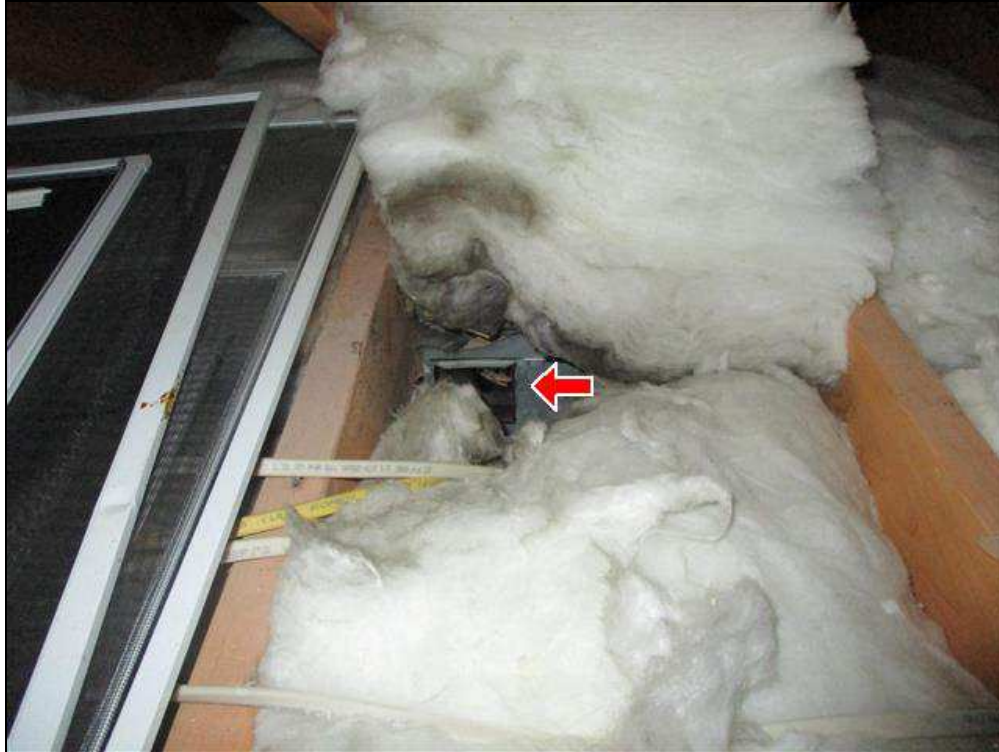
7.4 Item 1(Picture) Master bathroom exhaust fan

The exhaust fan does not vent to the outside at the master bathroom. Vent pipes that terminate in attic space can sometimes cause moisture that can lead to mold or cause condensation. A qualified contractor should inspect and repair as needed.

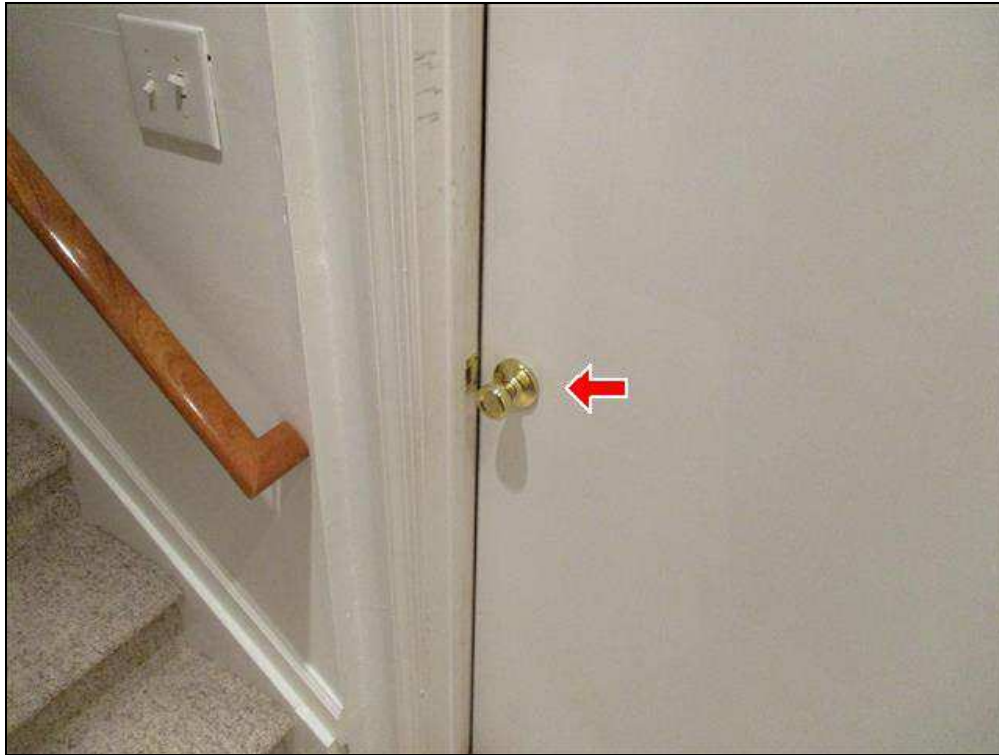
8.5 Item 1(Picture) Basement office

The entry door needs strike and latch adjustment to shut tight at the basement office. This is a maintenance issue and is for your information. A qualified person should repair or replace as needed.

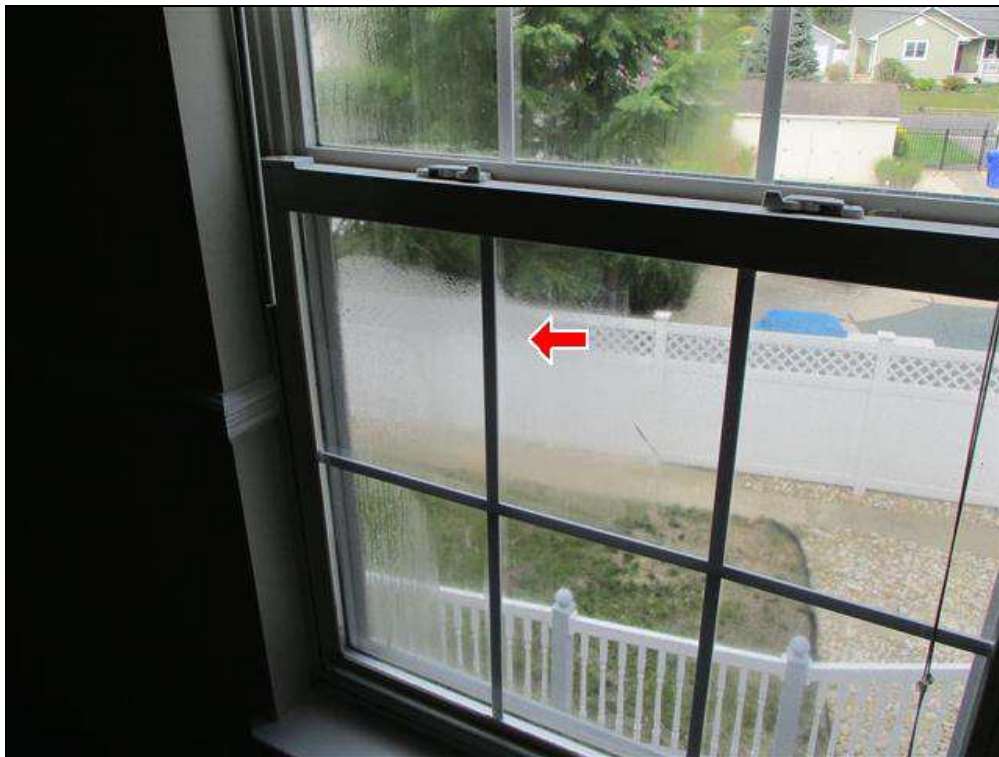
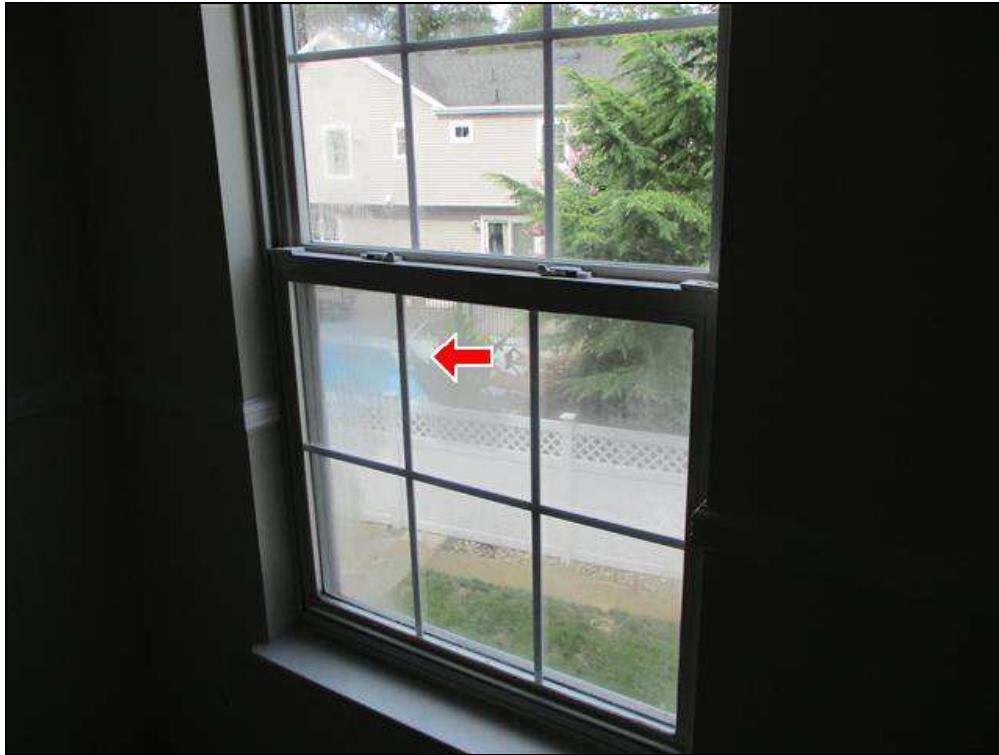
8.6 Item 1(Picture) Guest bedroom

Two windows are cloudy (lost seal) at the guest bedroom. This can cause some heat loss in winter and loss of cool air in summer if not corrected. A qualified contractor should inspect and repair as needed.

8.6 Item 2(Picture) Guest bedroom

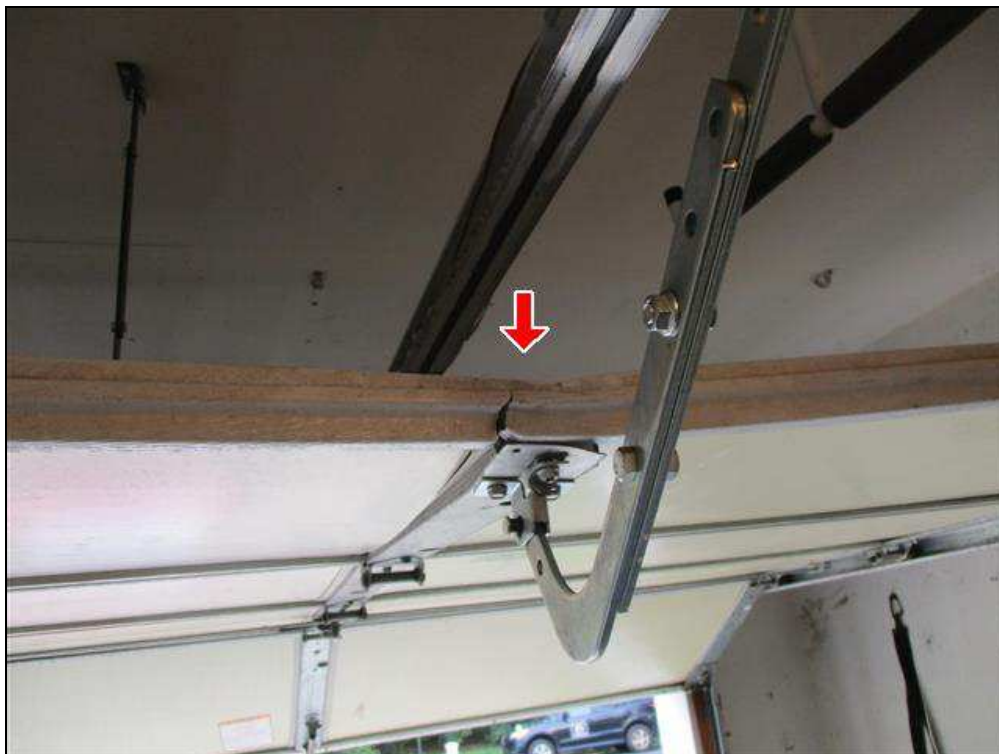
9.3 Item 1(Picture) Garage door

The garage door is broken in the top middle portion where it connects to the door opener. This is for your information.

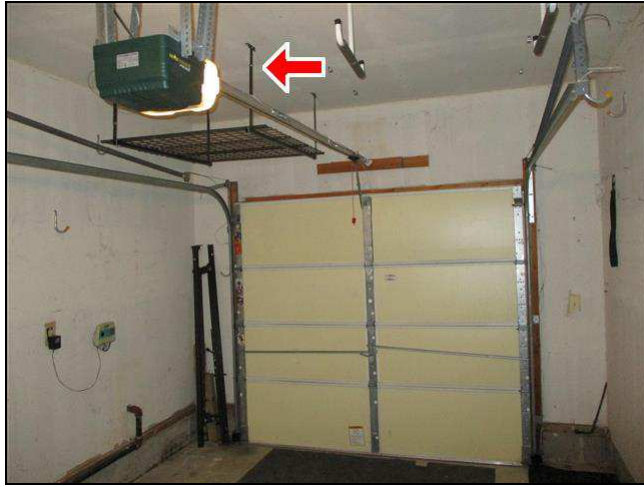
9.5 Item 1(Picture) Garage door operator

The garage door operator does not reverse when met with resistance. This is a safety concern and serious bodily injury or death may occur if not corrected. I recommend further evaluation by a licensed garage door specialist
