Inspection Report

South Seaside Park NJ 08752

JLC Home Inspections, llc

Date: 8/24/2017	**Time:** 02:00 PM	**Report ID:**
Property:	**Customer:**	**Real Estate Professional:**
South Seaside Park NJ 08752

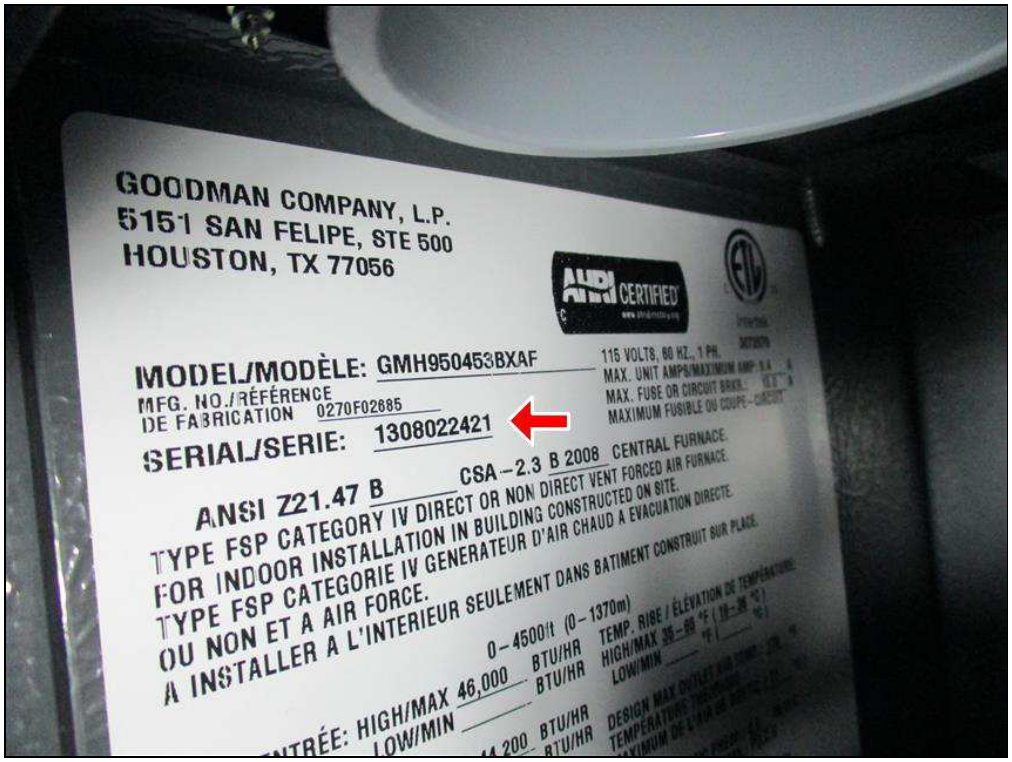
4.0 (1) The attic furnace data plate indicates a manufacture date during the 8th week of 2013

4.0 Item 1(Picture) Furnace data plate (attic)

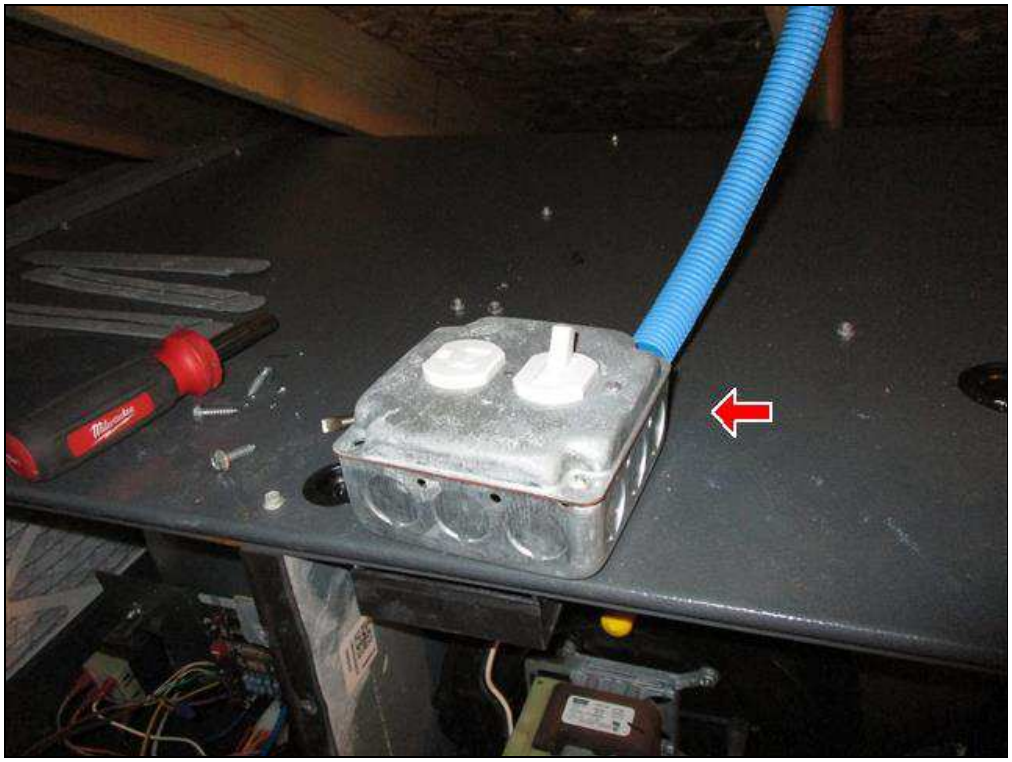
4.2 Both emergency shut off switches at the attic and lower level furnaces are not equipped with red cover plates indicating such. I recommend installation of the correct cover plates be performed by a qualified person

4.2 Item 1(Picture) Emergency shut off at attic furnace

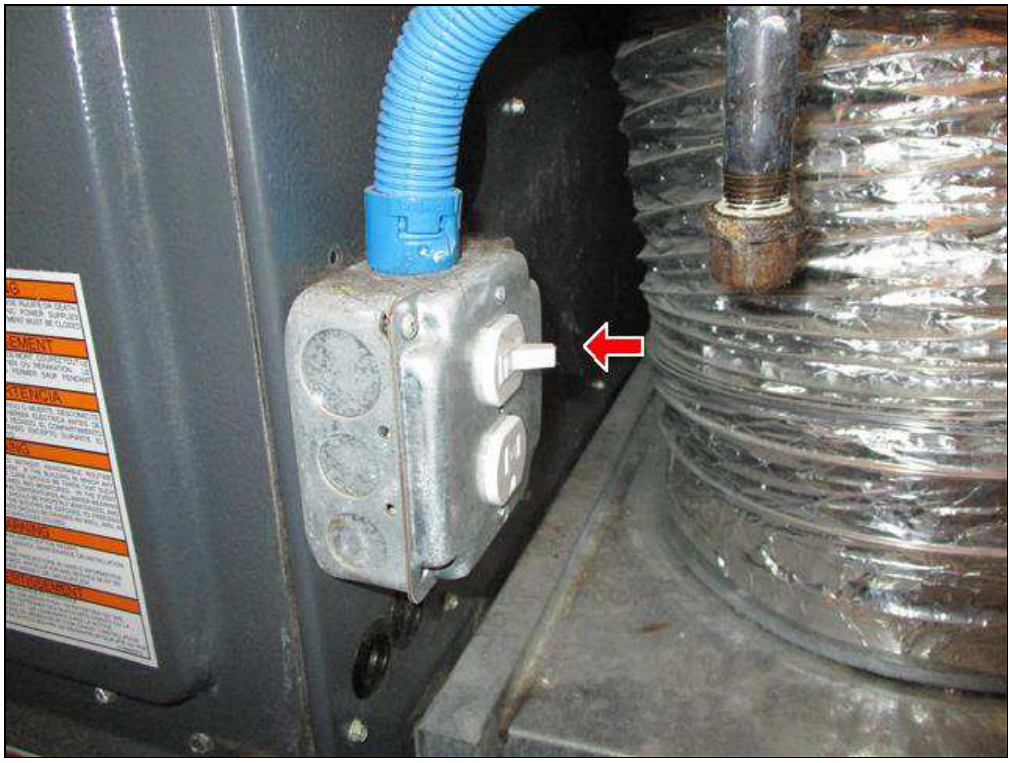
4.2 Item 2(Picture) Emergency shut off at lower level furnace

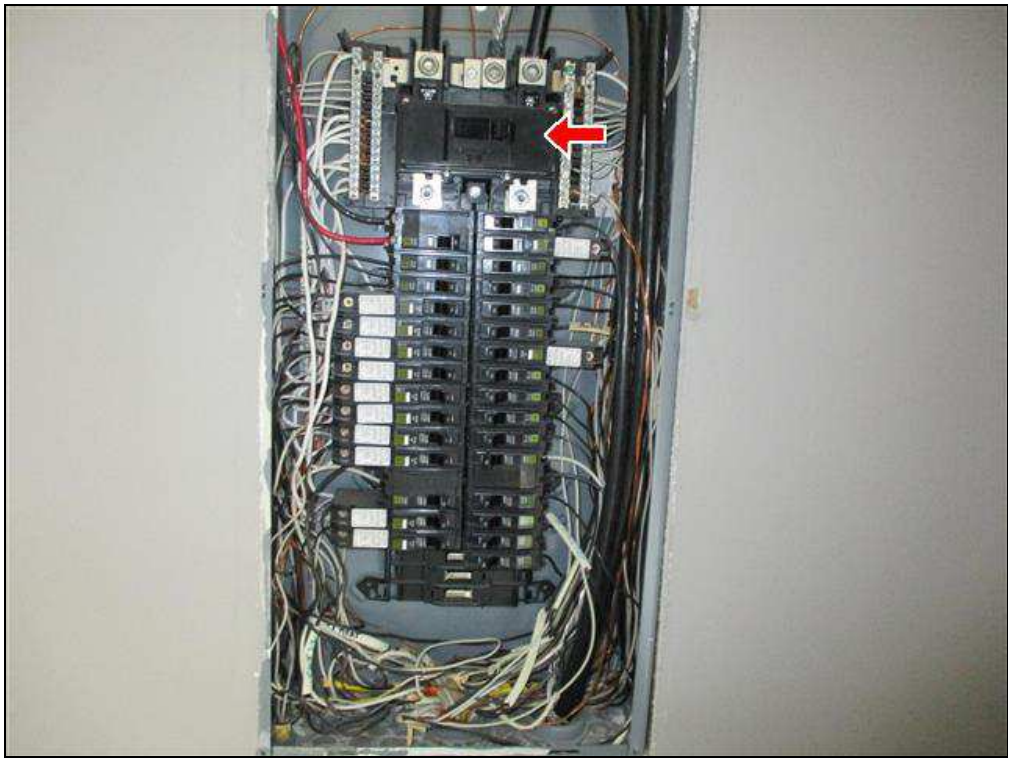
6.7 (1) The electrical distribution panel is located in the front sitting room on the first floor

6.7 Item 1(Picture) 200 amp main breaker

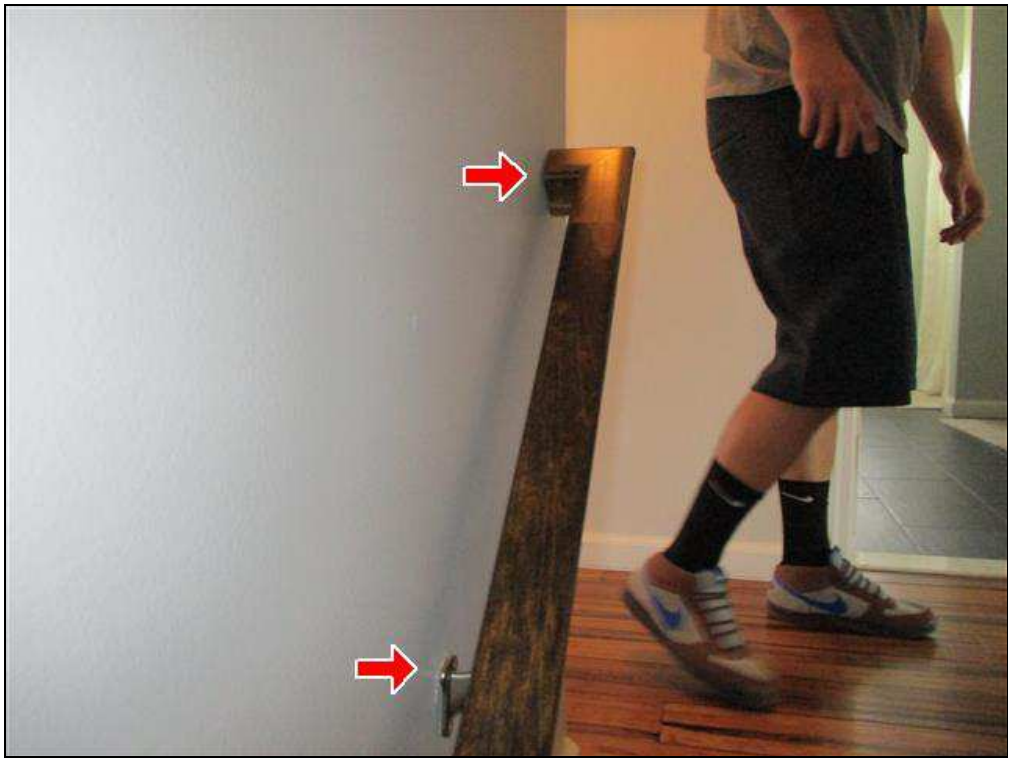
8.3 The hand/guard rail for the second story stairs is loose. A fall or injury could occur if not corrected. A qualified contractor should repair or replace as needed.

8.3 Item 1(Picture) Loose handrail

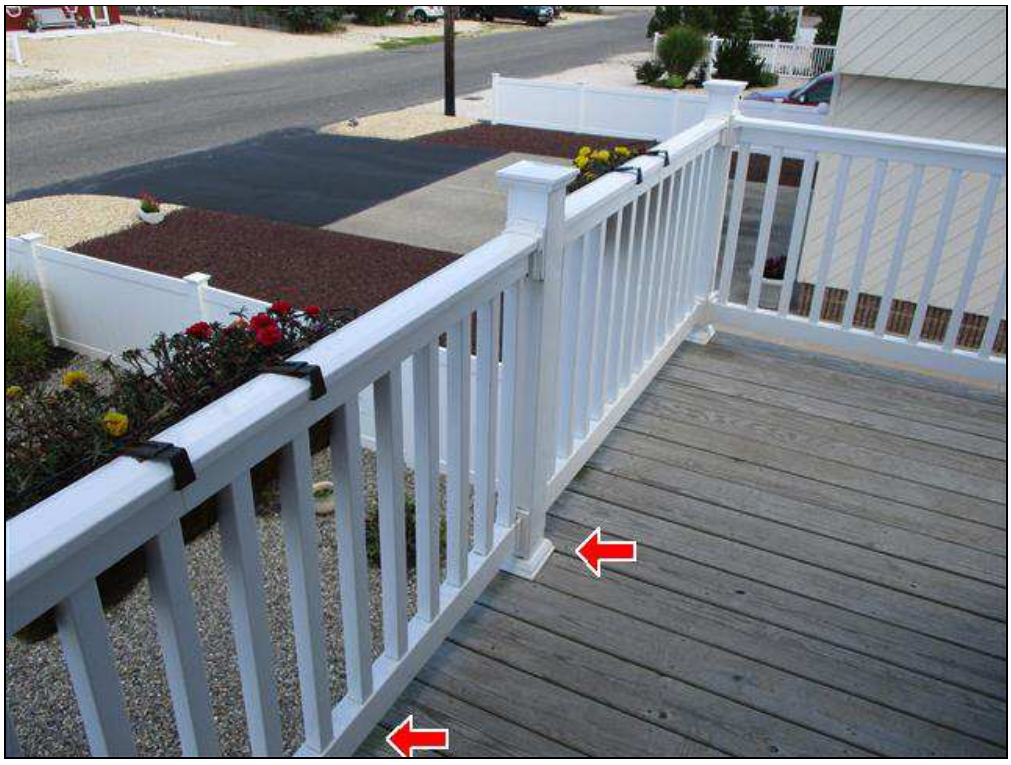
(2) The hand/guard rail for the deck at the front entry way is loose. A fall or injury could occur if not corrected. A qualified contractor should repair or replace as needed.

2.3 Item 2(Picture) Front handrail

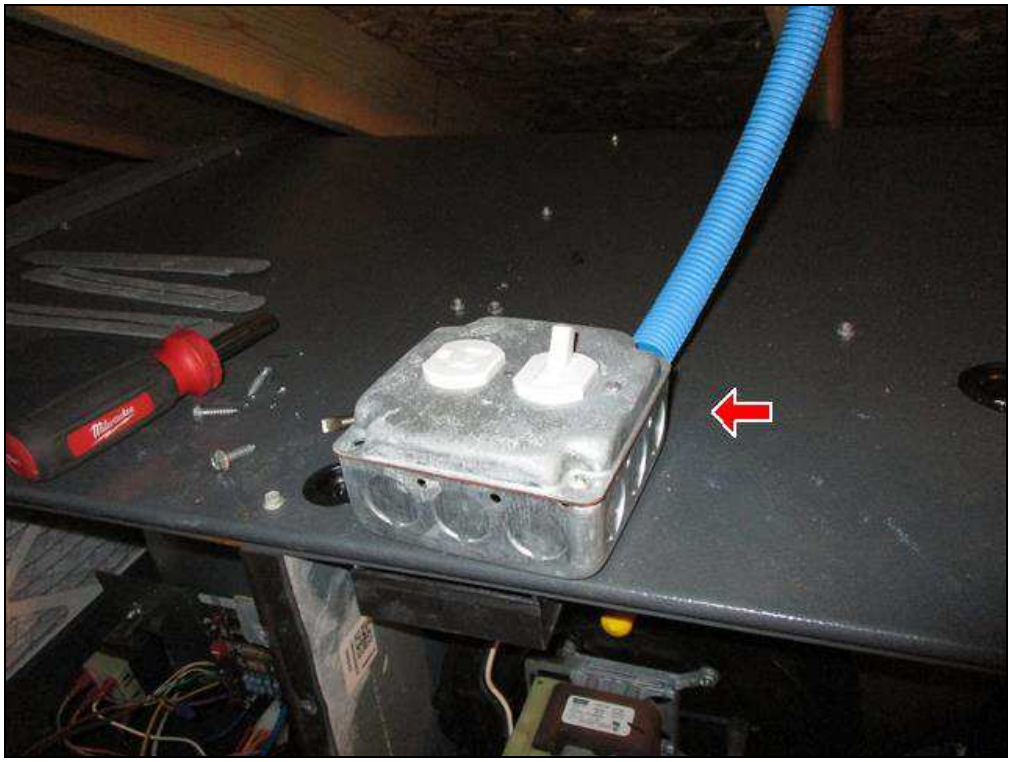
Both emergency shut off switches at the attic and lower level furnaces are not equipped with red cover plates indicating such. I recommend installation of the correct cover plates be performed by a qualified person

4.2 Item 1(Picture) Emergency shut off at attic furnace

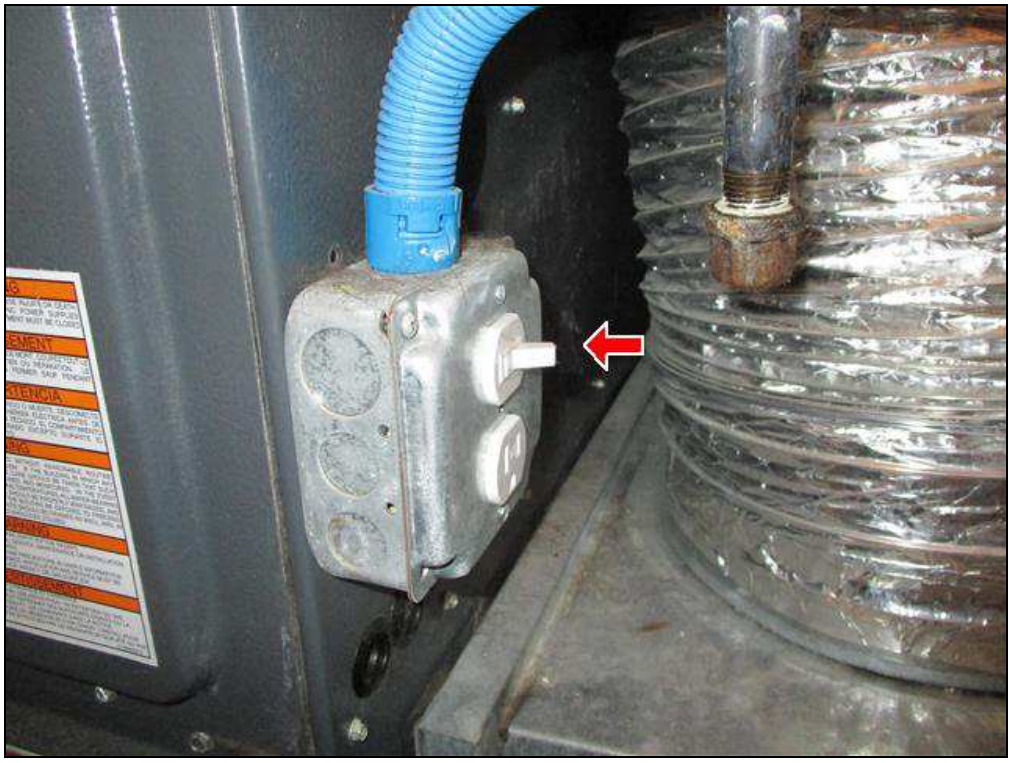
4.2 Item 2(Picture) Emergency shut off at lower level furnace

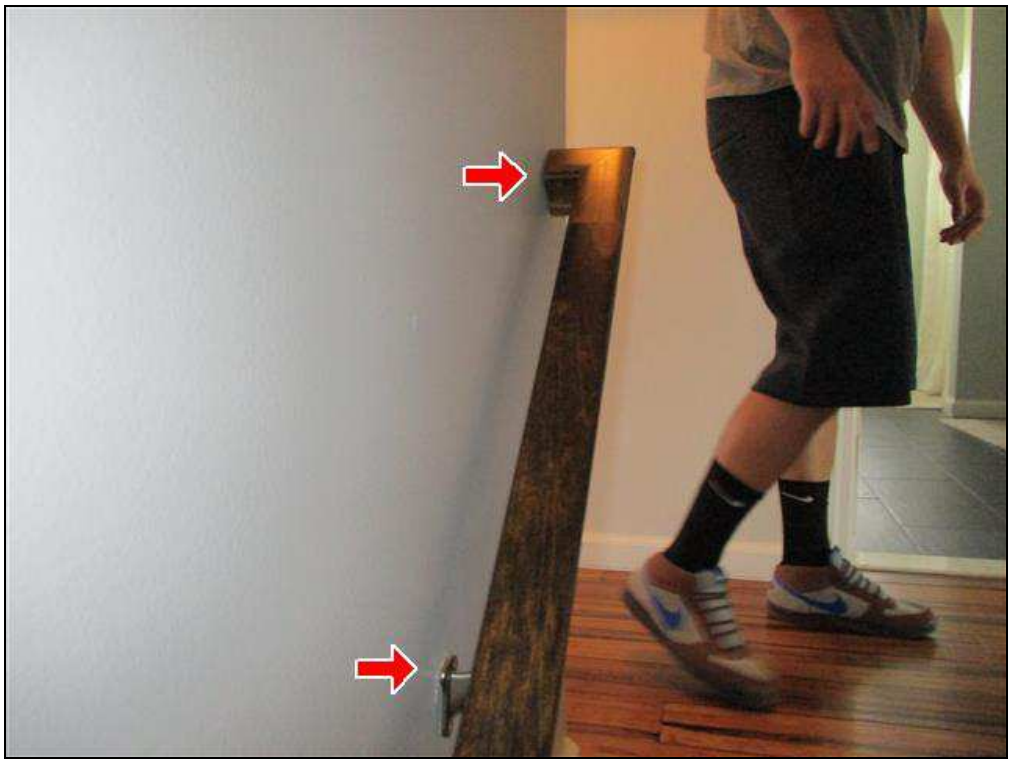
The hand/guard rail for the second story stairs is loose. A fall or injury could occur if not corrected. A qualified contractor should repair or replace as needed.

8.3 Item 1(Picture) Loose handrail
